Report of the Independent Inquiry into the Construction of the **DG One Complex in Dumfries**

APRIL 2018

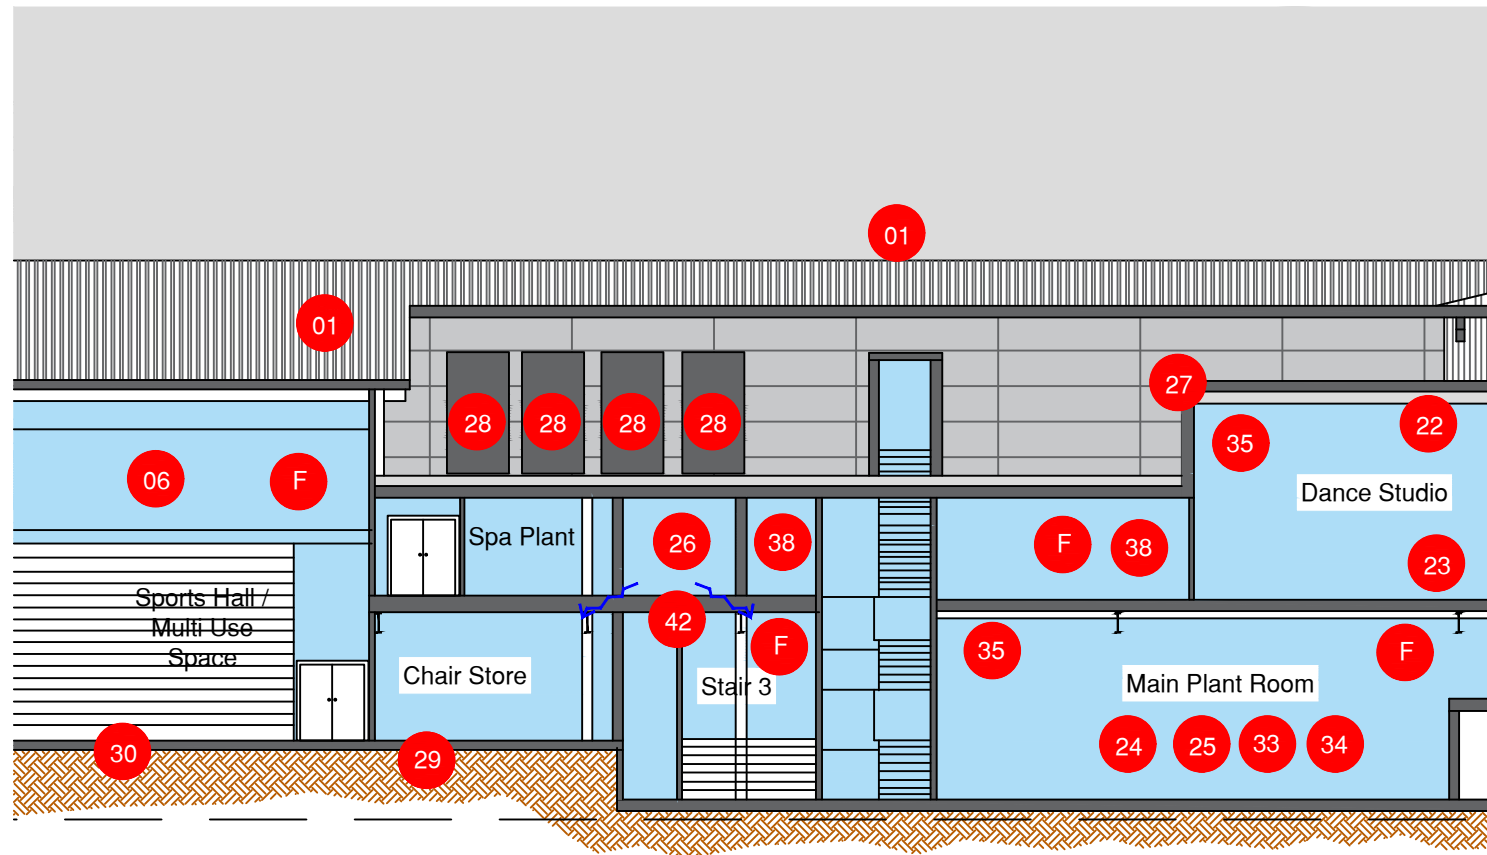
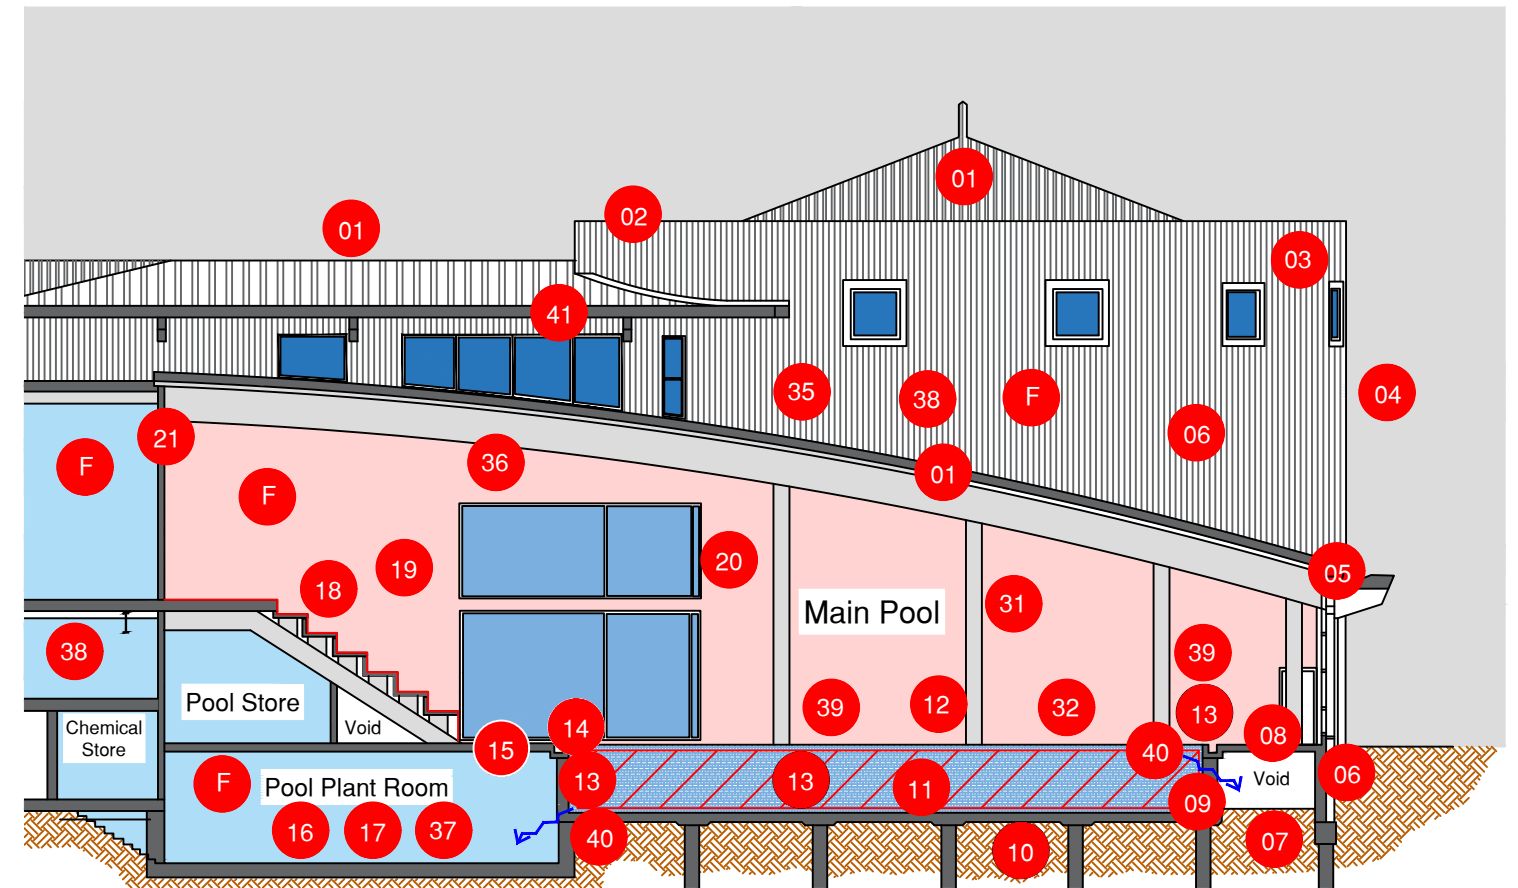
CROSS SECTION ILLUSTRATING EXTENT AND SPREAD OF DEFECTS THROUGHOUT THE BUILDING

The following sectional drawing of DG One provides an indication of the location and extent of defects to have been found in the building, based on the various reports prepared by the technical experts. Significant defects were identified in relation to virtually all key elements of the building as will be demonstrated in later sections of this Report.

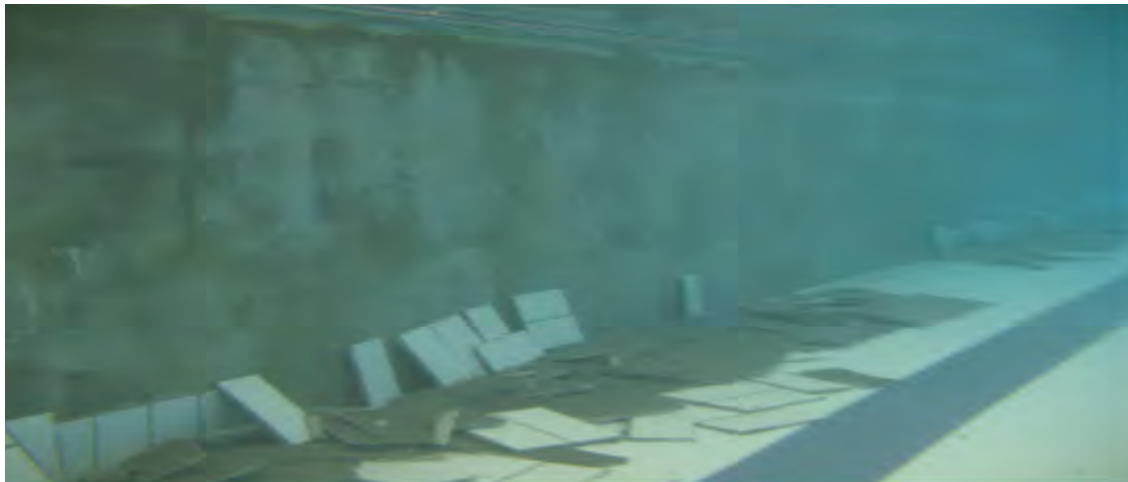
4.3 The following is an under-water photograph from a later report showing large areas of tiling de-bonded from one of the main swimming pool walls.

Tiles fully debonded from wall of main pool

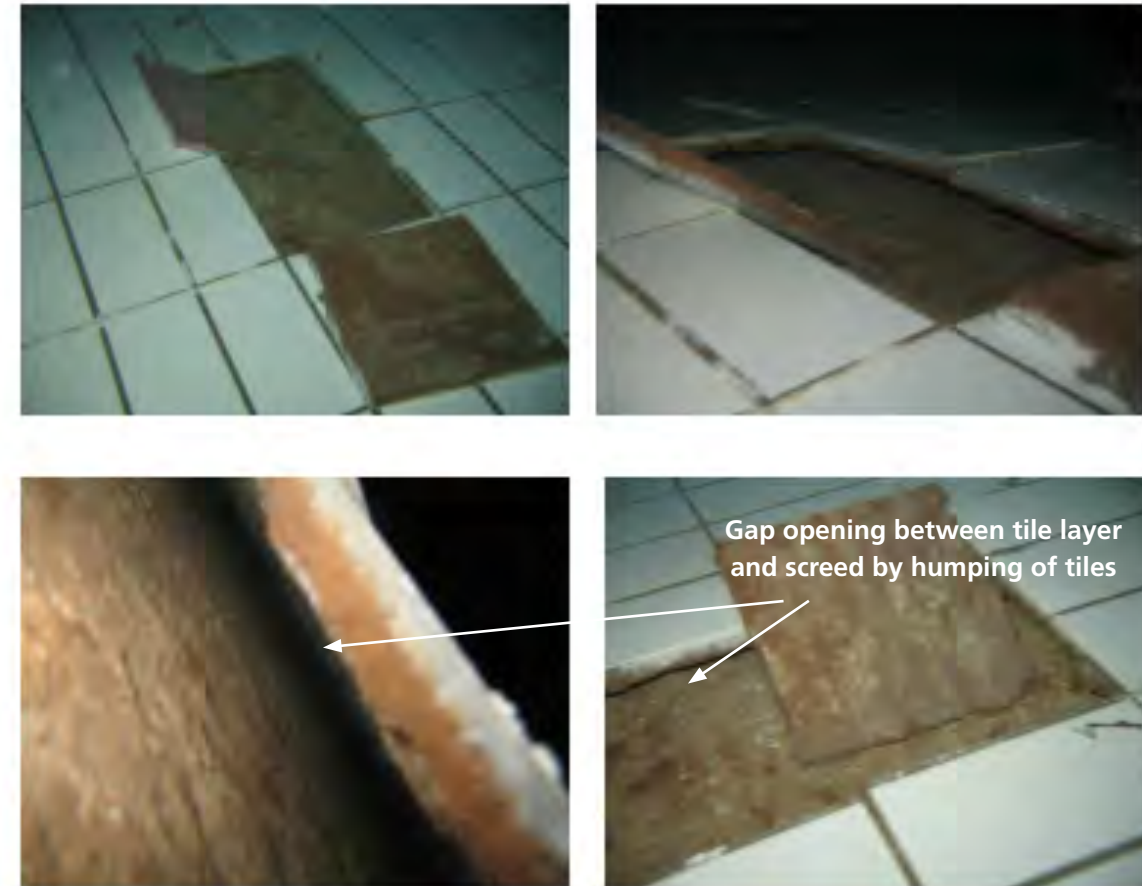
4.5 They reported that two areas of de-bonded tiles were lifting, which upon removal exposed the presence of excessive voids between the tiles and the background screed, resulting in extensive water ingress. The report also identified areas of calcium growth in tile grout joints throughout the base of the swimming pool, which it was suggested was potentially due to lime secretion from the existing adhesive/grout/screed, and a section of failing expansion joint.

Fully debonded and de-bonding tiles on floor of training pool

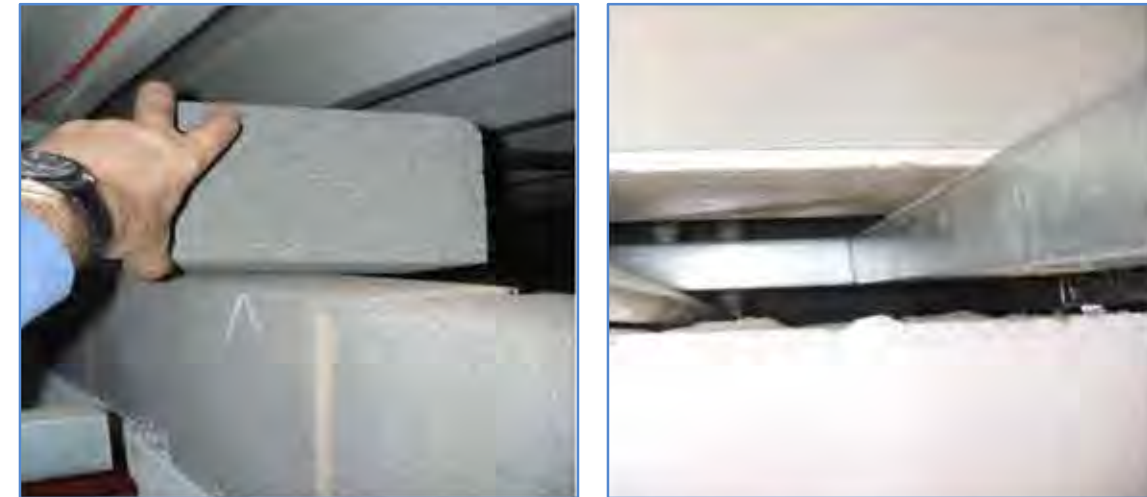
"In several locations in both the 'dry' and 'wet' sides, services and/or steelwork were noted to pass through compartment floors through excessively large holes where little or no fire-stopping was evident. This problem is also evident in internal compartment walls and must be addressed as a matter of urgency as this comprises a significant fire risk"

Defective fire compartmentation

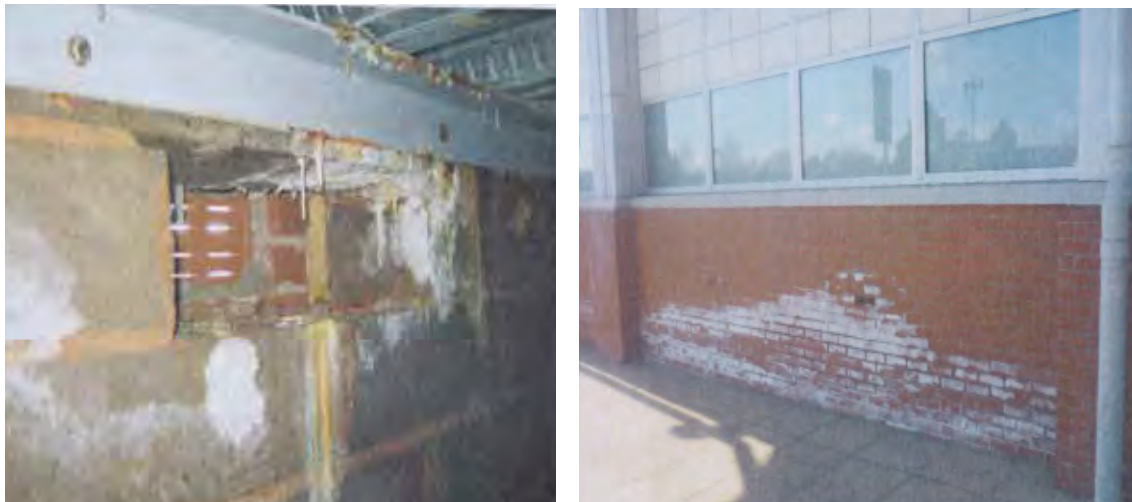
10.3 This had resulted in; the creation of extensive areas of encrustation along the full length of the external wall abutting Leaffield Road; the saturation with water of the masonry in the wall; the corrosion of both the steel angle supporting the floor and of the wind-posts used to stiffen the external masonry panels causing damage to their intumescent fire-protective coatings; and the saturation of an area of plywood deck which was supporting an area of the floor above. The following photographs from the report demonstrate the resulting level of saturation of areas of the external wall.

External and internal faces of saturated cavity wall

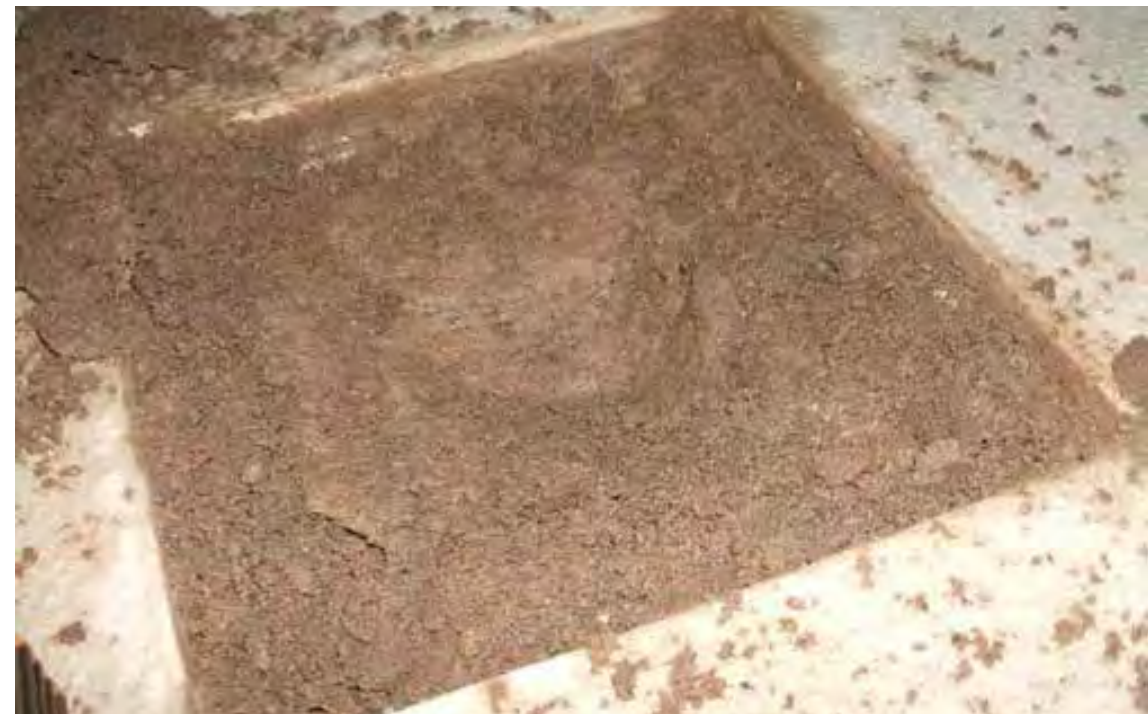
10.9 As DG One was still operating and open to the public, there were limitations on the extent of intrusive investigations that the in-house team could carry out, however, permission was given to lift a small area of tiling to the walkways around the pool in the pool hall. This revealed that the weak mix sand/cement screed on top of the concrete floor was fully saturated with water and had broken down into a loose sandy mix as shown below.

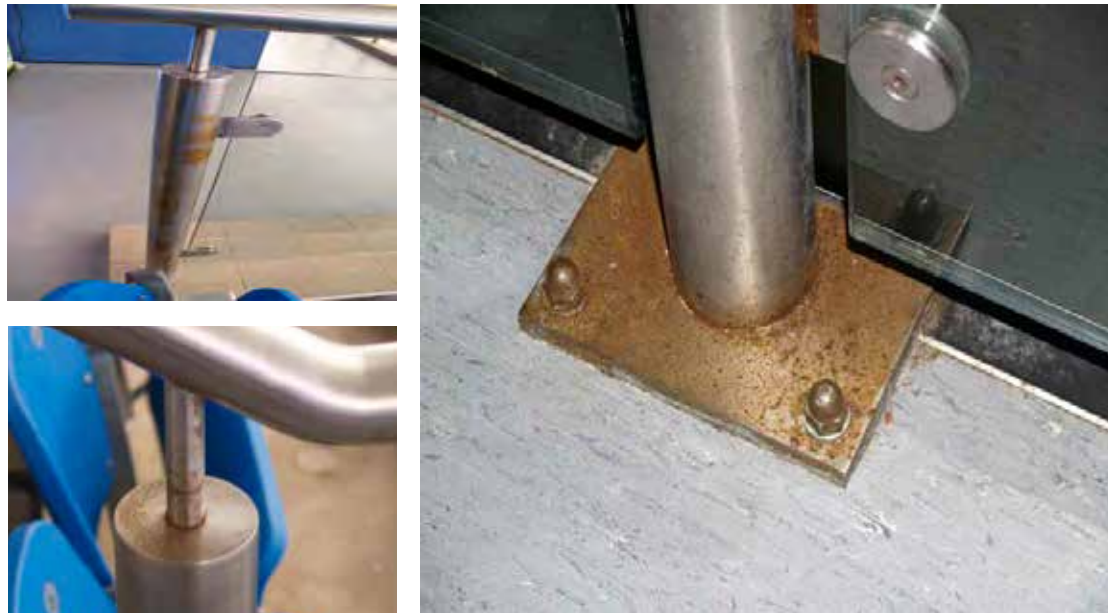
The poolside and changing village ventilation temperatures and humidity levels are operating out-with design parameters. This is resulting in condensation forming on hard surfaces, corrosion being evident on 'stainless steel' handrails etc."

Examples of corrosion to steel fittings throughout the wet area

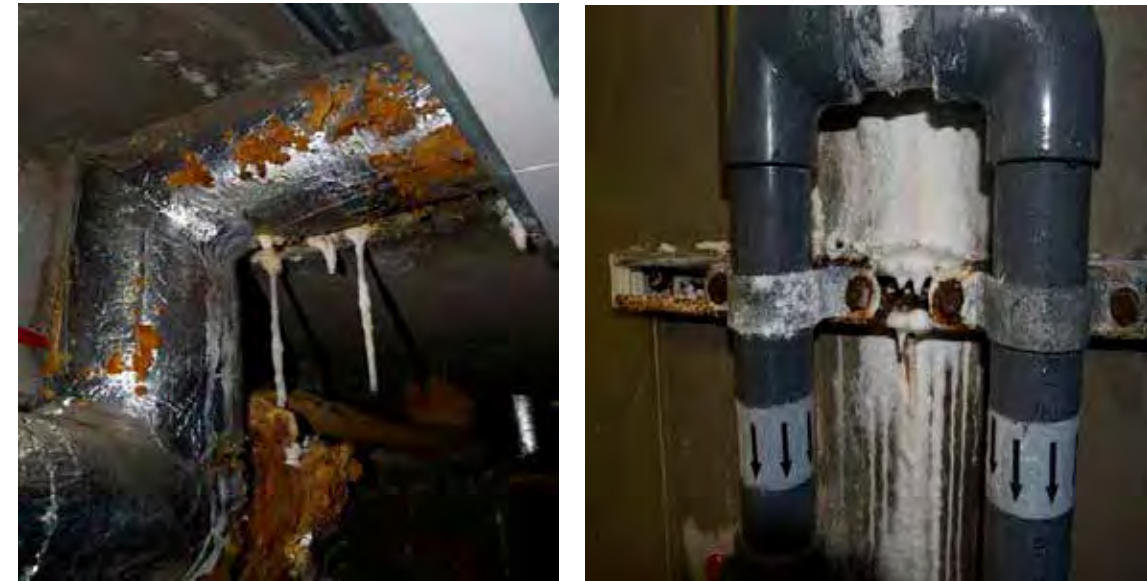
"Severe corrosion was evident to electrical and mechanical services from pool chemicals and condensation"

Examples of damage to pipe insulation and to galvanised fittings

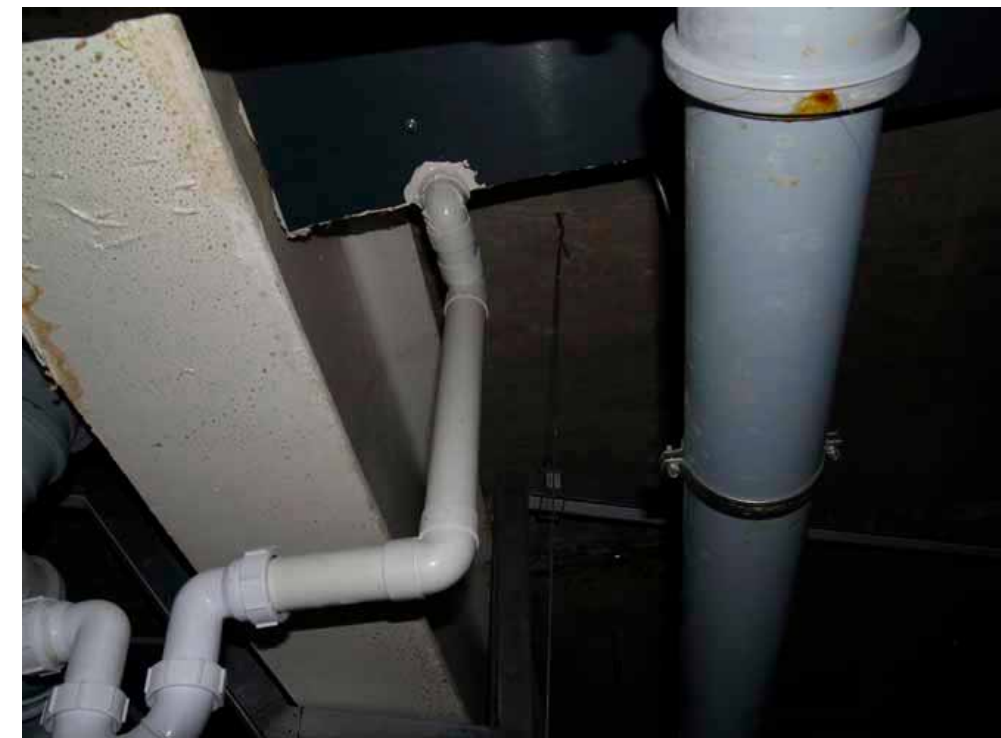
"The ventilation system within the changing village ceiling void sees ventilation insulation missing, pipework insulation missing, no insulation to drainage, leaks from drainage; the effect of the aforementioned leaves the ceiling tiles in a considerable state of disrepair"

Leaks over changing areas and contractor's 'metal tray with drainpipe solution'

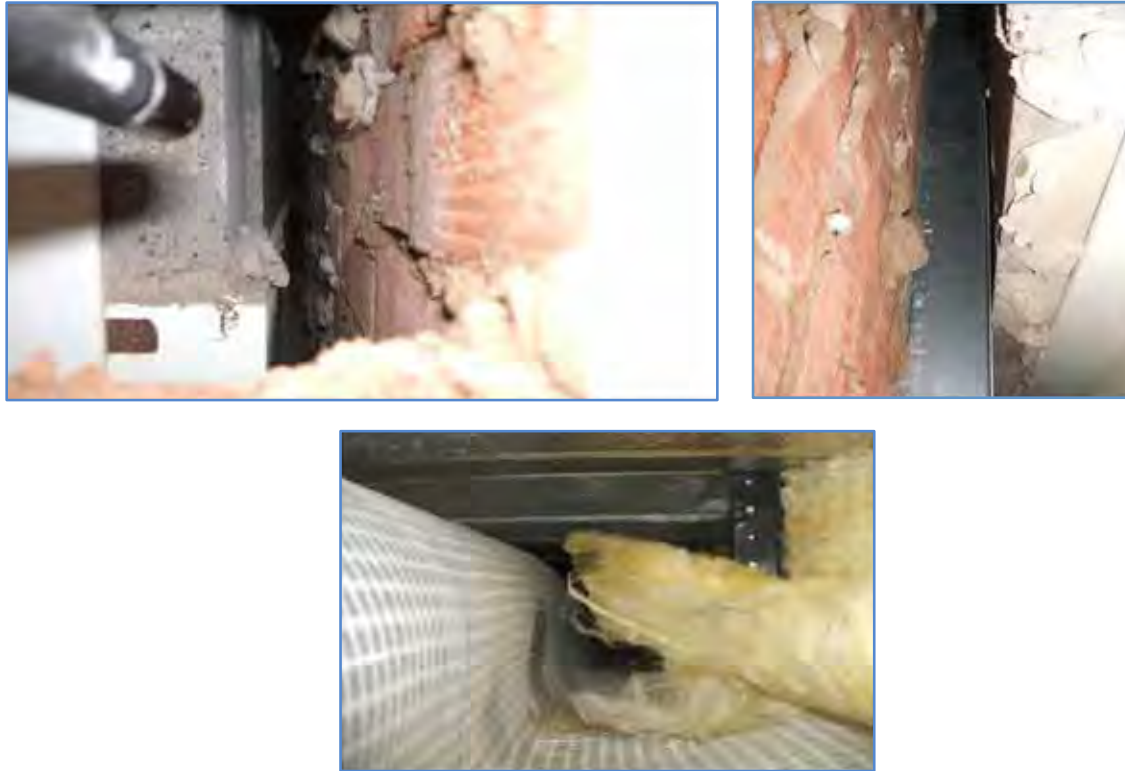
13.4 The bottom photograph below is of an opened-up section at the edge of the roof showing a wide gap in the insulation where it was not carried over the perimeter edge of the building to meet the insulation and vapour seal in the wall, thus creating a major route for heat loss.

Absence or inadequate installation of insulation to walls and roof

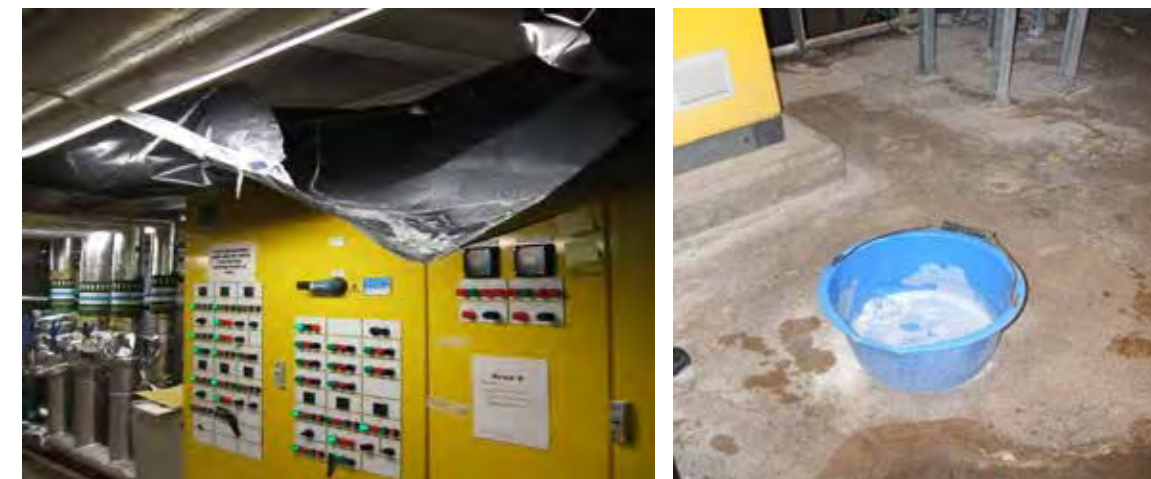
- *Leaking into the changing village area has been addressed by Kier by use of a series of metal tray and drainpipe constructions, hanging from the soffit. These measures have been in place for two years but should only be considered as temporary mitigation until the leaks can be located and responsibly repaired. (Similar even more basic techniques had been used by staff to redirect plant room ceiling leaks away from electrical switchgear. See photograph below)*

Polythene sheeting protecting electrical switchgear in the Plant Room from overhead water leakage, the redirected water being collected in a bucket.

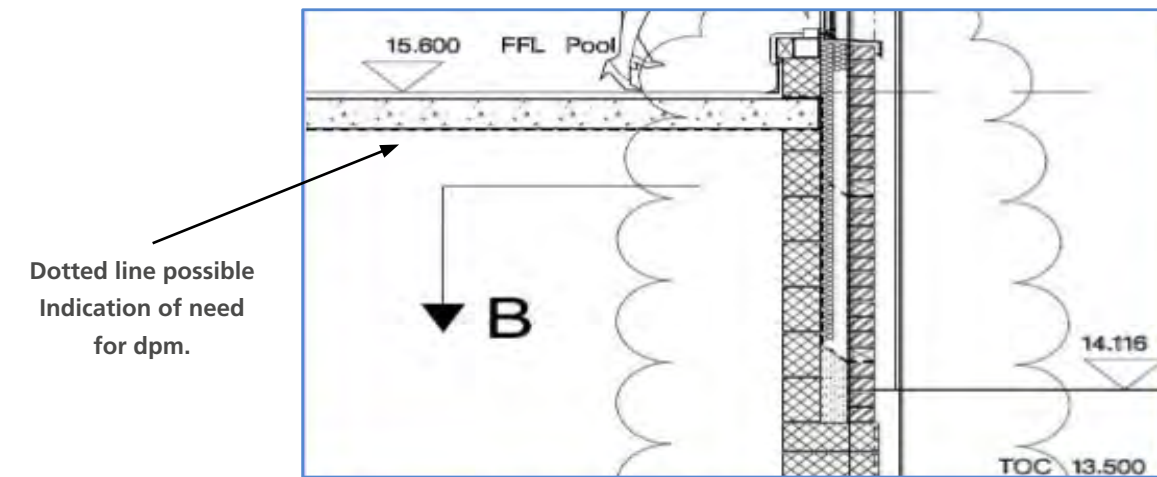
Detail from construction drawings showing section through void under pool

16.8 The presentation also showed the sectional detail below, which is from the construction drawings provided as part of the Operation and Maintenance information. It was prepared by a member of the design team appointed by Kier Construction. The drawing seems to be indicating by way of the dashed line under the concrete floor a requirement for the installation of a damp proof membrane. However it is difficult to see how this proposal would have been practically implemented and no damp-proof membrane pm was found.

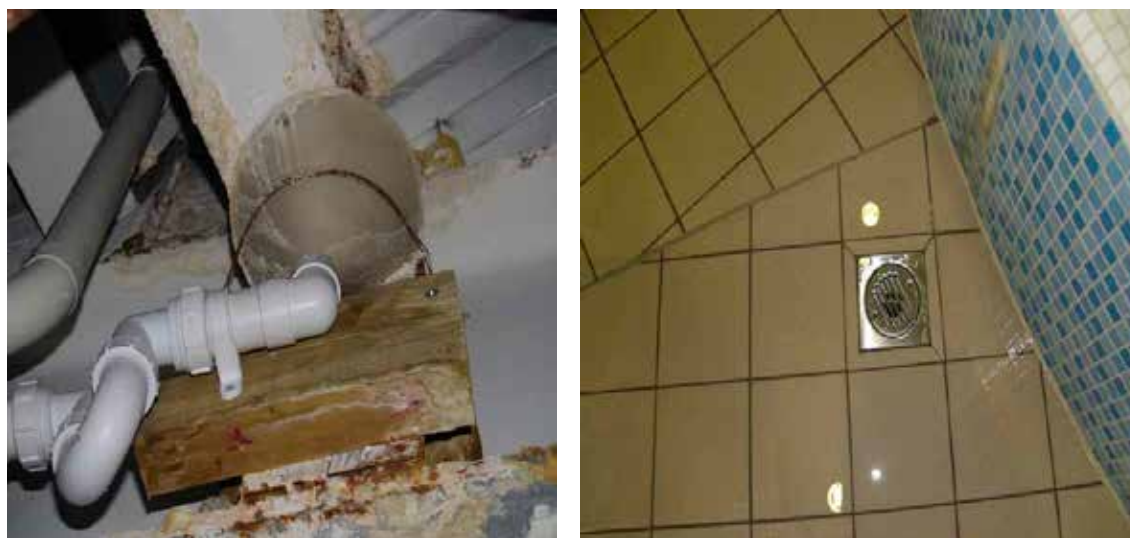
1. Saturated and disintegrating sand/cement screed under pool walkway and evidence of constant ponding on walkway

2. Domestic funnel collecting leaks from the spa pool and area of ponding at Spa

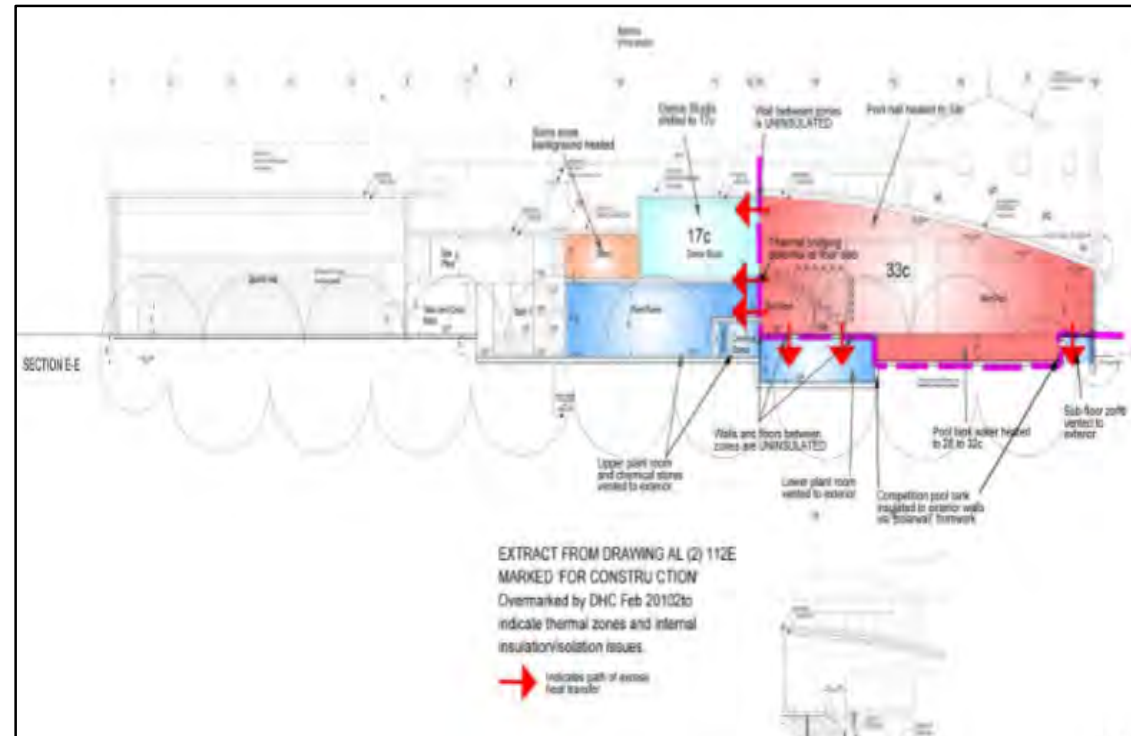
Section through Dance Studio / Pool Room Interface

21.2 The sectional drawing, shown below, indicates the direction of movement of hot moist air from the **pink coloured 'wet' zones** into the **blue coloured 'dry' zones**, plant rooms and voids. The penetration of hot air into the dance studio and fitness suite areas, which were required to maintain a cool temperature of 17 degrees, meant that these areas were often very hot and uncomfortable for users. The air-handling units serving these areas were therefore continuously running to extract unwanted hot air, resulting in major inefficiencies in the overall heating and ventilation systems of the building.

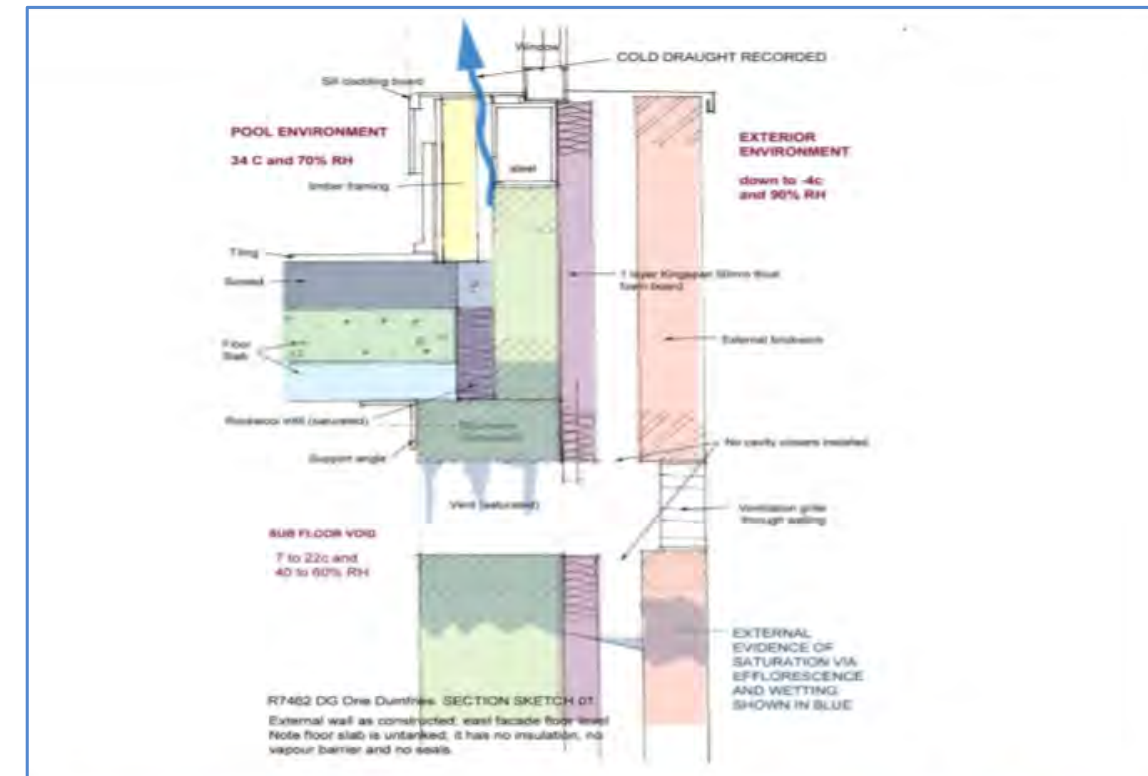
21.4 As a result of the absorption of moisture, significant areas of insulation in the external envelope of the building, had become saturated therefore reducing its effectiveness. The following three drawings were part of the March 2012 presentation made to Council by the expert advisers as examples of what had been found in this regard.

Saturated Insulation and blockwork in external wall to side of Pool Hall

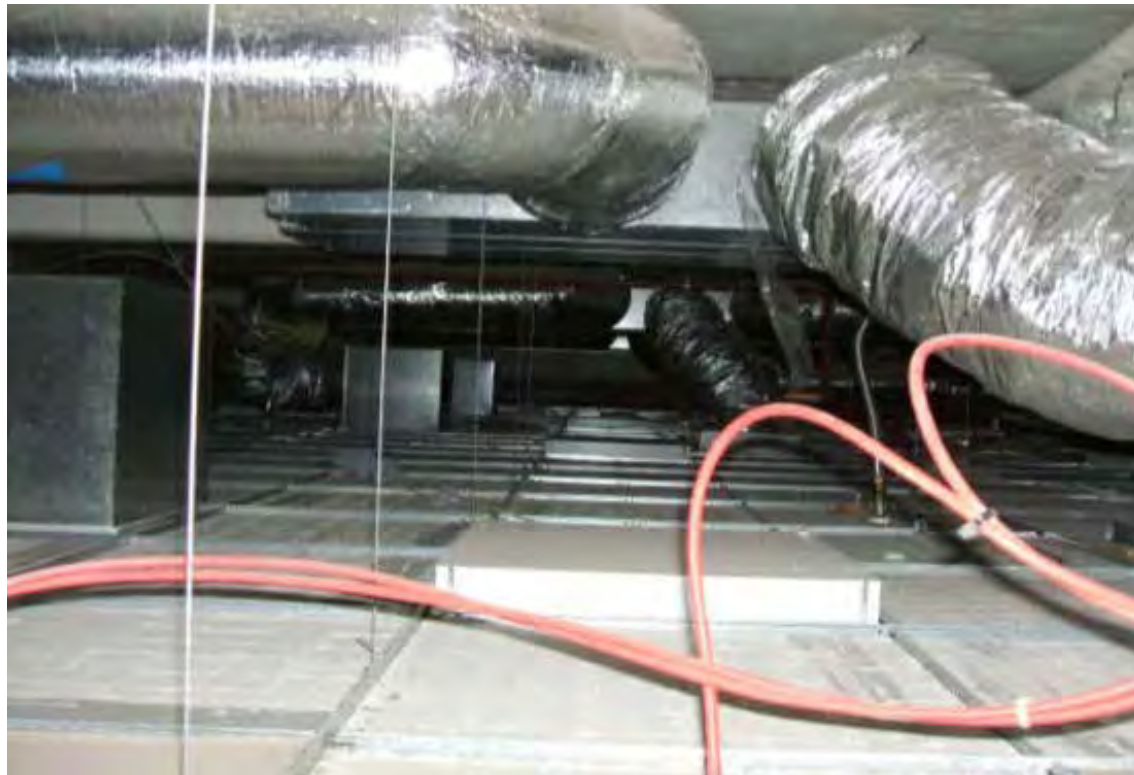
- It has been found that recessed luminaires (light fittings) mounted within the suspended ceilings have been installed directly into the suspended ceiling grid at all locations inspected throughout the building. No independent supports for the luminaires have been provided. The same has been found for the air supply and extract grills within the suspended ceilings although in some areas (dry changing) they were found to be independently supported. The luminaires and air diffuser grills exceed the 3kg weight limit and require being independently supported.

Luminaires without independent support resting on ceiling over gym

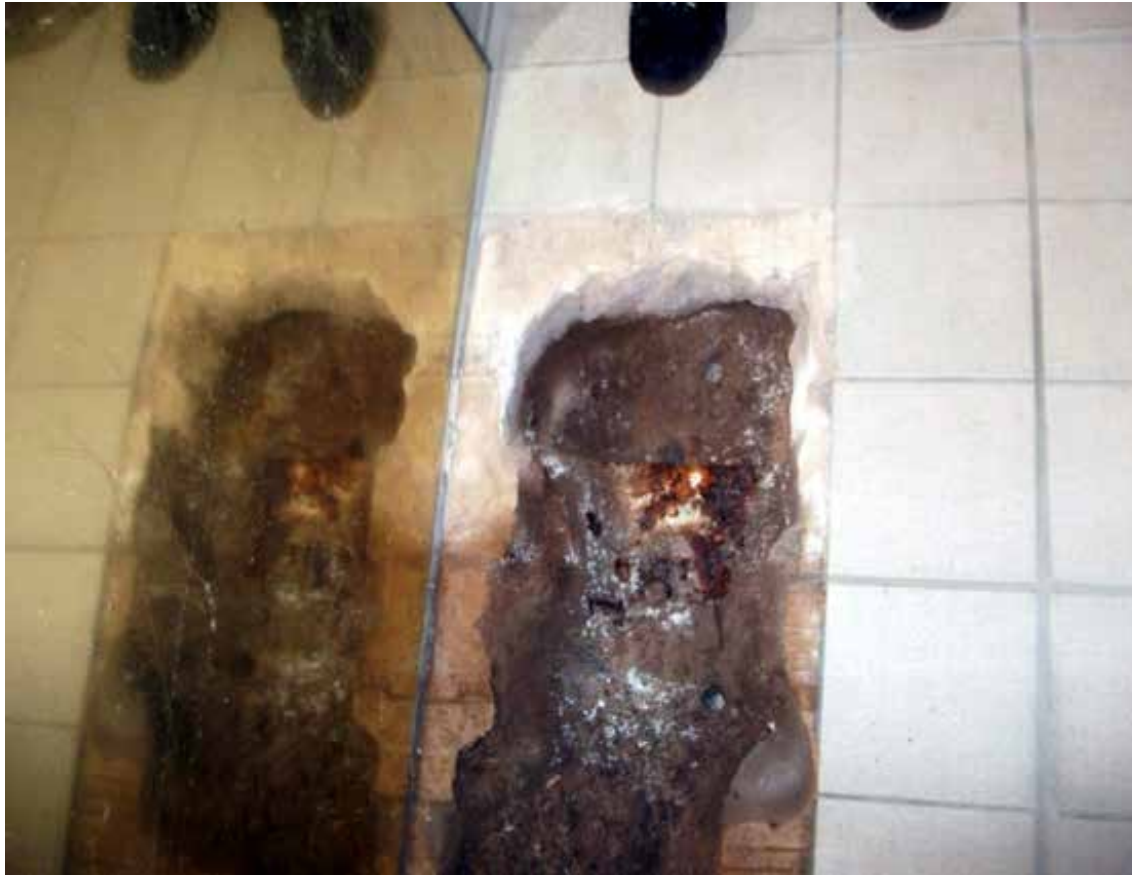
23.3 The following photograph, which was included with the file note, shows the corroded steel beam (and its reflection in a mirror) in the screed below an opened section of tiling.

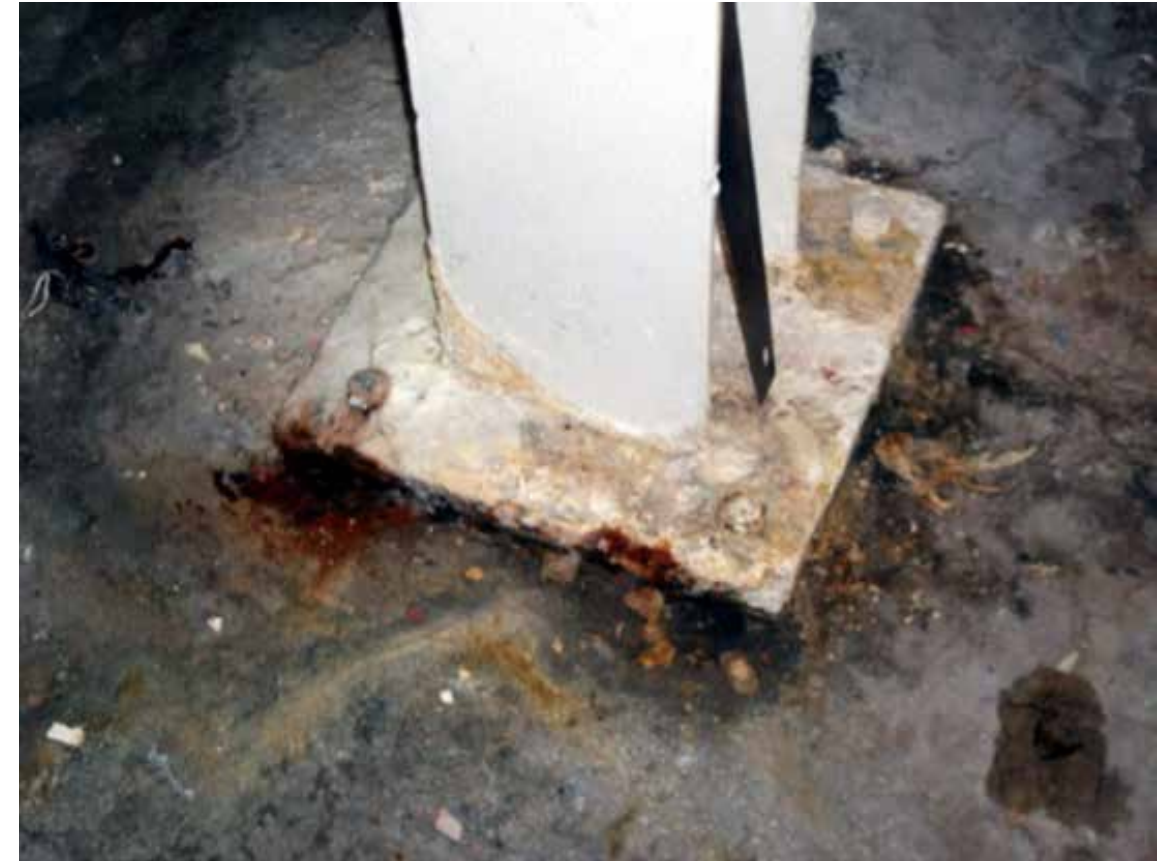
23.5 This comment was supported by the following photograph of this rusting column, which was taken during the structural engineer's visit.

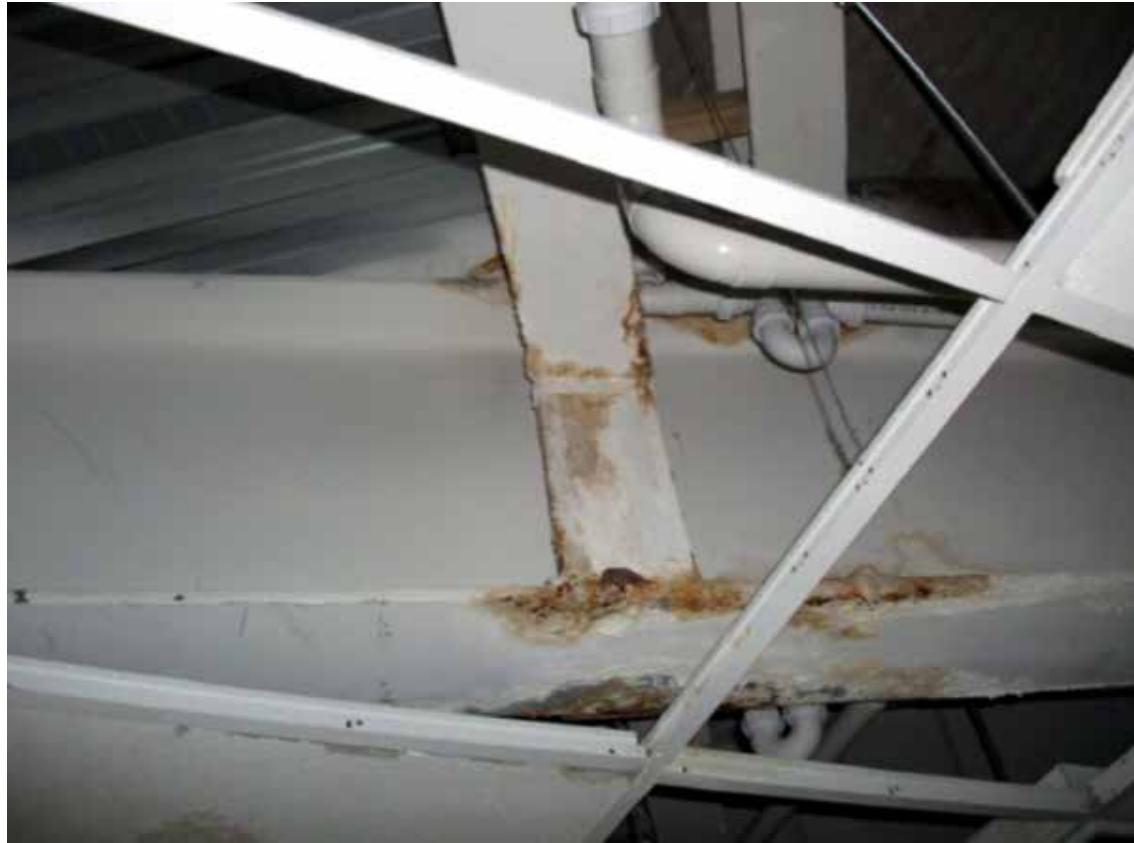
"Similar issues of rusting steelwork and efflorescence was evident within the changing village to the soffit of the first floor supporting the spa pool. Where ceiling tiles had been removed to expose the soffit of the floor above, significant rusting of the main structural steelwork frame, efflorescence to the underside of the precast concrete floor slabs and evidence of salts leaching from Holorib floor slabs could be observed as in the following photograph".

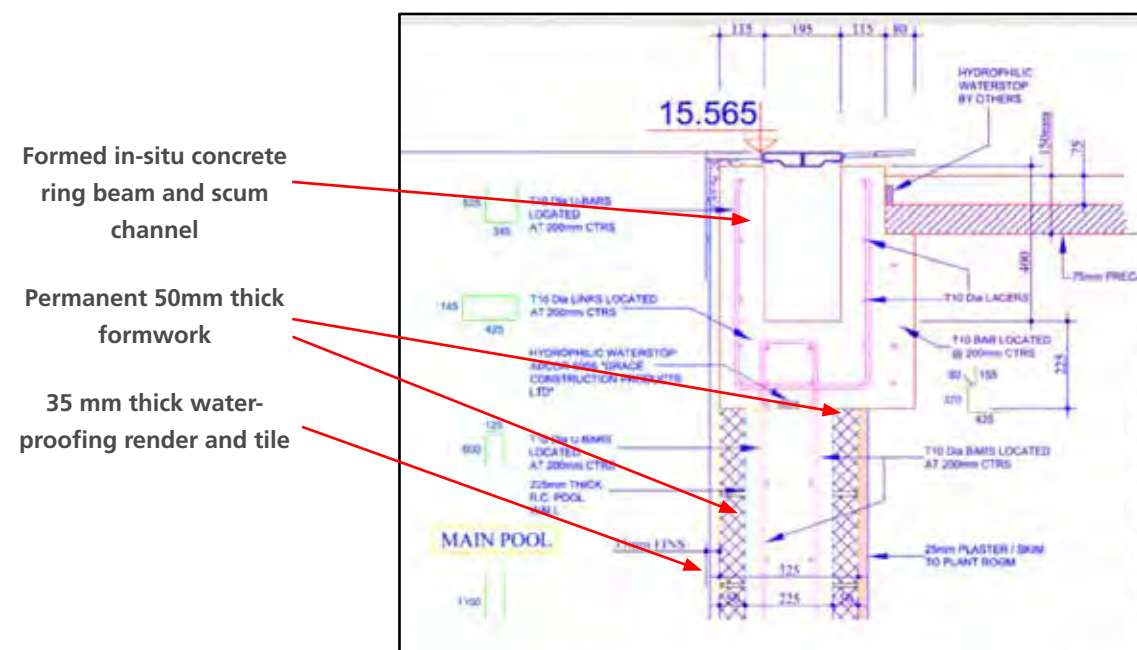
Detail from Contractor's construction drawings by Harrison and Taylor Ltd.

24.15 The as-built documentation for the project, required under both the terms of the contract and the statutory CDM regulations, failed to show the actual detailed construction of the pool walls as built.

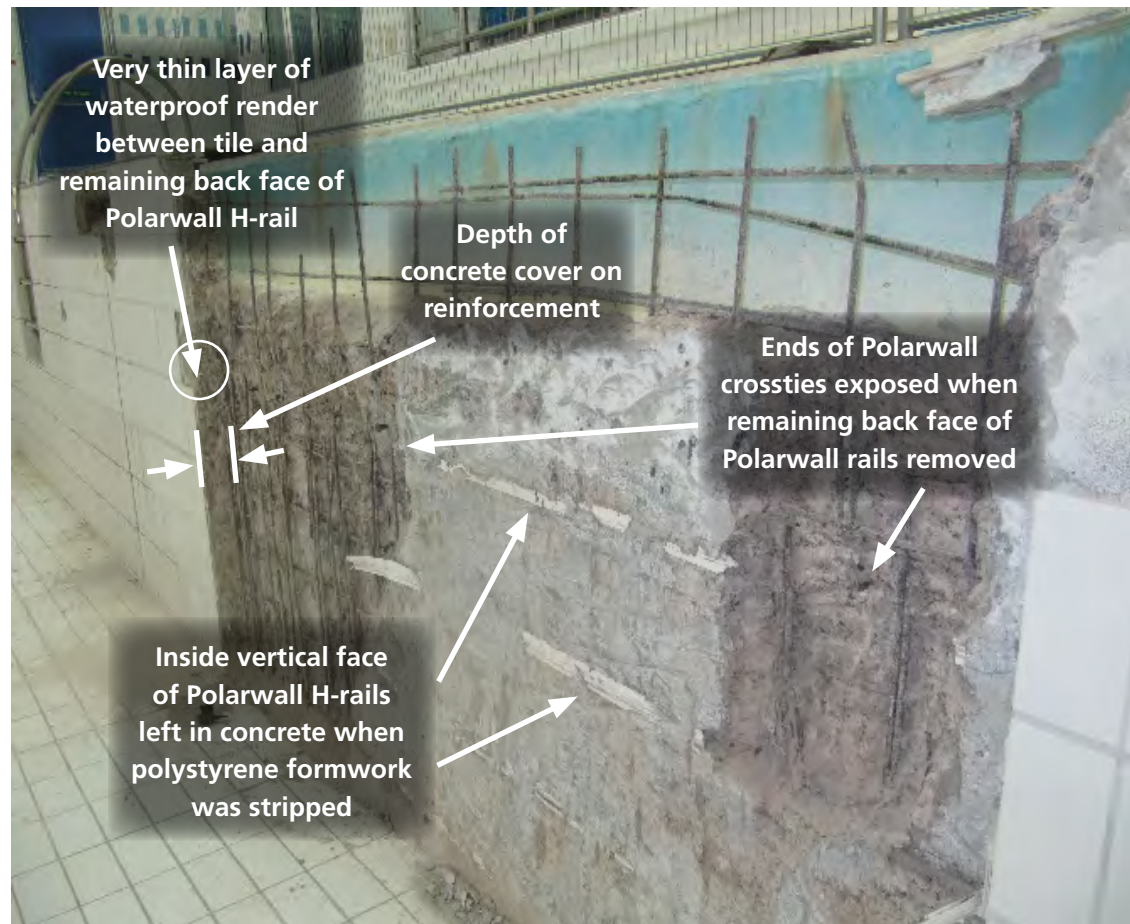
24.23 The following photograph was taken of a section of the wall of the main pool closest to the viewing area after it was opened up as part of the ongoing remedial works contract to address corrosion of reinforcement, inadequate waterproofing and debonding of tiles. One can see the remaining single inner face of the physically cut away H-shaped rails, which would have held the polystyrene shuttering slabs that have been removed

24.24 Technical advice suggests cover depths of 50–75 mm of concrete are required to protect reinforcement against corrosion in aggressive environments, but that thick cover leads to increased crack widths in flexural reinforced concrete members. Large crack-widths (greater than 0.3 mm) are liable to permit ingress of moisture and chemical attack to the concrete, resulting in potential corrosion of reinforcement and deterioration of concrete. As a result, thick cover on reinforcement can defeat the purpose for which the cover is provided.

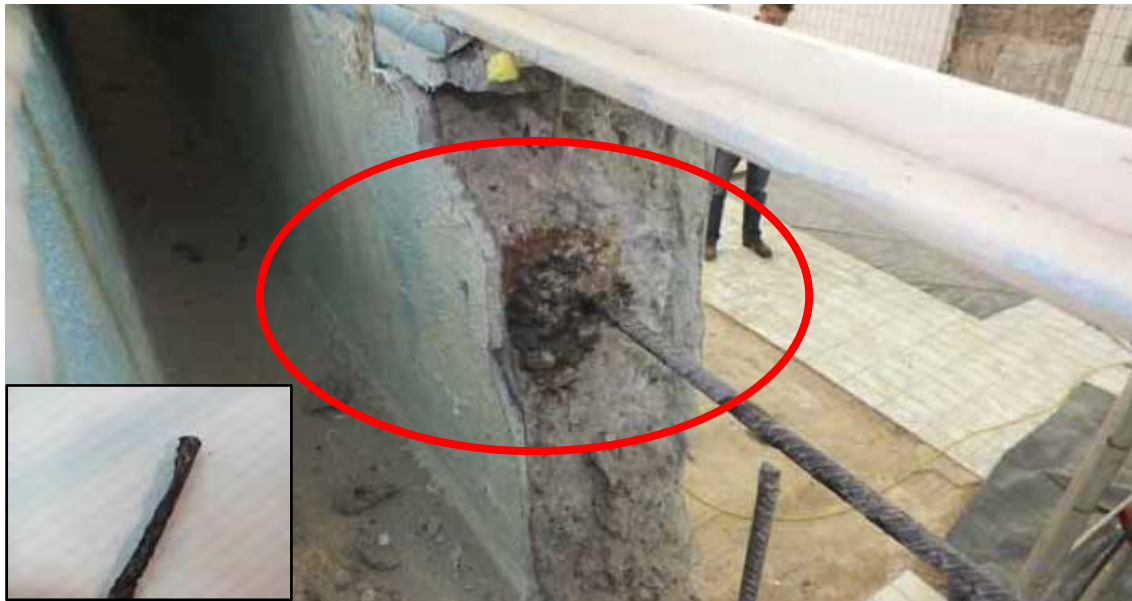
24.34 Defects in the water-proofed render, adhesive and tile layer, such as reported above, would create the potential for chlorinated pool water to gain ingress to the non-water-proof concrete wall substrate and could cause corrosion to the reinforcement.

24.35 Above and below are two from many available examples of photographs of corrosion of steel reinforcement and staining of surrounding concrete in pool walls. The inset photograph above is an example of a corroded bar removed from the upper scum channel section of the tank wall showing depleted section as a result of corrosion

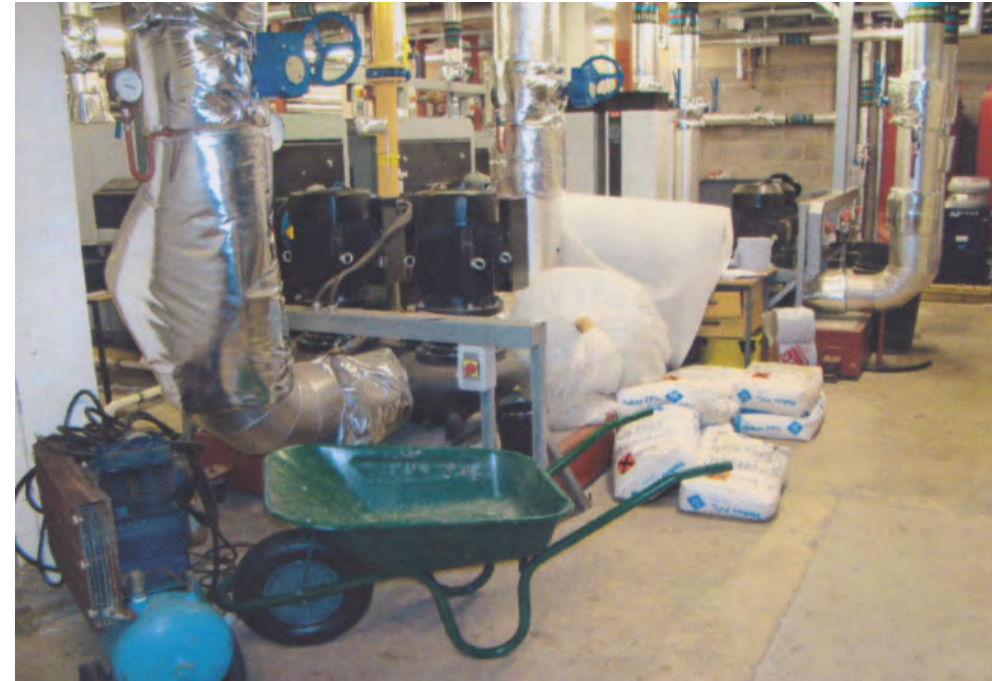
"Plant rooms are not presented in a manner that suggests regular expert attention is provided." H&K 2011

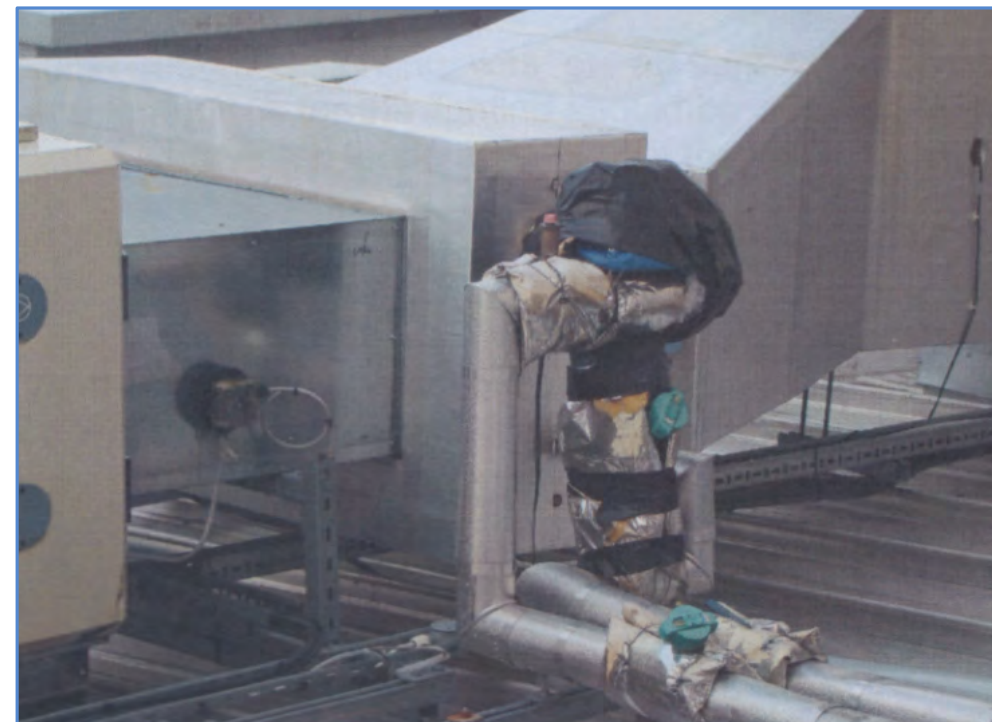
"Temporary repair to valve insulation" H&K 2011
