Report of the Independent Inquiry into the Construction of the **DG One Complex in Dumfries**

APRIL 2018

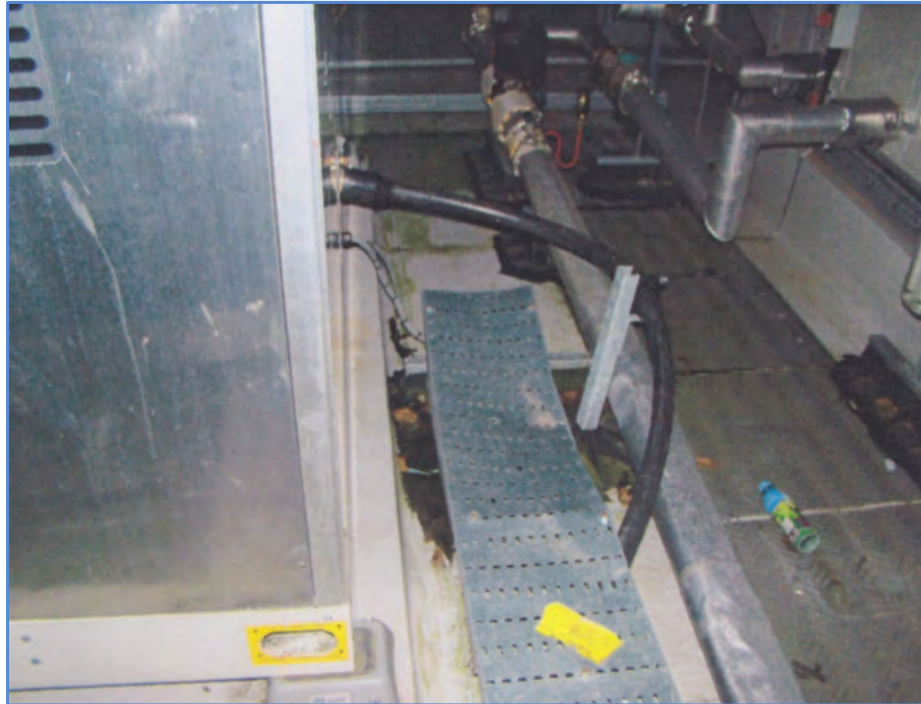
"Electric containment trays are being damaged by foot traffic and should be protected". H&K 2011

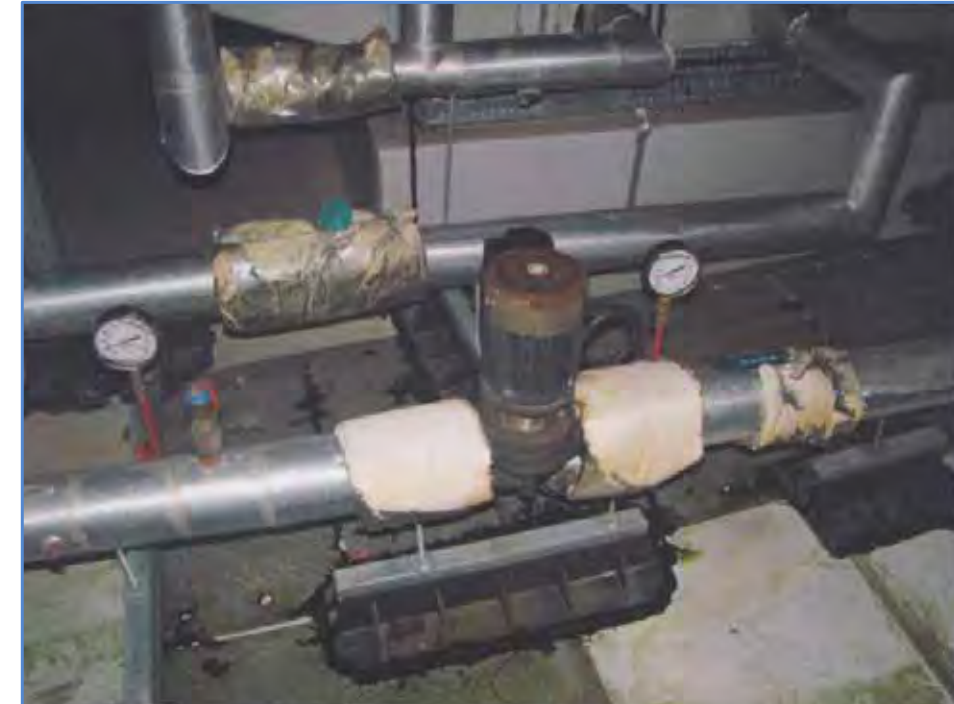
"Damaged insulation and corrosion to pump on roof" H&K 2011 allowing water to pond". H&K

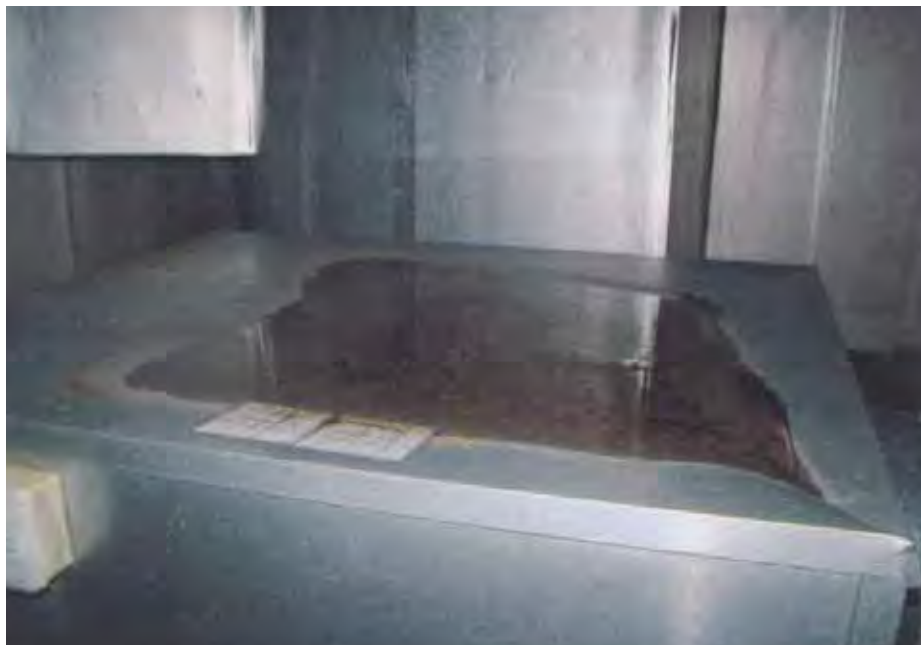
"Damaged extract fan cover allowing water to pond". H&K 2011

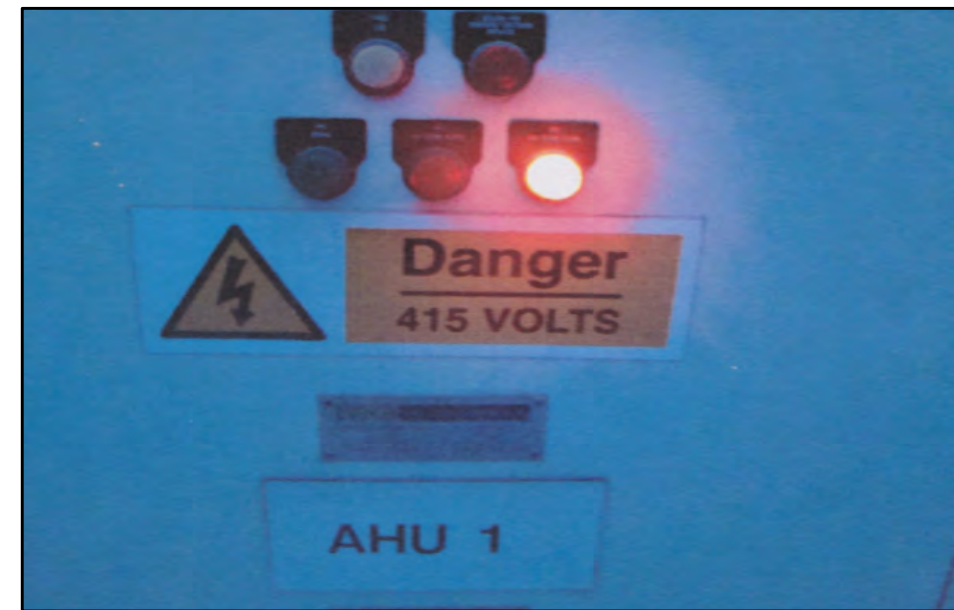
"The system was indicating fault and plant alarms from a variety of points with a host of unacknowledged alarms indicating the building management system is not utilised and operated as it should" H&K 2011

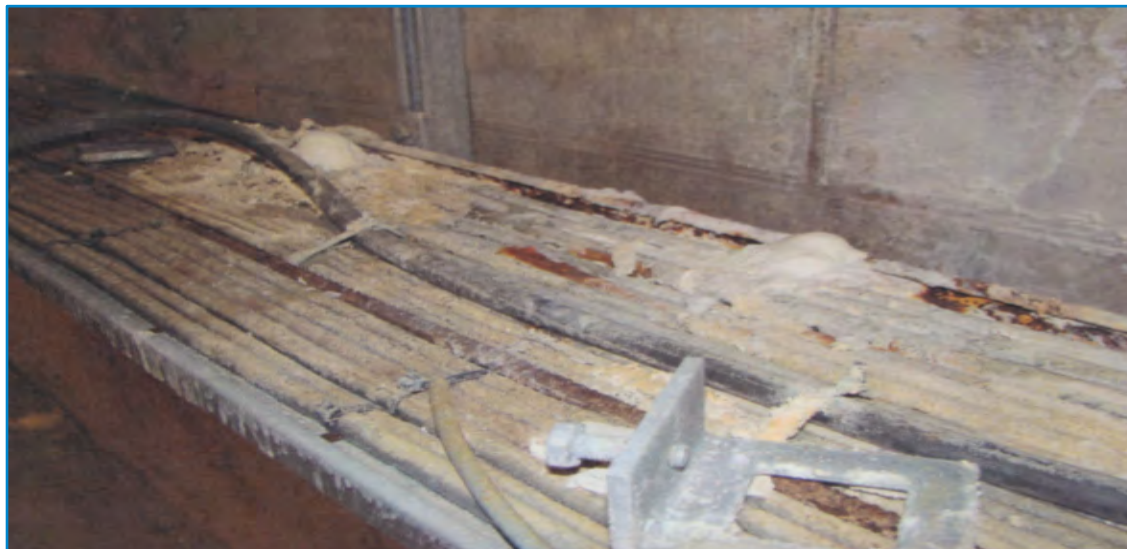
“Severe corrosion evident to electrical and mechanical services from pool chemicals and condensation”. H&K 2011

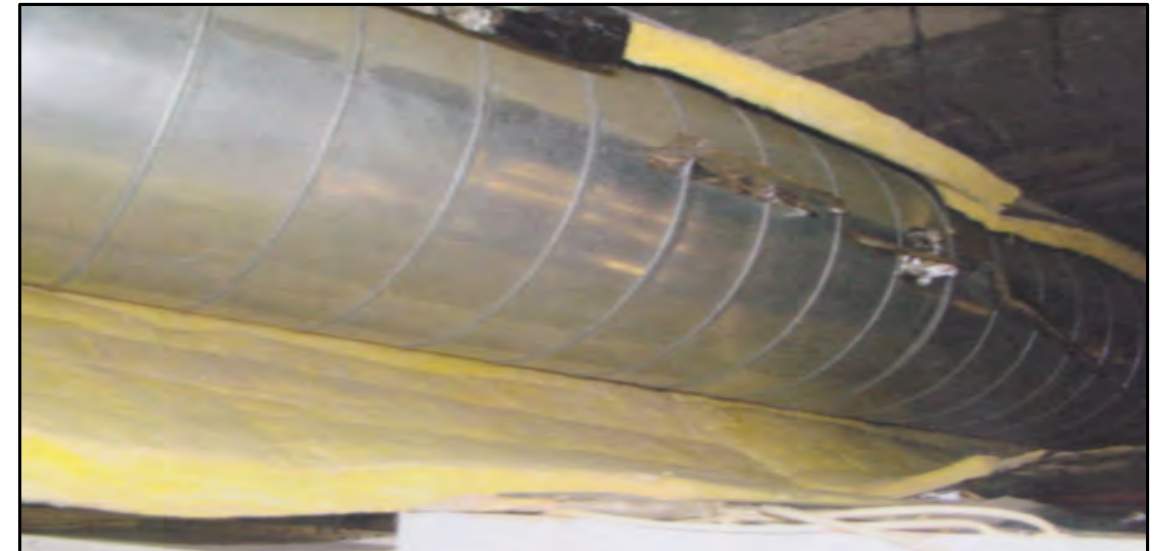
“Example of insulation detached from ductwork”. H&K 2011

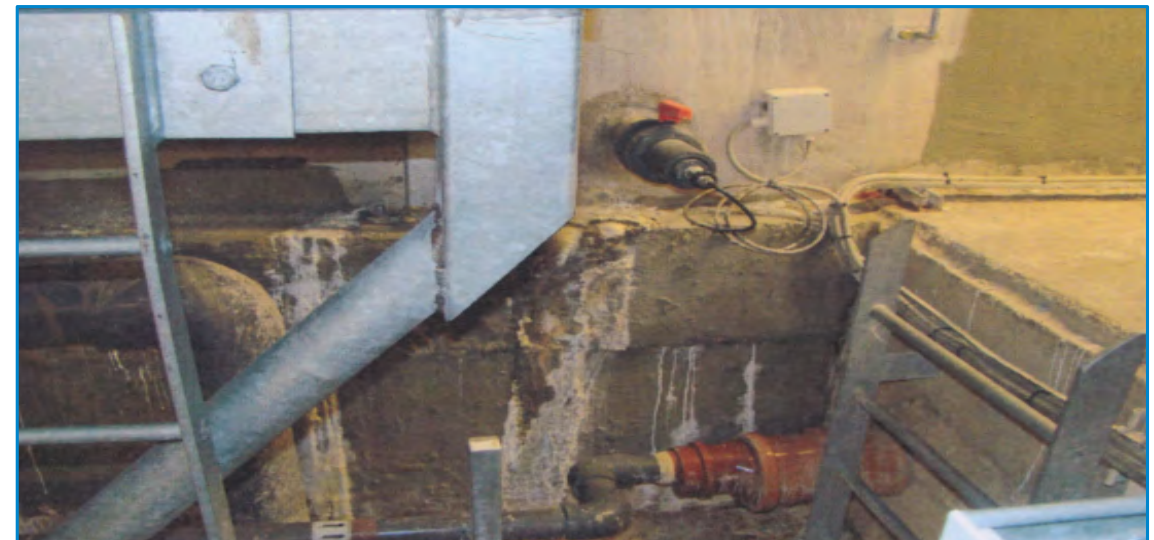
“Access to boilers for serving and replacement of tubes requires removal of plant. Also, evidence of water leaks from pool plant”. H&K 2011

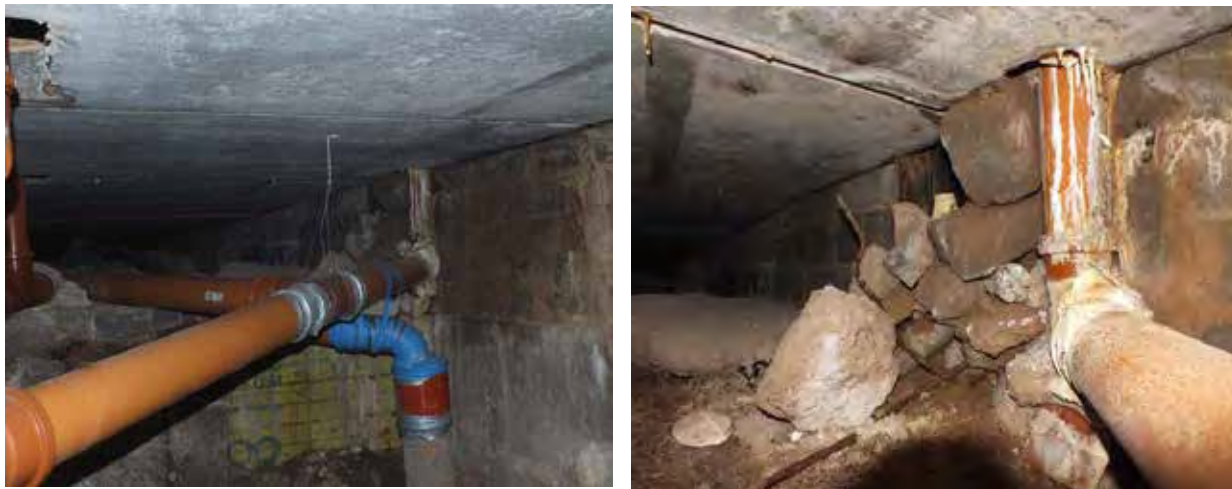
- *“Inadequate cover had been provided to reinforcement in the reinforced concrete construction of the pool tank walling such that localised corrosion to reinforcement was occurring. Watertight tanks with a life expectancy of 40 years had been required but had not been provided”*
- *“Below floor drainage was required to conform to British Standard 12056 and to the Building Regulations. It does not because the drain pipes are not adequately supported and adequate access for rodding and maintenance at changes in direction and level have not been provided”*

Examples of photographs of inadequately joined, supported and sealed drainage in the voids under DG One

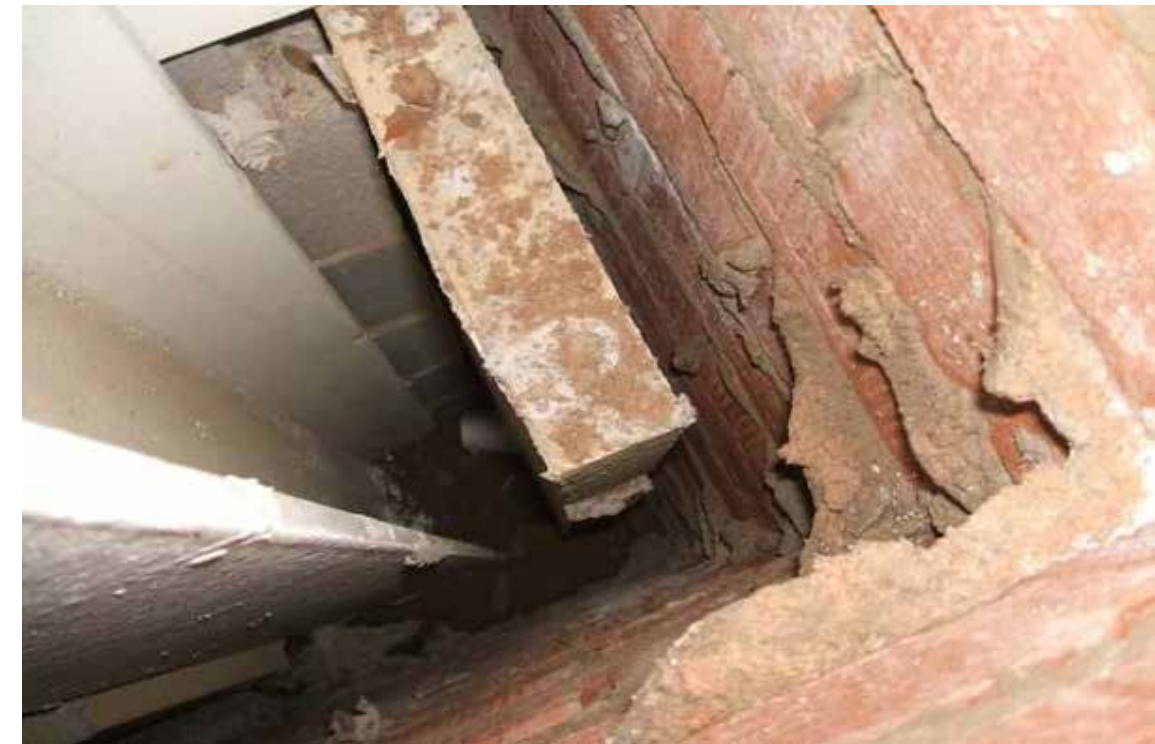
NOV 2011 PHOTOGRAPHS – NO VISIBLE EVIDENCE OF WALL TIES

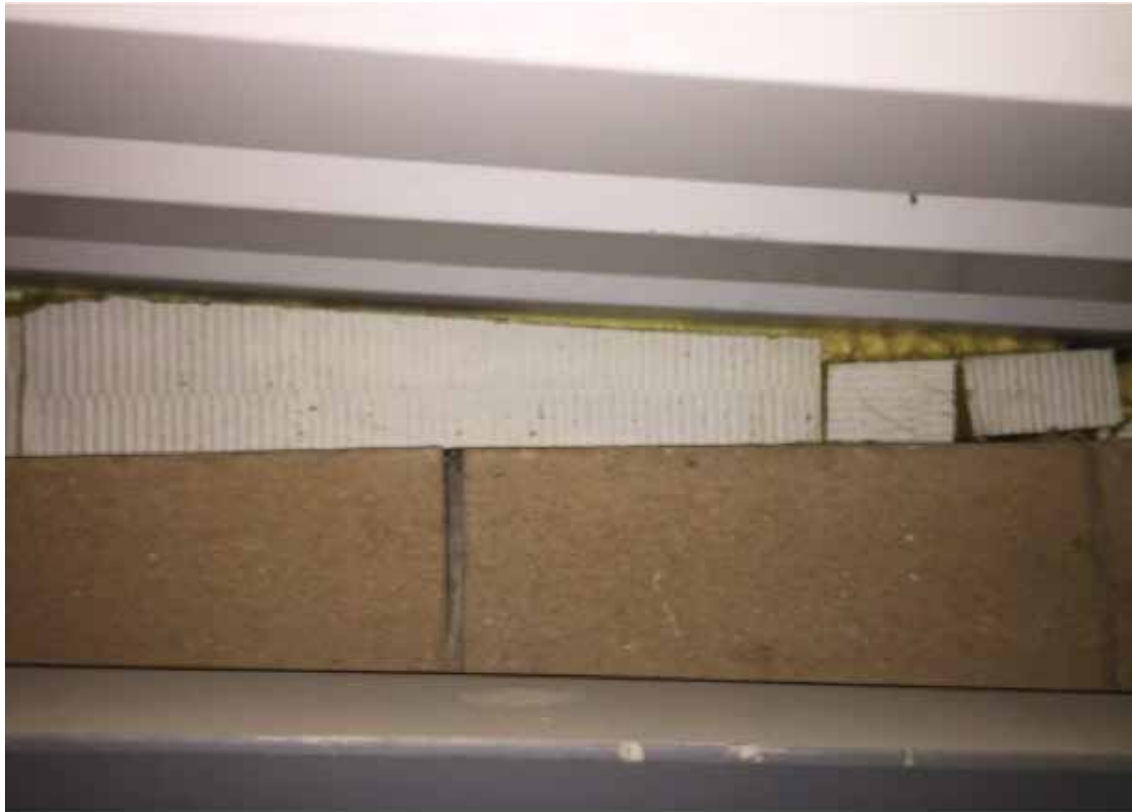
Wall to east of reception. No ties at wallhead

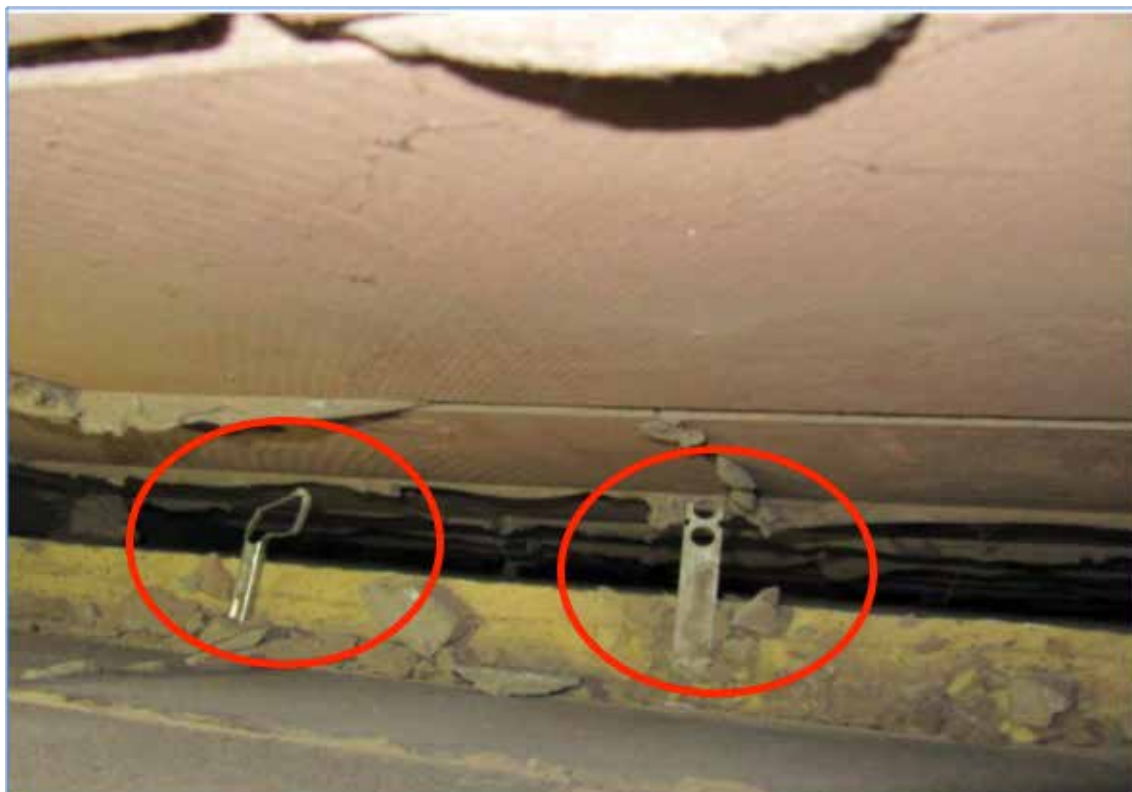
Fitness Suite Ties. Ties too short.

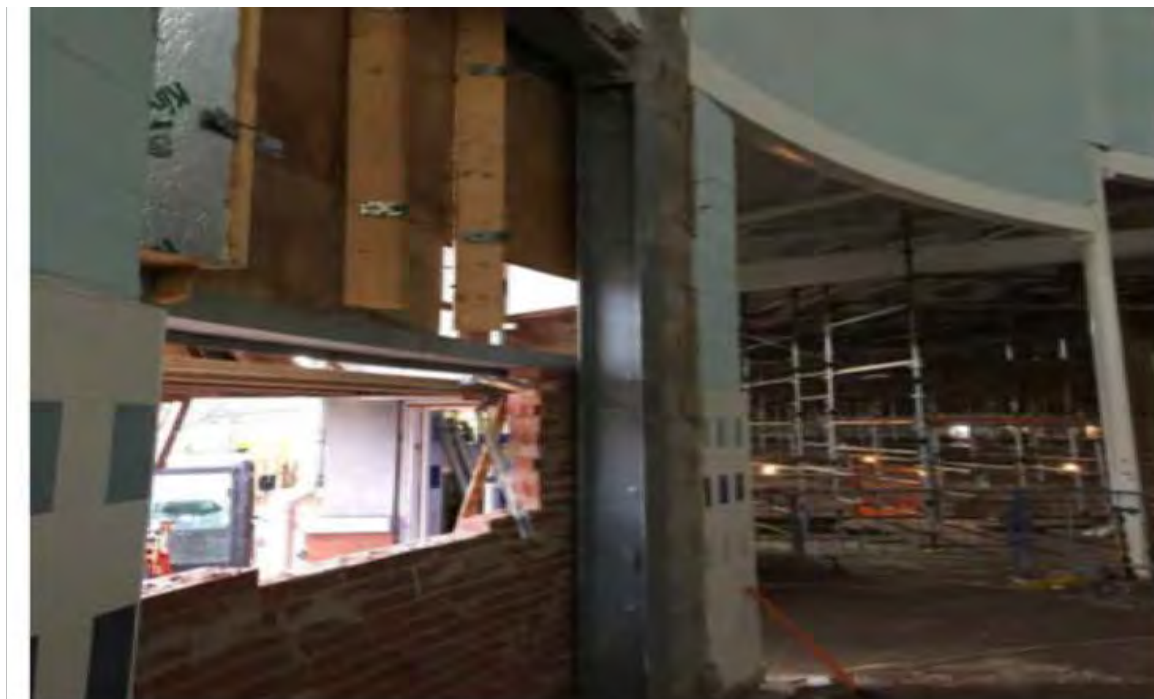
Piers 6. Wall panel in course of break out - inadequate wall tied to column and between external and internal leaf. External timber studs show fixings to single block leaf..

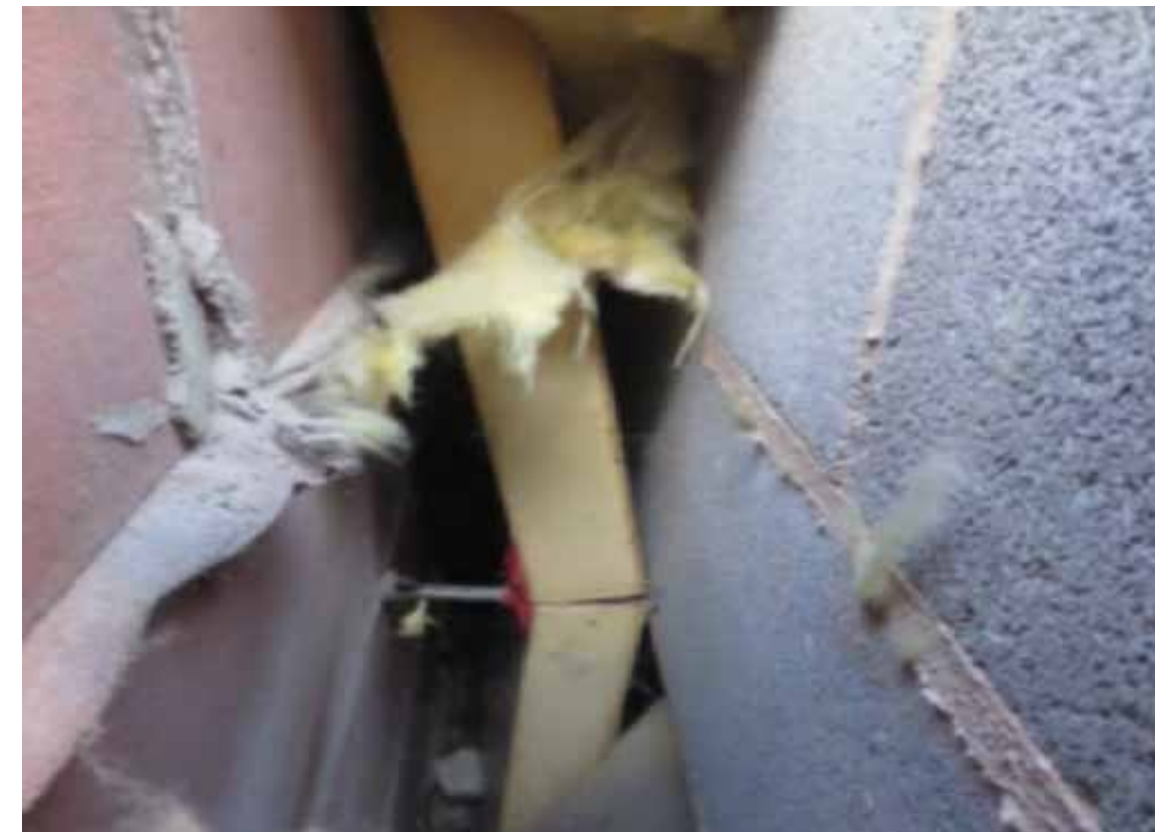
Improperly installed insulation

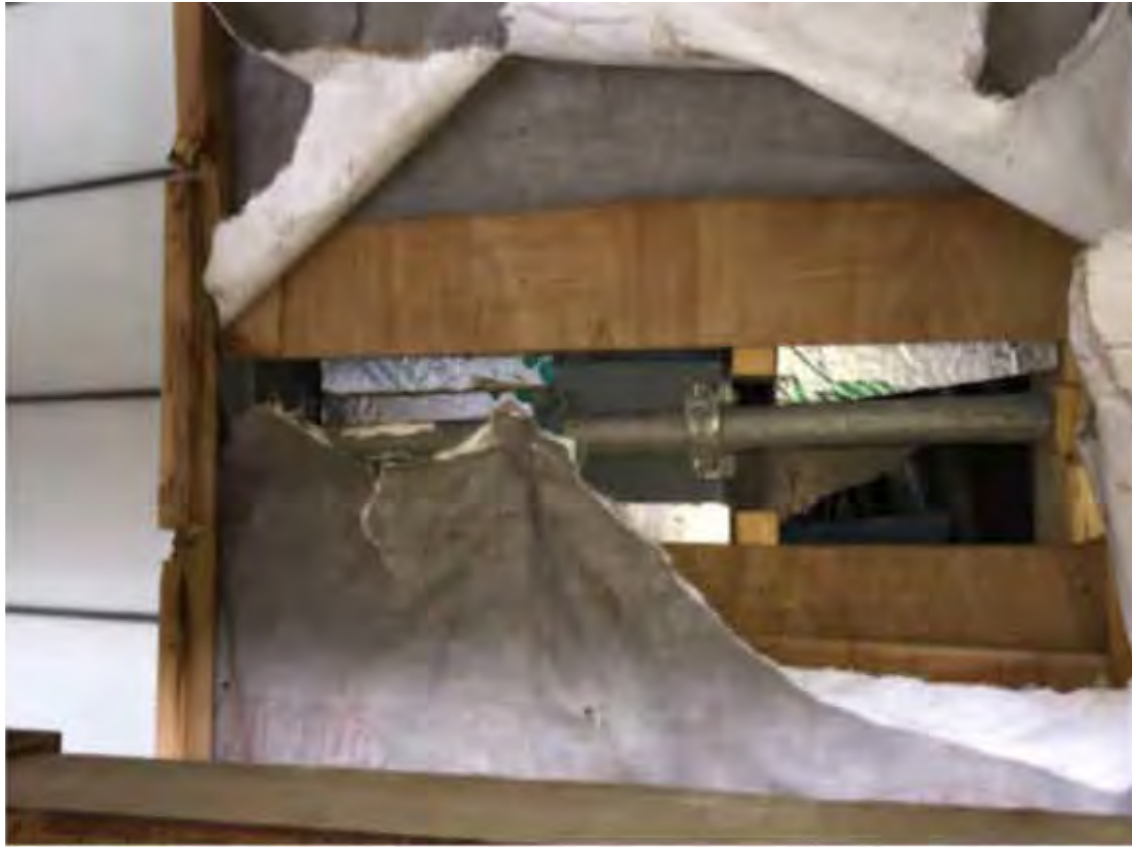
Scaffold tube remaining from original construction revealed on removal of external cedar cladding. Timbers and insulation bled around scaffold tube.

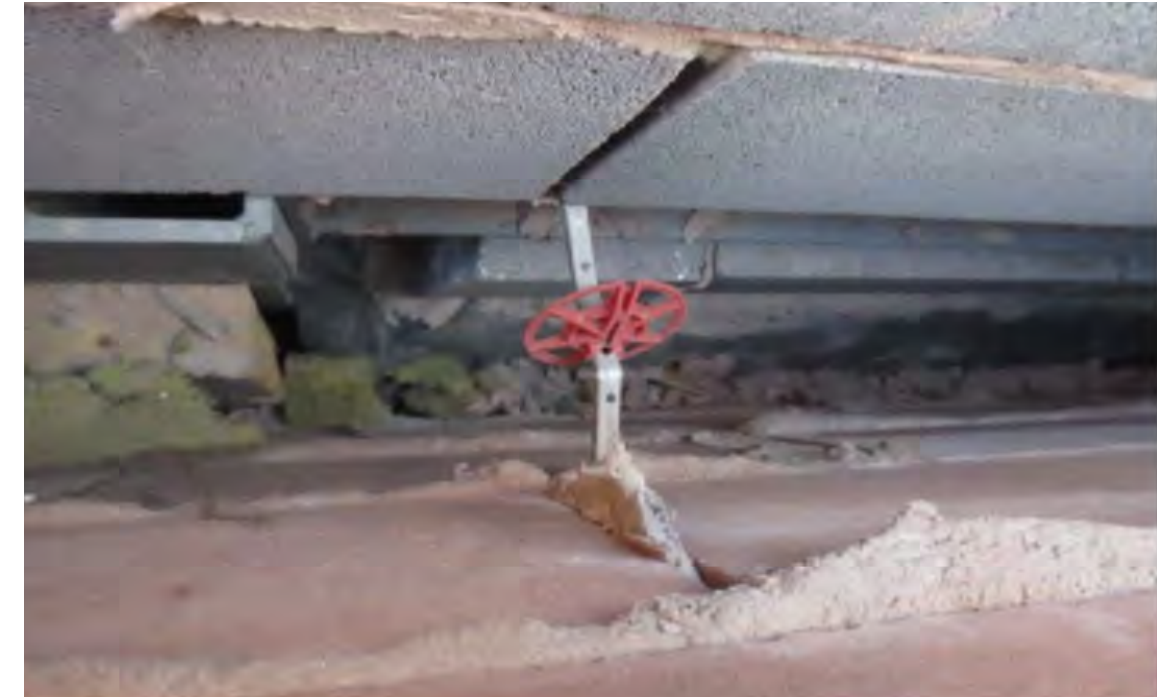
Bent wall tie, missing insulation and unfilled perpend joint.

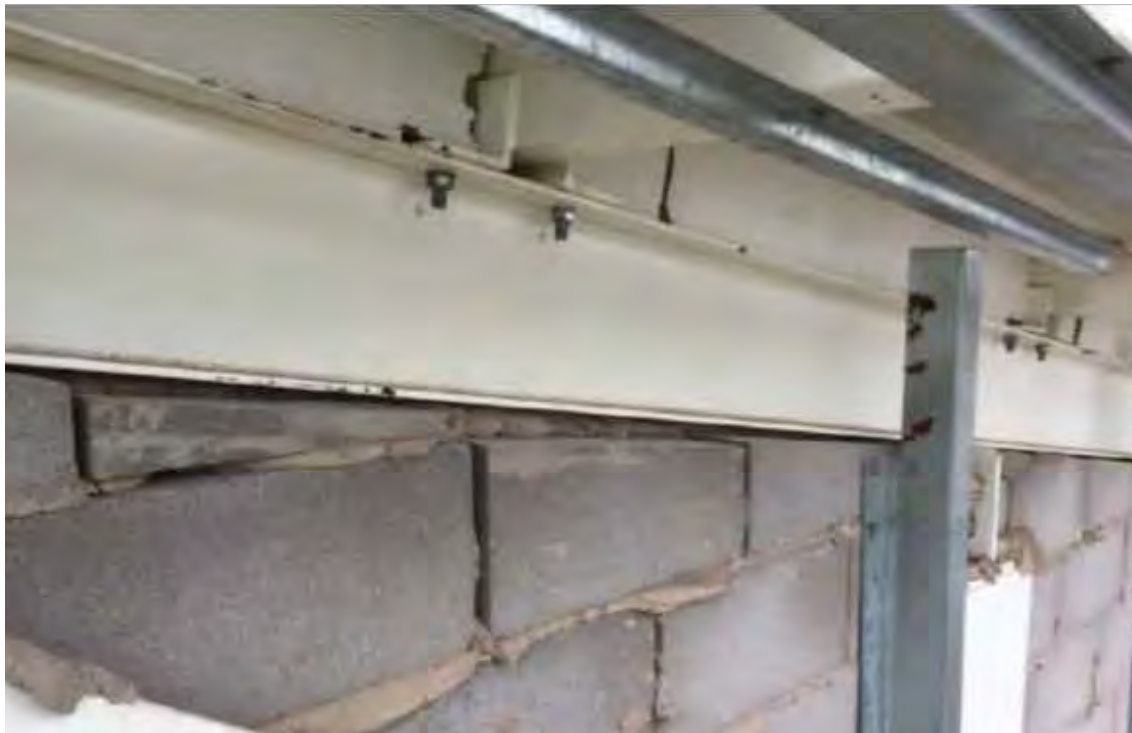
South Wall Main Pool. No supports to head of blockwork. Inadequate supports for external cladding panels.

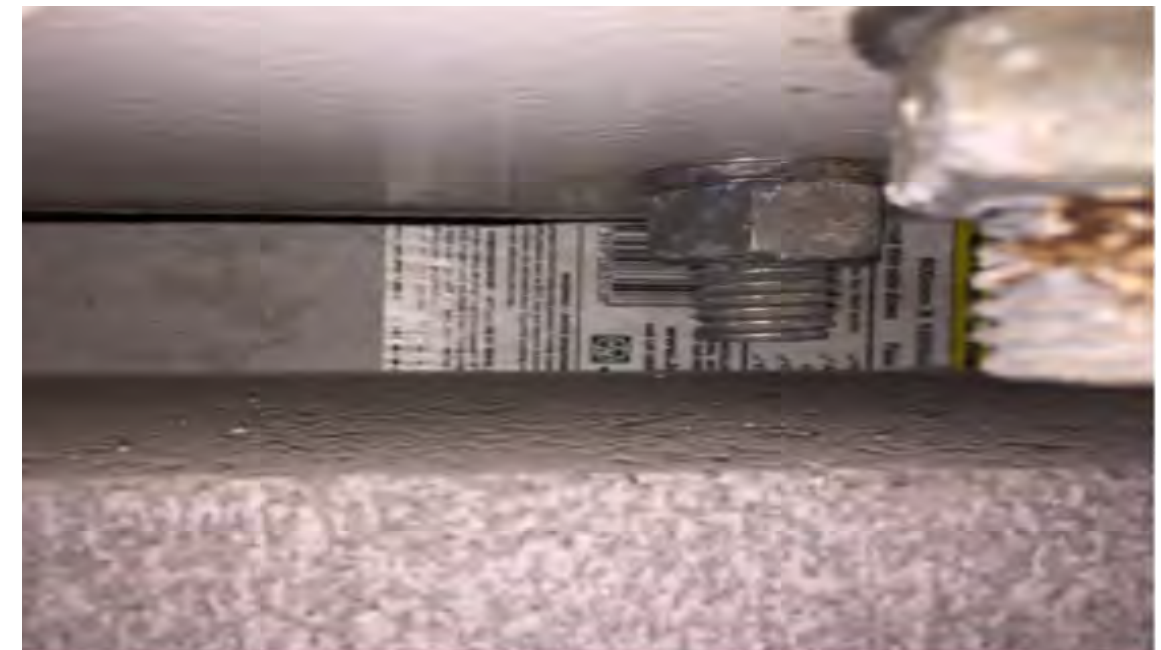
South Wall Main Pool. Unsealed and unfilled gaps at head of block panels.

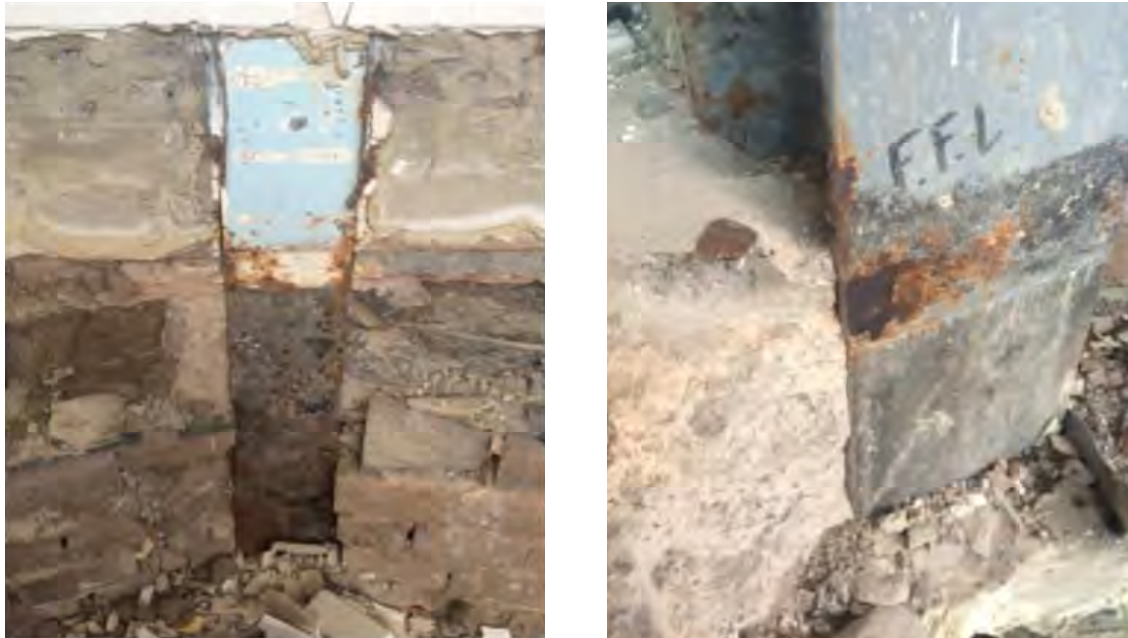
Corroded underfloor sections of steel columns

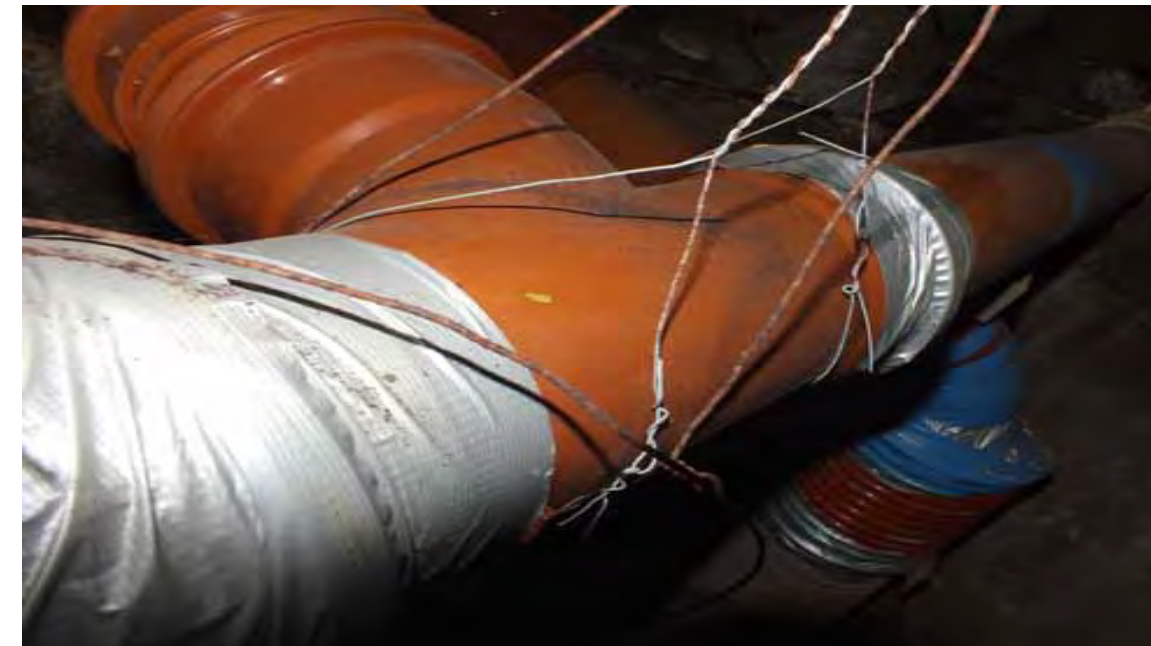
An example of the condition of underfloor drainage found

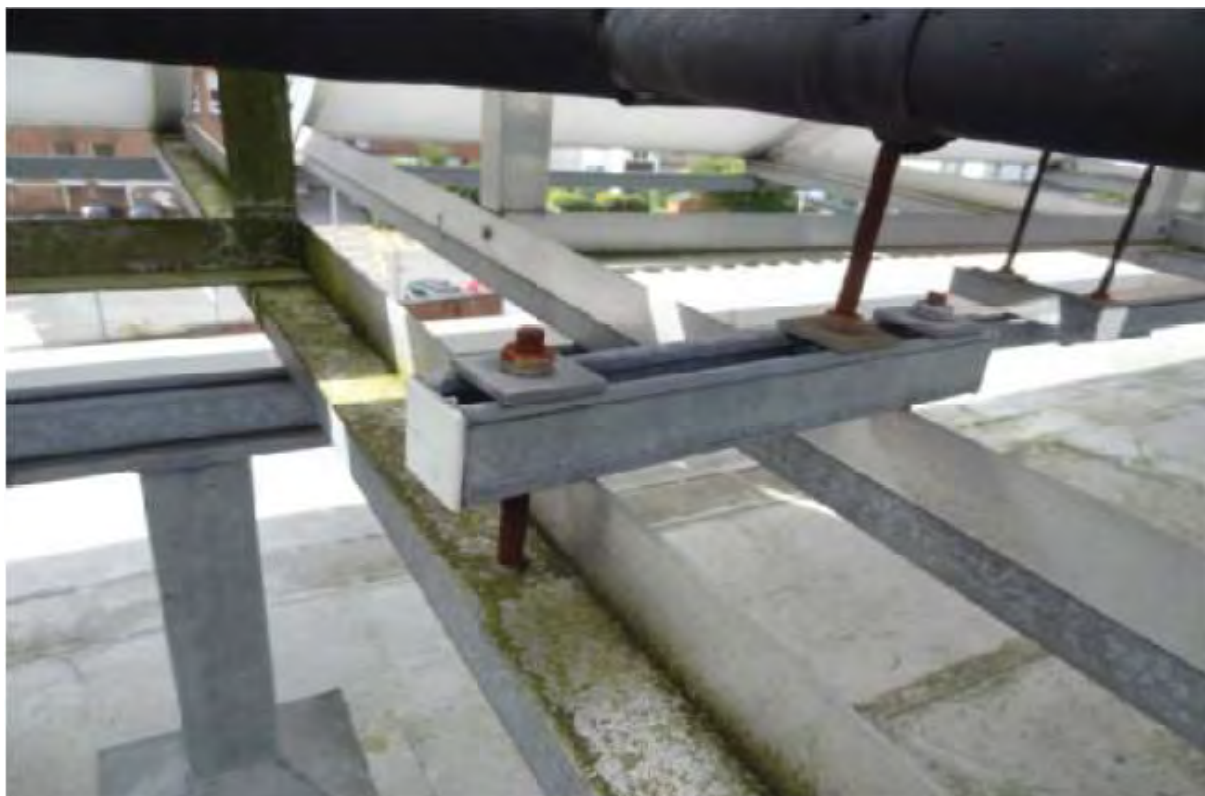
Corroded pipe supports

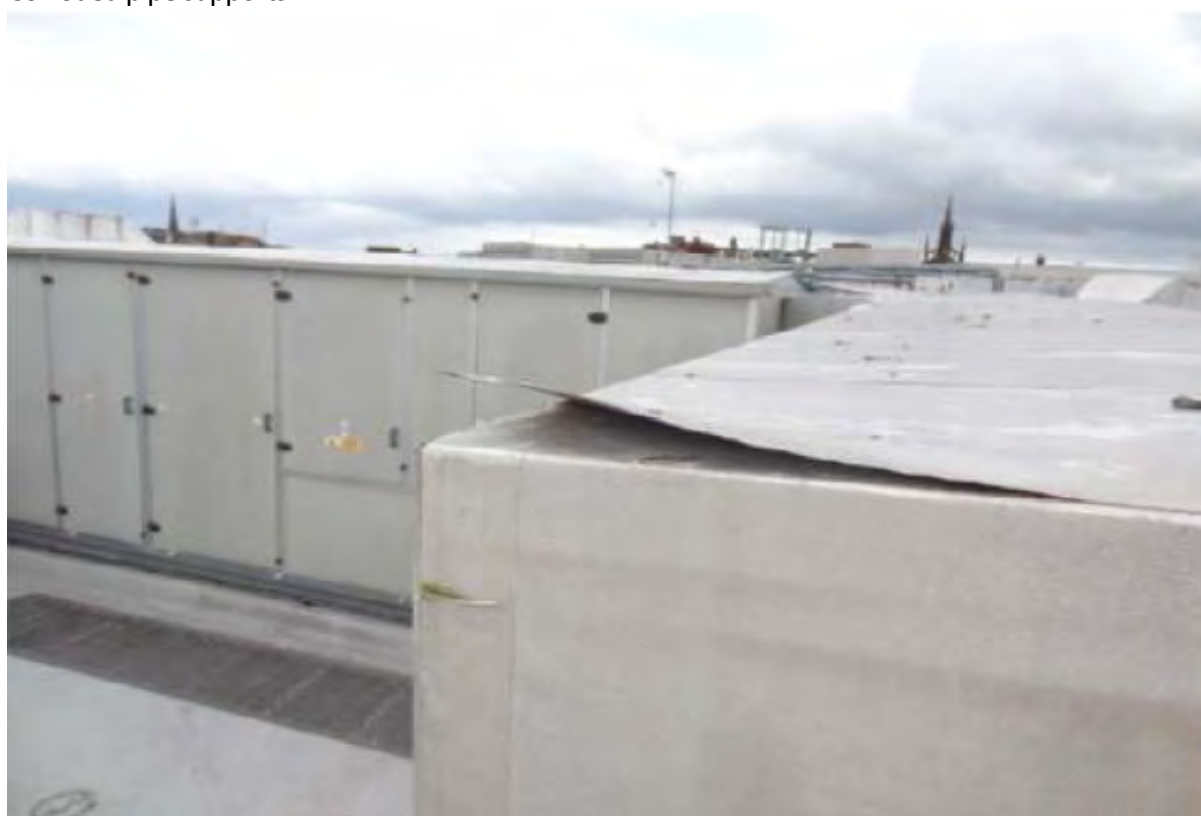
Damaged ductwork

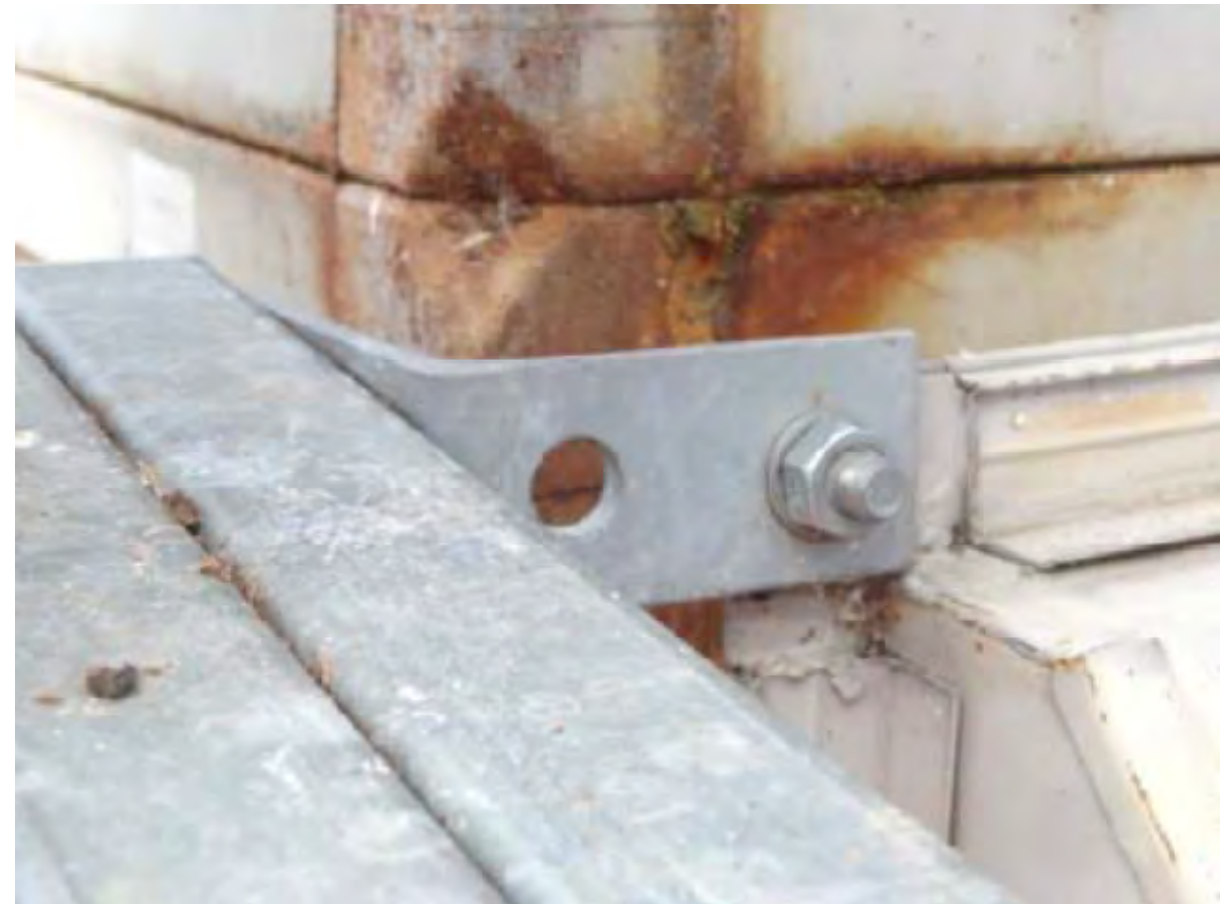
Corrosion to panels on roof

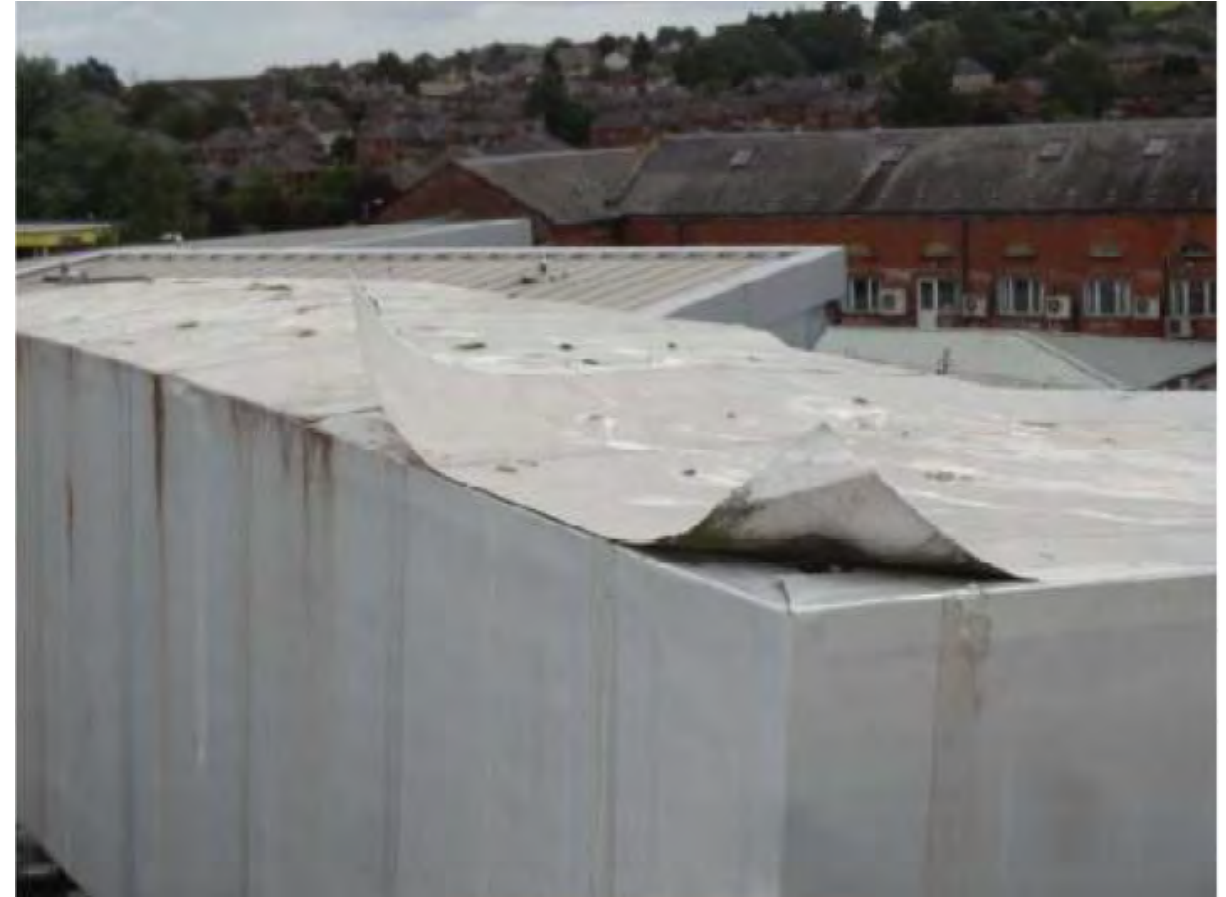
Potentially dangerous delaminating coverings

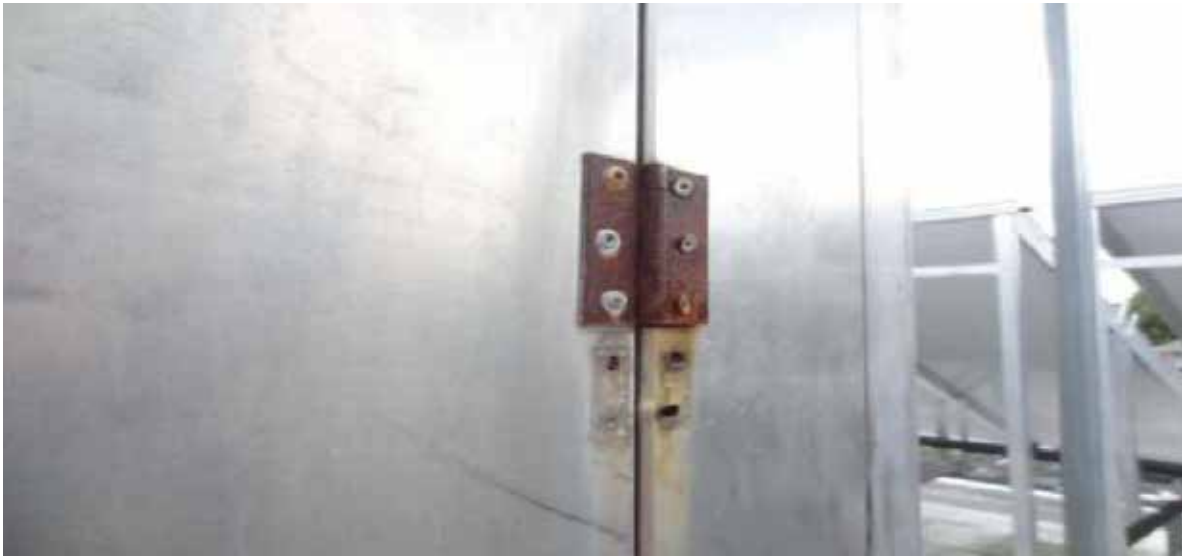
Corroding expansion chamber and valve

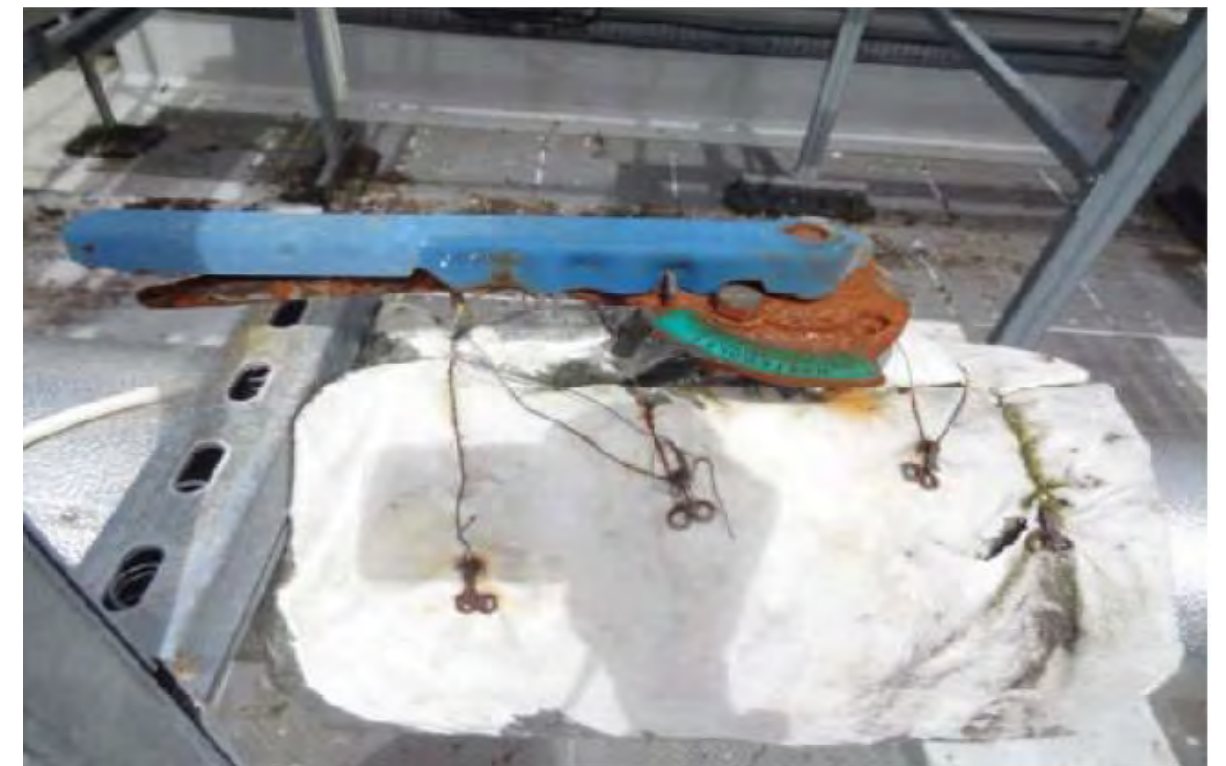
Corroded valve

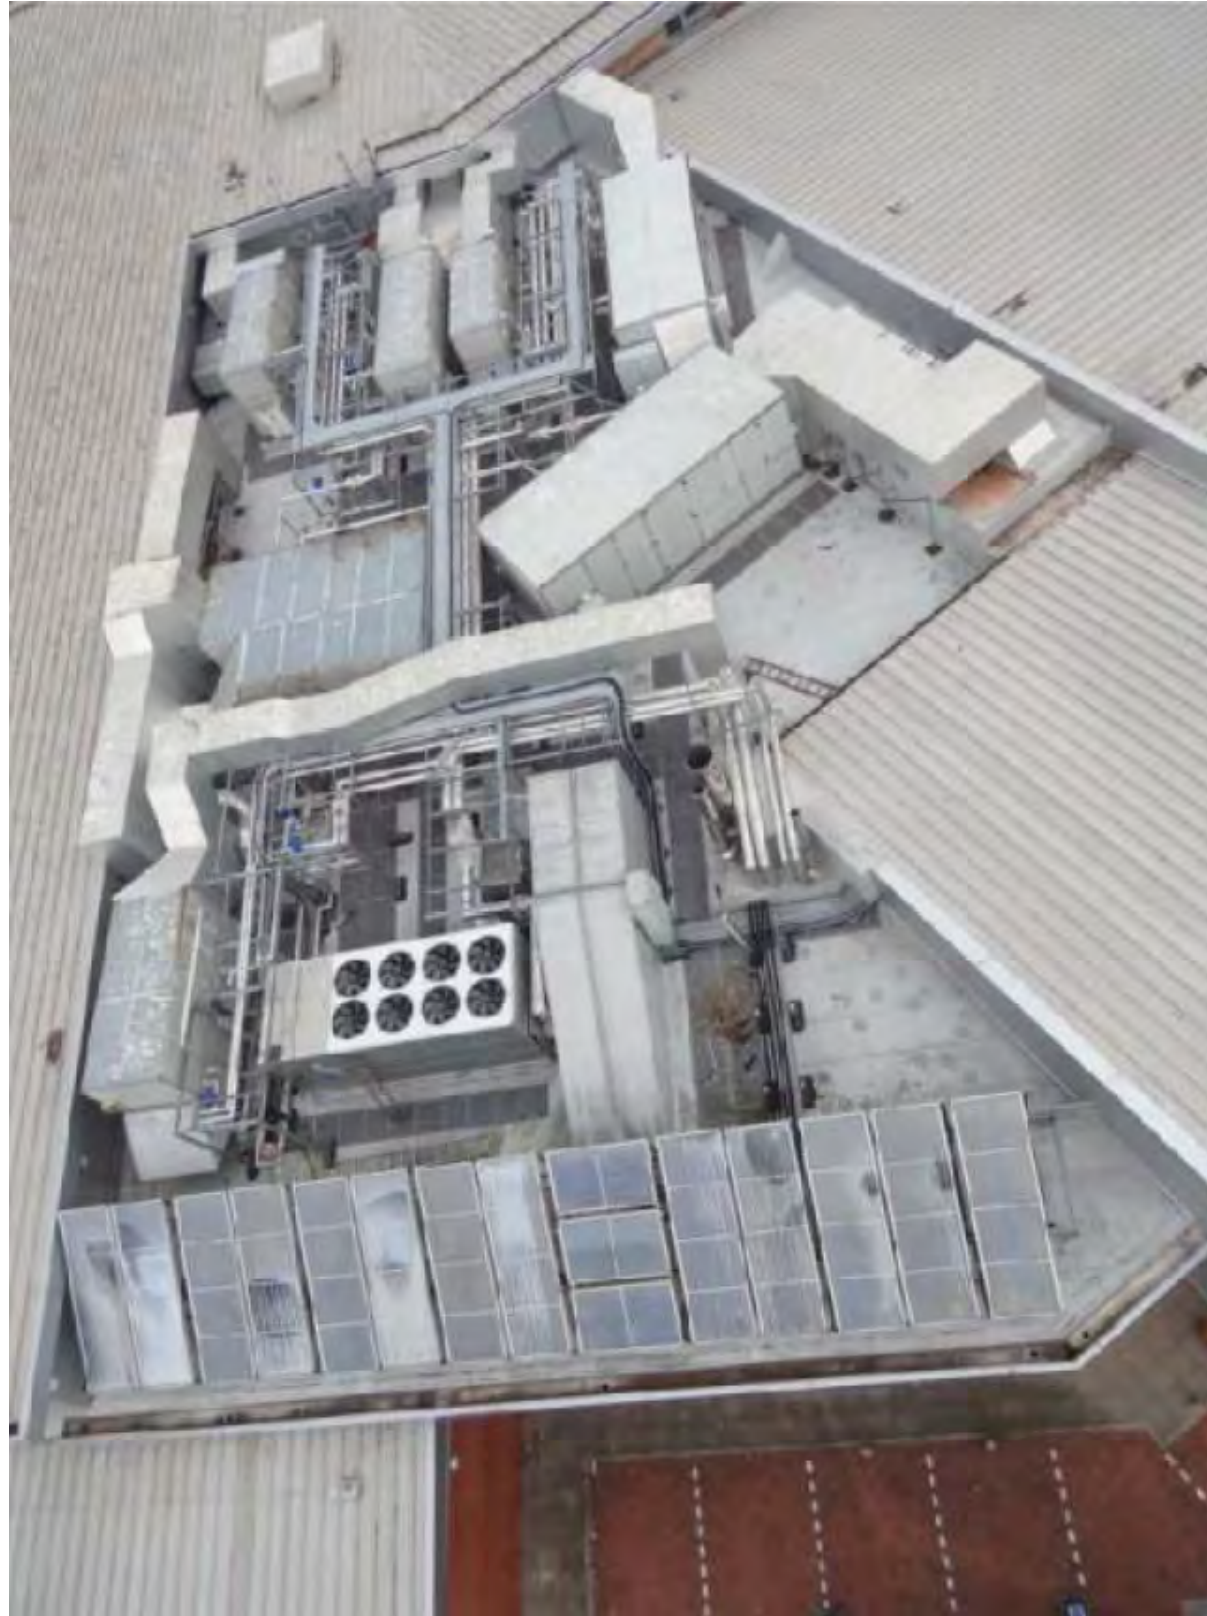
No proper maintenance access to plant. Poor condition of solar panels
