Report of the Independent Inquiry into the Construction of the **DG One Complex in Dumfries**

APRIL 2018

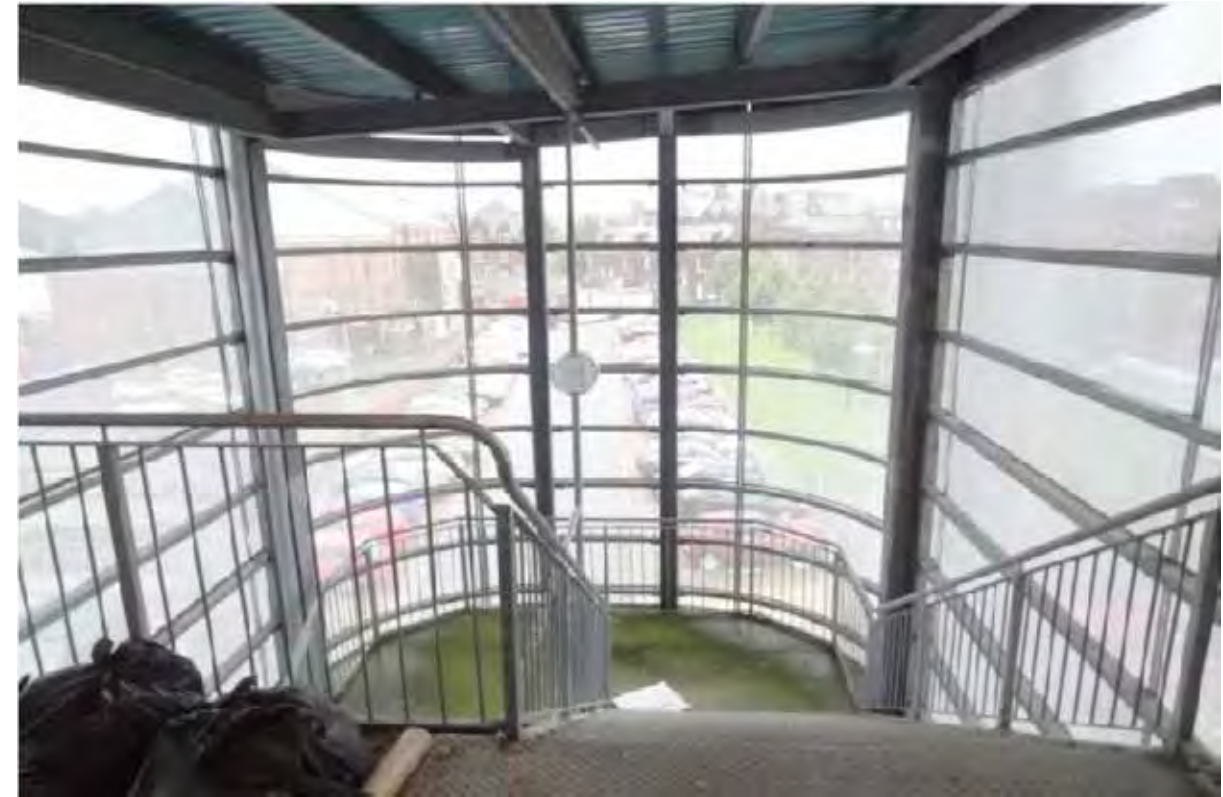
Staining and water ingress to escape stairs

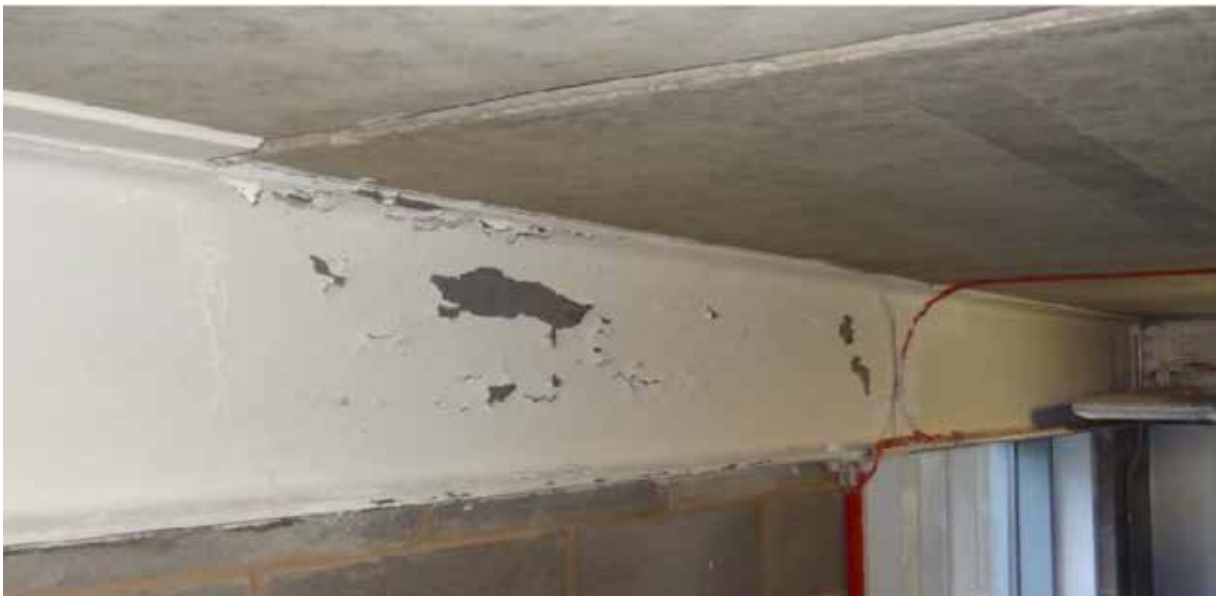
Failure of paint system
