Condition Survey

Kirkcolm Village Hall, North Rhins

Kirkcolm Community Hall

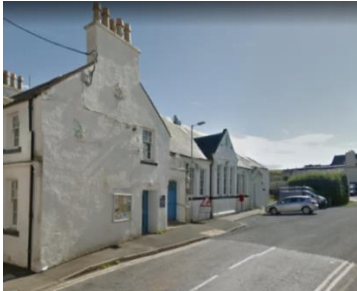
North East elevation from Main Street

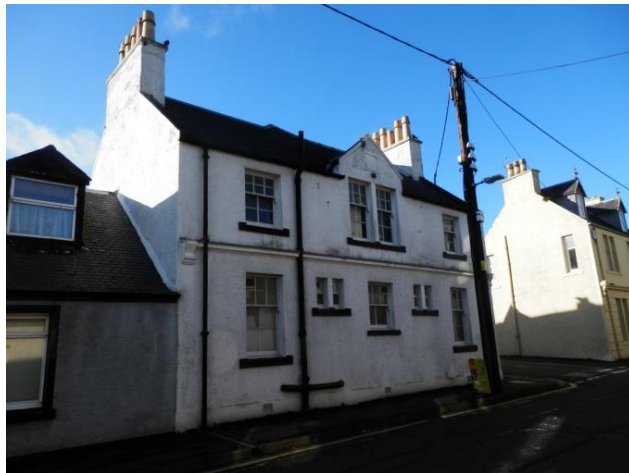
From East with Church Street to right

1.1 Roof - Apart from minor vegetation and moss growth, slates are in reasonable condition. There are a couple of loose slates close to the right hand skew. There is some rusting to clips securing zinc ridge. Skews have mortar haunching as opposed to lead which is potentially a weakness. Lead valley to central dormer projection could not be observed/*remove vegetation, wire brush and paint ridge clips, re-fix slipped slates, consider installing DPC under skews if none fitted, check lead valleys to dormer projection.*

1.3 *Rainwater system* – cast iron rainwater system appears sound but paintwork a little deteriorated and some replacement joints unpainted. Downpipe to right goes directly into pavement without obvious means of cleaning/*consider checking all joints, wire brushing and painting rain water system. Provide means of cleaning right hand downpipe.*

1.4 *Walls* – minor vegetation growth and mould to roughcast, minor cracking, paintwork starting to deteriorate, underfloor vents at base of wall partially painted up/*remove vegetation and treat areas of mould, monitor cracking, consider repainting roughcast, clean off build-up of paint on underfloor vents.*

1.5 *Openings* – timber, sash and case, single glazed, un-draught proofed windows appear in reasonable condition but some sashes painted up/*consider refurbishing windows, inserting double glazed panes (such as slimlite) and fitting draught proofing.*

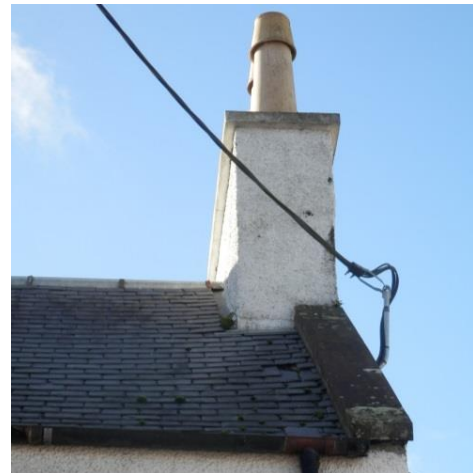
Right hand chimney stack to NW elevation

1.2 Chimney stacks – there appears to be only mortar haunching as opposed to lead flashings to base of stacks, chimney pots don't appear to have ventilated caps allowing unused flues to become damp. Evidence of dampness on masonry in roof space below stack specifically to NW gable, paintwork starting to deteriorate/*consider re-building chimney stacks and installing lead safes/flashings, cap all chimney pots with ventilated caps, consider repainting roughcast.*

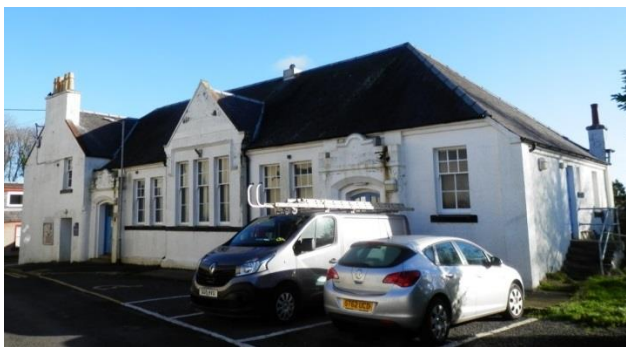
From West showing Church Road elevation

2.1 *Roof* – There is quite a bit of moss growth but slates in reasonable condition. There would appear to have been some minor repairs to the lead valley of the projecting gable above the central window. There is some rusting to clips securing zinc ridge. It was not possible to inspect the slate/skew joint on the roof side of the projecting gable or the flashings to the ventilator terminal on the ridge/*Remove moss growth, wire brush and paint ridge clips, consider installing DPC under skew of projecting gable, consider replacing lead valleys to projecting gable, check skew roof joint to projecting gable and flashings to ventilator terminal on roof when a contractor has safe access.*

2.2 *Rainwater system* – cast iron rainwater system appears sound but paintwork slightly deteriorated. Downpipes to both sides of projecting gable, grass growing in guttering, evidence of overflowing, especially at downpipes and above main entrance, dampness showing internally/*consider checking all joints, wire brushing and painting rain water system. Ensure proper maintenance regime established to keep gutters and downpipes clear of debris (ideally twice yearly).*

2.3 *Walls* – minor vegetation growth and mould to roughcast especially where gutters overflowing, minor cracking, paintwork starting to deteriorate, underfloor vent at base of wall partially painted up/*remove vegetation and treat areas of mould, monitor cracking, consider repainting roughcast, clean build-up of paint on underfloor vent, consider increasing number of vents to underfloor area.*

2.4 *Openings* – timber sash and case single glazed, un-draught proofed windows appear in reasonable condition but some painted up and paintwork slightly deteriorated, mastic pointing between masonry and frames failing especially to central windows, doors in reasonable condition /*consider refurbishing windows, inserting double glazed panes (such as slimlite) fitting draught proofing, painting and repointing between masonry, consider refurbishing doors, fitting draught proofing and checking door locks and hinges.*

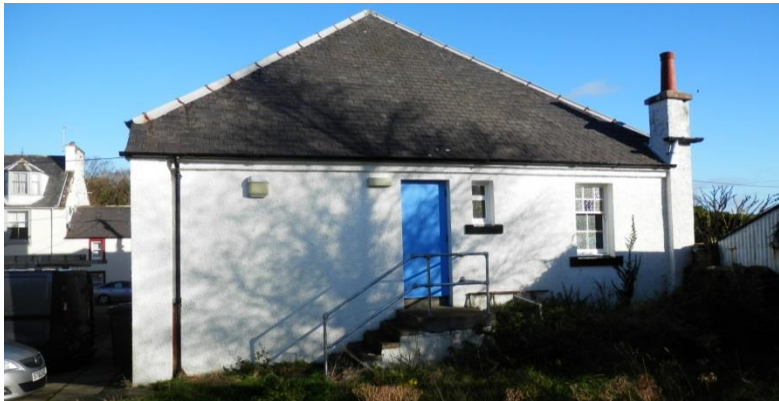
South West elevation

3.1 *Roof* – Slates to hipped roof of hall are in reasonable condition. There are some loose and slipped slates to South West pitch of Main Street building particularly to the right hand side beside the valley gutter (see image in South East section). There is some rusting to clips securing zinc ridge. The roughcast to the chimney stack to the right hand side of the elevation is cracking/ *wire brush and paint ridge clips, consider taking down redundant chimney stack and roofing over or re-rendering of chimney stack, re-fix loose and slipped slates to Main Street roof.*

3.2 *Rainwater system* – cast iron rainwater system appears sound but paintwork slightly deteriorated. Stain on wall adjacent to downpipe suggests leak at joint /*consider checking all joints, wire brushing and painting rain water system. Ensure proper maintenance regime established to keep gutters and downpipes clear of debris (ideally twice yearly).*

3.3 *Walls* – minor stain adjacent to downpipe, underfloor vent at base of wall partially painted up, vegetation growth at base of walls, gutter of adjacent garage sheds onto ground to right hand side of this elevation/ *consider repainting roughcast where stained, clean off build-up of paint on underfloor vent, consider increasing number of vents to underfloor area, cut back vegetation growth at base of wall to reduce retention of moisture in masonry, negotiate alternative arrangement for gutter to neighboring garage so as not to shed onto ground at southern corner of building.*

3.4 *Openings* – timber sash and case single glazed, un-draught proofed windows appear in reasonable condition but some painted up and paintwork slightly deteriorated, mastic pointing between masonry and frames failing especially to central windows, door in reasonable condition /*consider refurbishing windows, inserting double glazed panes (such as slimlite), fitting draught proofing, painting and repointing between masonry and frame, consider refurbishing door, fitting draught proofing and checking door locks and hinges.*

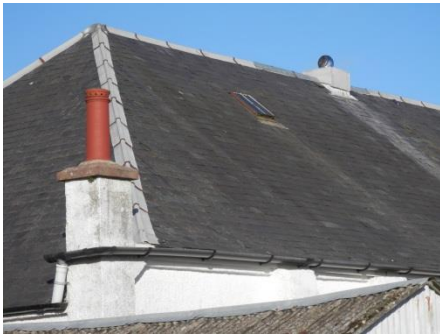
Left hand end of South East elevation

4.1 *Roof* – The slates appear to be in reasonable condition with relatively few showing signs of being loose. There is some rusting to clips securing zinc ridge. It was not possible to inspect the flashings to the ventilator terminal on the ridge/*Wire brush and paint ridge clips, consider installing DPC under skews of projecting gable, consider replacing lead valleys to projecting gable, check for loose/slipped slates and flashings to ventilator terminal on roof when a contractor has safe access.*

4.3 *Walls* – minor vegetation growth and mould to roughcast especially where gutters overflowing, paintwork starting to deteriorate, underfloor vents in base of buttresses to wall partially painted up/*remove vegetation and treat areas of mould, consider repainting roughcast, clean build-up of paint on underfloor vent, consider increasing number of vents to underfloor area.*

4.4 *Openings* – timber sash and case single glazed, un-draught proofed windows appear in fair condition but there is evidence of rot in the astragals (likely to be due to putty failure), some sashes are painted up and paintwork slightly deteriorated, mastic pointing between masonry and frames could be failing (as North West elevation) especially to central windows/*consider refurbishing windows, replacing rotten astragals, inserting double glazed panes (such as slimlite) fitting draught proofing, painting and repointing between masonry.*

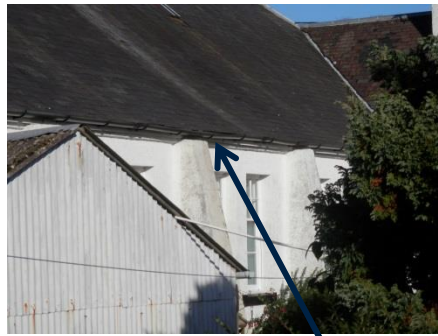
Central section of elevation with dipping gutter

4.2 *Rainwater system* – The majority of the UPVC rainwater system appears to be in tact however there is a considerable dip to the middle of this elevation. There is grass growing in the gutter. An existing cast iron downpipe to the right of this elevation has not been used when the UPVC guttering was fitted and the whole South East pitch of the hall roof and half of the South West pitch of the roof of the Main Street building is taken to a 75mm downpipe on the South West elevation of the hall building which is already taking the water from that elevation/*consider checking all joints, re-level guttering where dipping, install additional downpipe (preferably 100mm) to South East elevation. Ensure proper maintenance regime established to keep gutters and downpipes clear of debris (ideally twice yearly).*

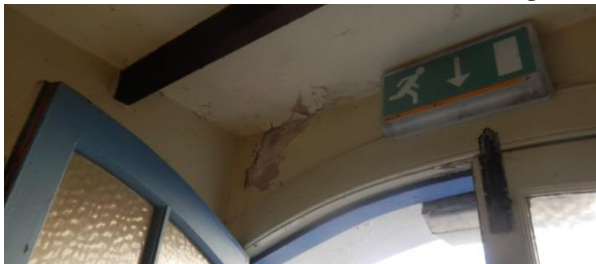
Damp above front entrance door

5.1 Entrance lobby – evidence of damp above entrance door/*This is likely to be due to the gutters leaking as identified in 2.2 and should be cured if gutter overflowing/leaking is addressed.*

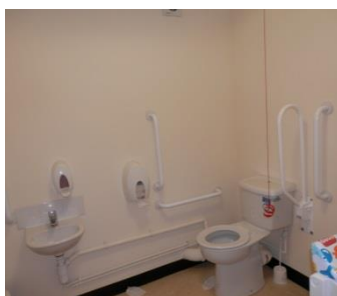
Accessible toilet/baby changing

5.4 Accessible toilet – in reasonable condition/*no major work required.*

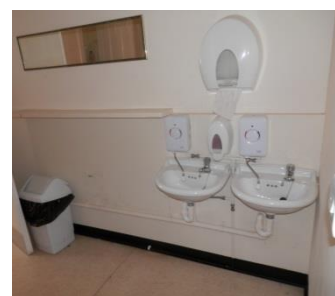
Female toilets

5.5 Female toilets – in reasonable condition, minor cracks, minor deterioration to paint/*no major work required, monitor cracking.*

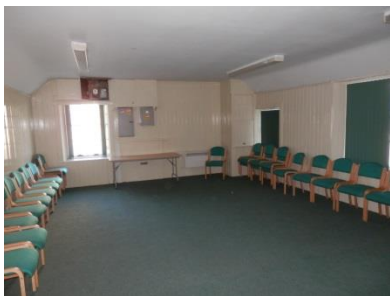
Meeting room

6.1 *Meeting room* – evidence of possibly historic damp above switchgear which appears to be from water penetration around the chimney stack/skews and is apparent on the gable wall above the switchgear within the roof space, also damp minor evidence of damp showing at South East end of room at ceiling level /*Establish if any repairs have been undertaken to the North West chimney stack and monitor carefully. If dampness persists this needs to be dealt with urgently due to the proximity of electrical equipment. Chimney stack may require dismantling and rebuilding with lead safe inserted. South East gable chimney stack should also be monitored in similar fashion and if dampness persists, rebuilding with a lead safe should be considered. Ensure flues are ventilated and ventilated caps are fitted to chimney pots. Decorate areas where damp showing once dampness cured.*

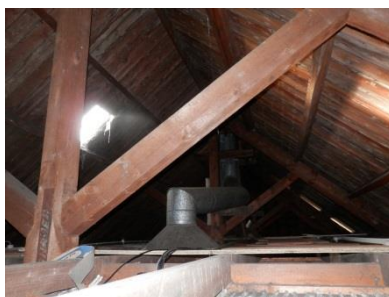
NW gable front building

6.4 *Roof spaces* – only space above Main Street building accessed fully, possibly historic dampness evident to both gables in this area, noted that one ridge ventilator in main hall had been disconnected and remaining one has been modified with rotating s/s cowl ventilating only roof space, no insulation to either roofs/*monitor and follow advice in 6.1, consider insulating above ceilings in roof space and reviewing ventilation system.*

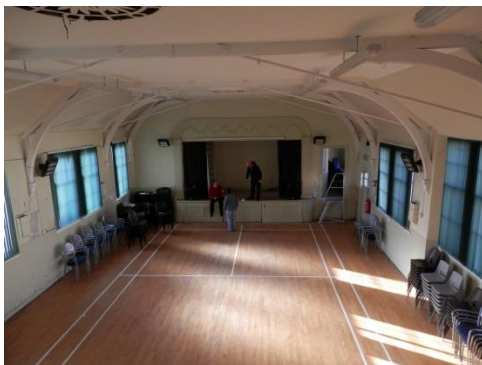
Main hall

7.1 North West wall of main hall – evidence of damp and settlement to right hand side of right hand window and at high level to both sides of central window, paint deterioration, undecorated replacement timber boarding at low level to left hand side of exit door with evidence of damp above/*dampness appears to be as a result of long term overflowing guttering/blocked downpipes (see 2.2 and recommendations), has caused truss end to rot and settle. Truss ends to both sides of central window require exposing and replacement with DPC surrounding new pieced in truss end, dampness to right hand side of right hand window appears also to be caused by overflowing guttering, truss end should also be checked and repaired if necessary, redecorate once dampness cured, replacement timber boarding likely to be evidence of historic dampness and rot caused by overflowing guttering, dampness above suggests still occurring.*

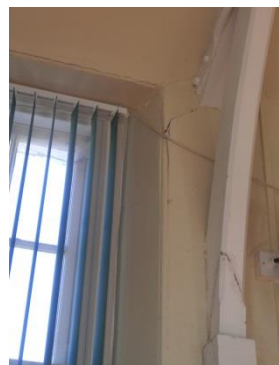
RH central window

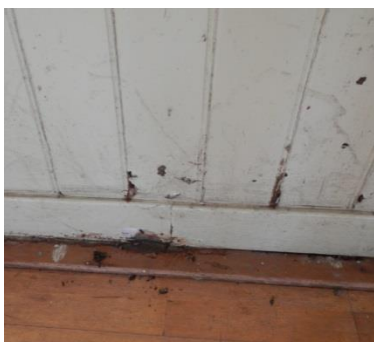
7.3 South East wall of main hall – new undecorated plaster panel in coombe above right hand window, evidence of damp/condensation to right of central window, evidence of severe dampness at skirting level along majority of wall, areas of deteriorated paintwork/ *dampness appears to be as a result of long term overflowing guttering/blocked downpipes (see 4.2 and recommendations) and solid brickwork wall is likely to be saturated, investigation required to establish extent of rot to dooks supporting plaster walls/skirting/timber boarding, once remedial work complete and dampness cured redecoration required. Note: there are electrical sockets on this wall which should be disconnected if they are likely to be affected by dampness.*

SE wall dampness under skirting

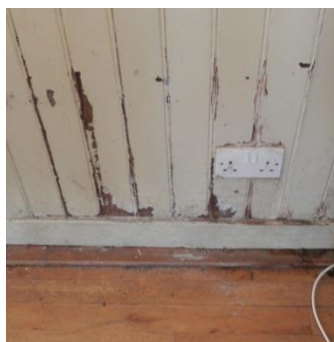
Dampness in timber boarding

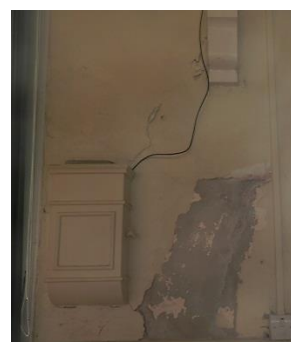
Dampness to wall

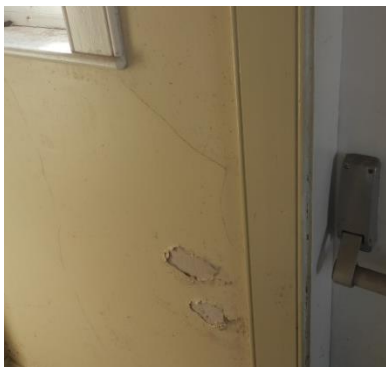
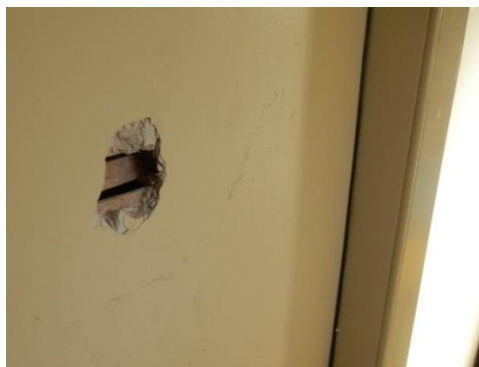
Green rooms – deteriorated paintwork and damaged plaster

7.7 *Green rooms* – in reasonable condition, some minor areas of damaged/cracked plaster and deteriorated paintwork/*no major work required, repair plasterwork and re-decorate.*

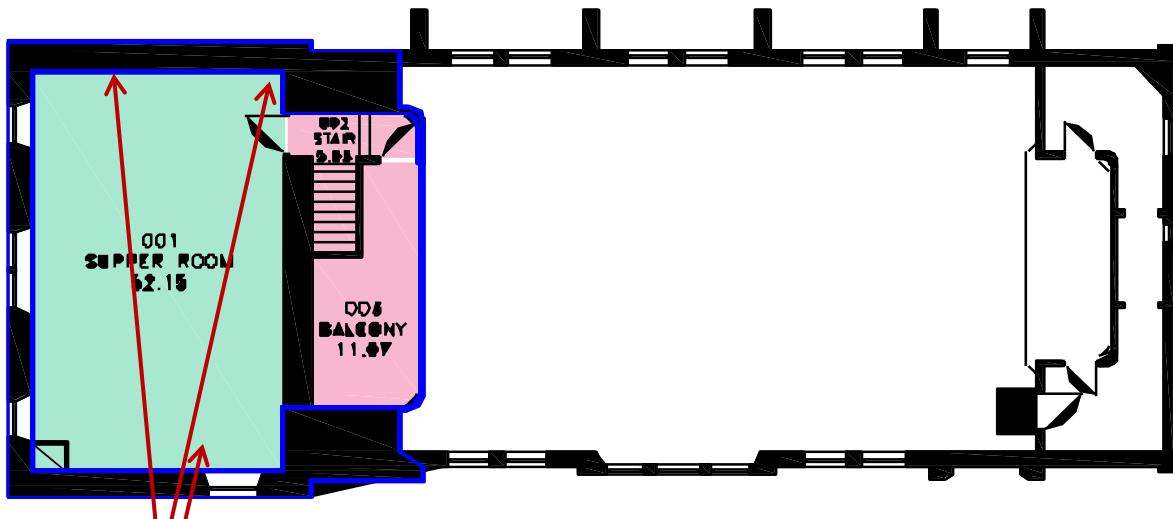
First floor - areas of damp

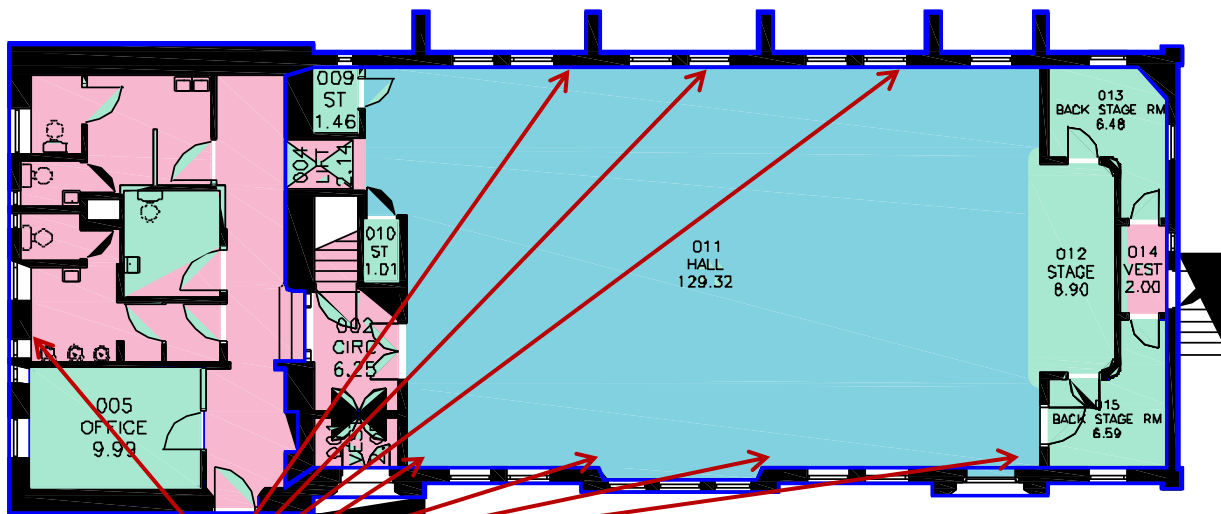
Ground floor - areas of damp
