Report of the Independent Inquiry into the Construction of the **DG One Complex in Dumfries**

APRIL 2018

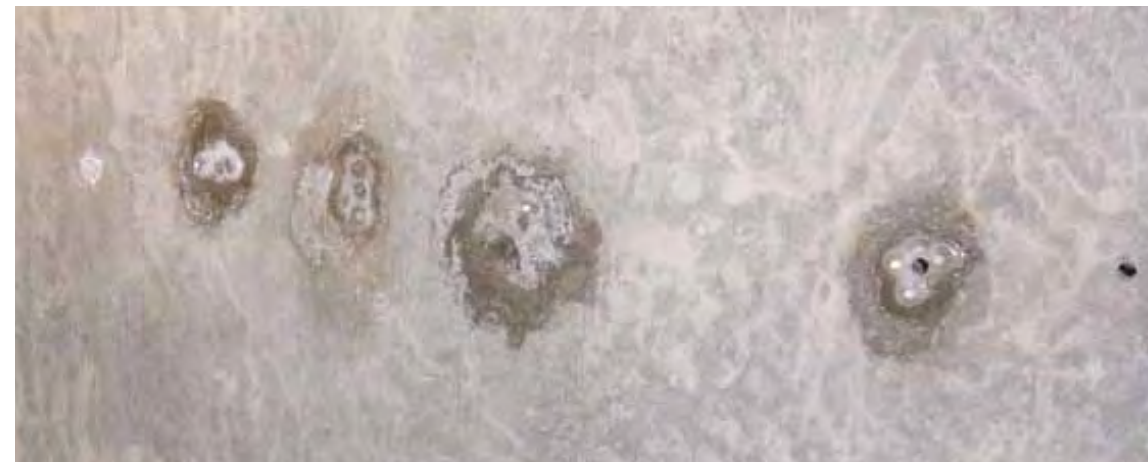
10.7 The report described the apparent use of further unconventional methods to alleviate the problems of water trapped in the hollow voids in the 'bison' floor slabs in the form of a series of almost 200 holes drilled into the soffit of the slabs. At the time of the inspection water was reported to be constantly dripping from several of these holes, which to make matters worse, were directly in front of an electrical control panel.

Water dripping from holes drilled in soffit of bison slabs

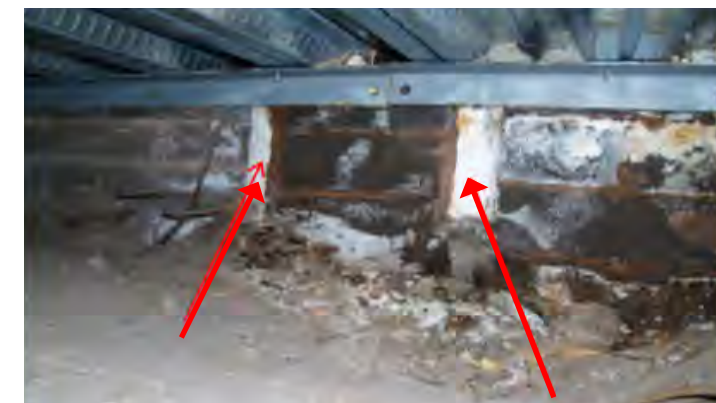
Steel columns indicated with red arrows are rusted and corroded

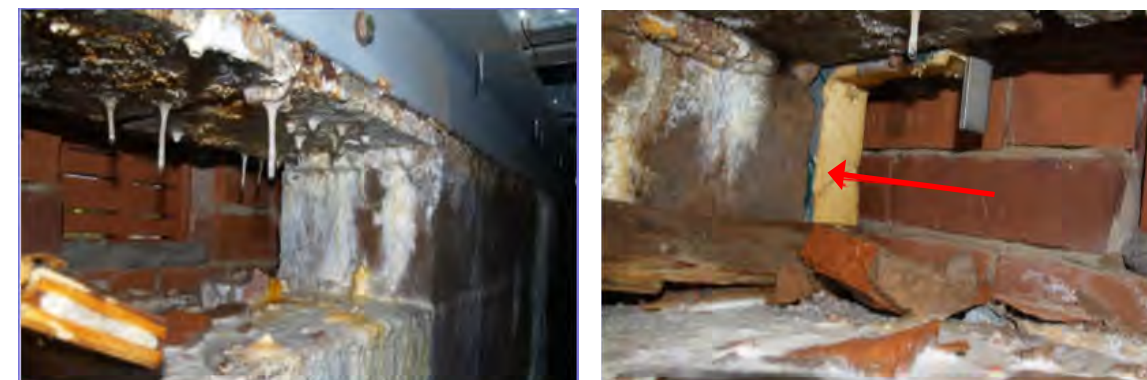
Saturated damp and efflorescence in void under pool area

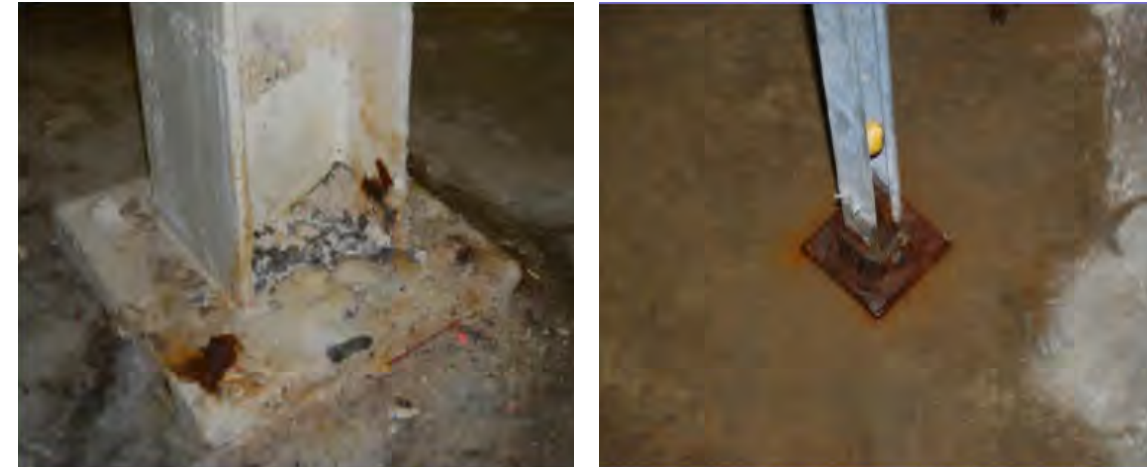
3. Corrosion of steel columns in the basement plant room

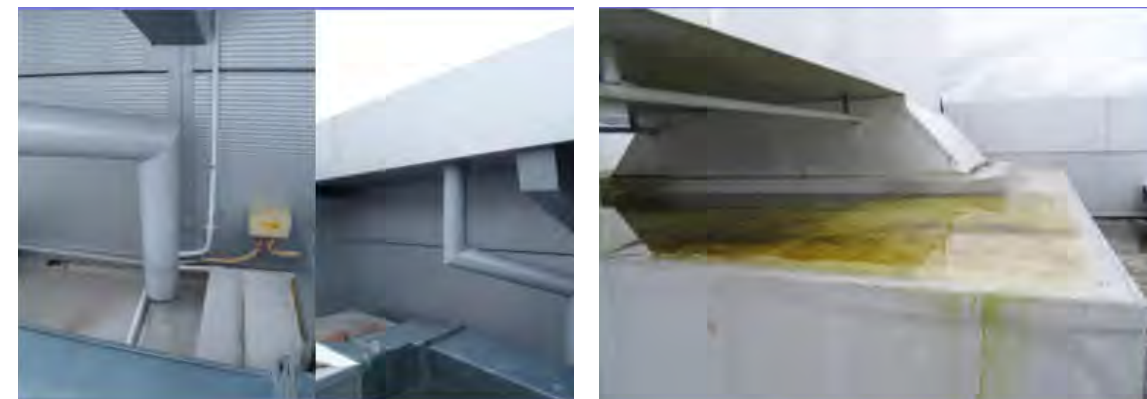
4. Examples of poor roof drainage. Water cascading from higher roof on to PVC membrane and ponding on roof due to no fall having been provided

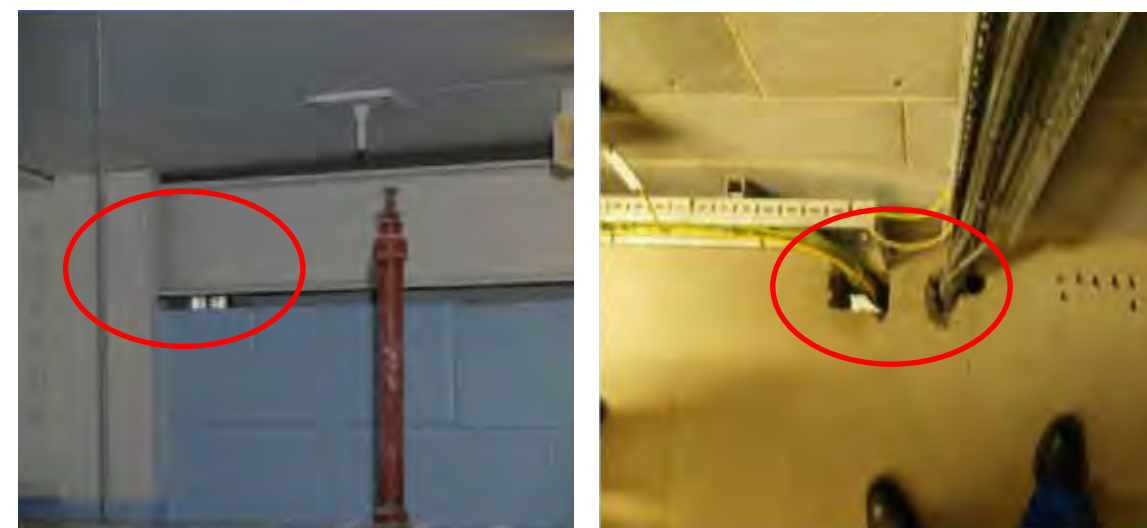
5. Two examples of many major omissions of essential fire-stopping, one in an escape corridor and second in the floor slab of a first-floor plant room

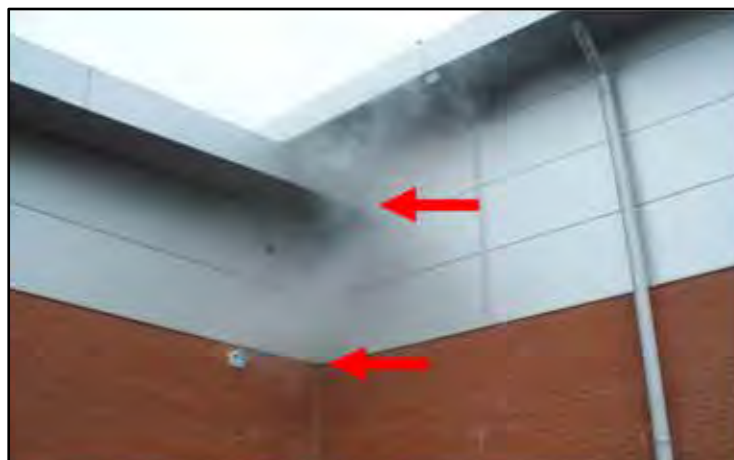
18.2 Smoke introduced internally was noted to rapidly egress the building at the cladding to brick junction and at the eaves junction as in the photograph below.

Test smoke rapidly escaping through eaves junction demonstrating lack of air-tightness

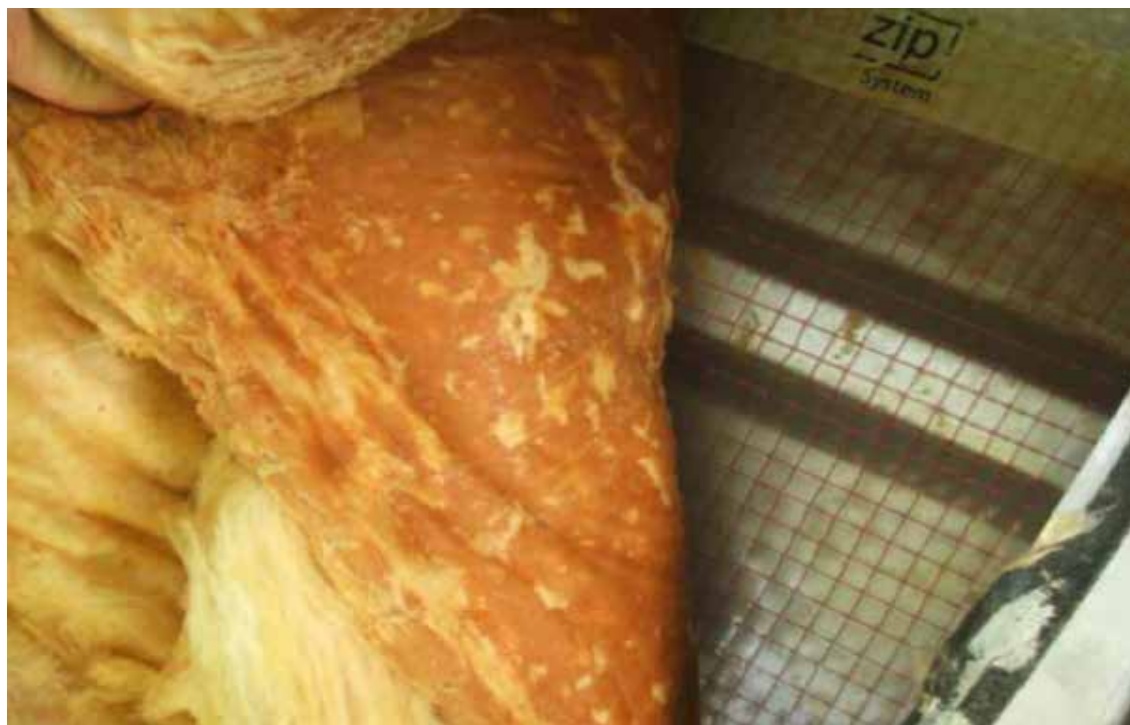
Insulation saturated with water at roof edge

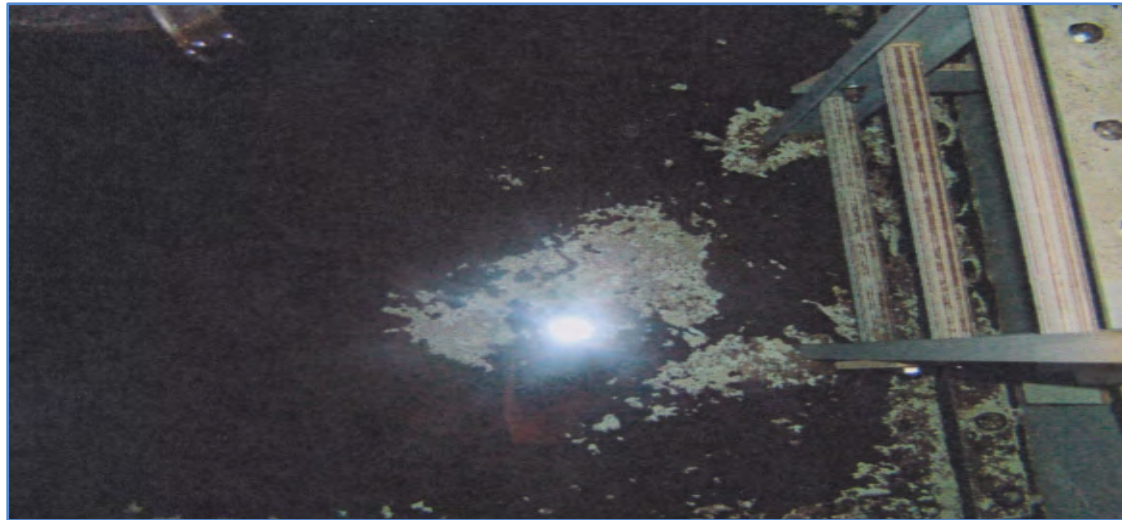
“The cold-water tanks show signs of organic matter and should be cleaned at the earliest opportunity and the system sampled for bacteria”. H&K 2011

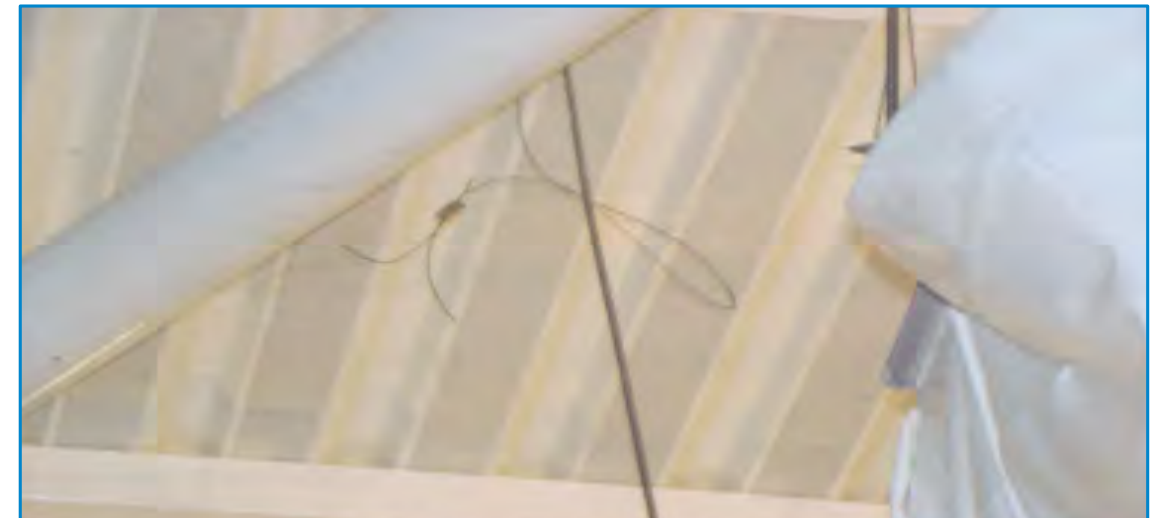
“Example of a snapped hanger to the pool ventilation duct work”. H&K 2011

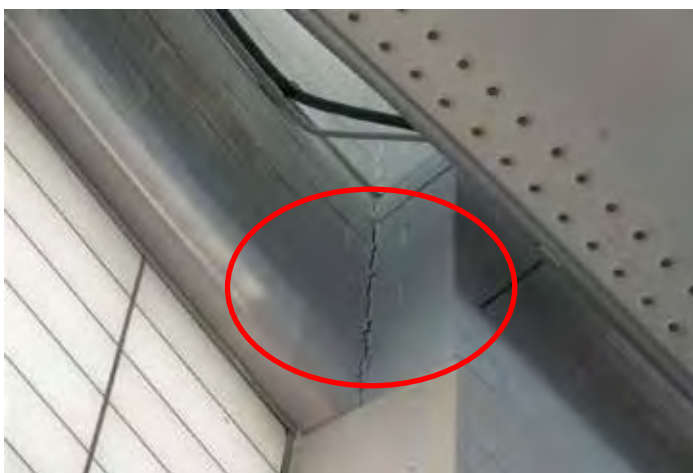
Photographs taken in Nov 2013 of cracking to blockwork encasement of columns in the Rotunda

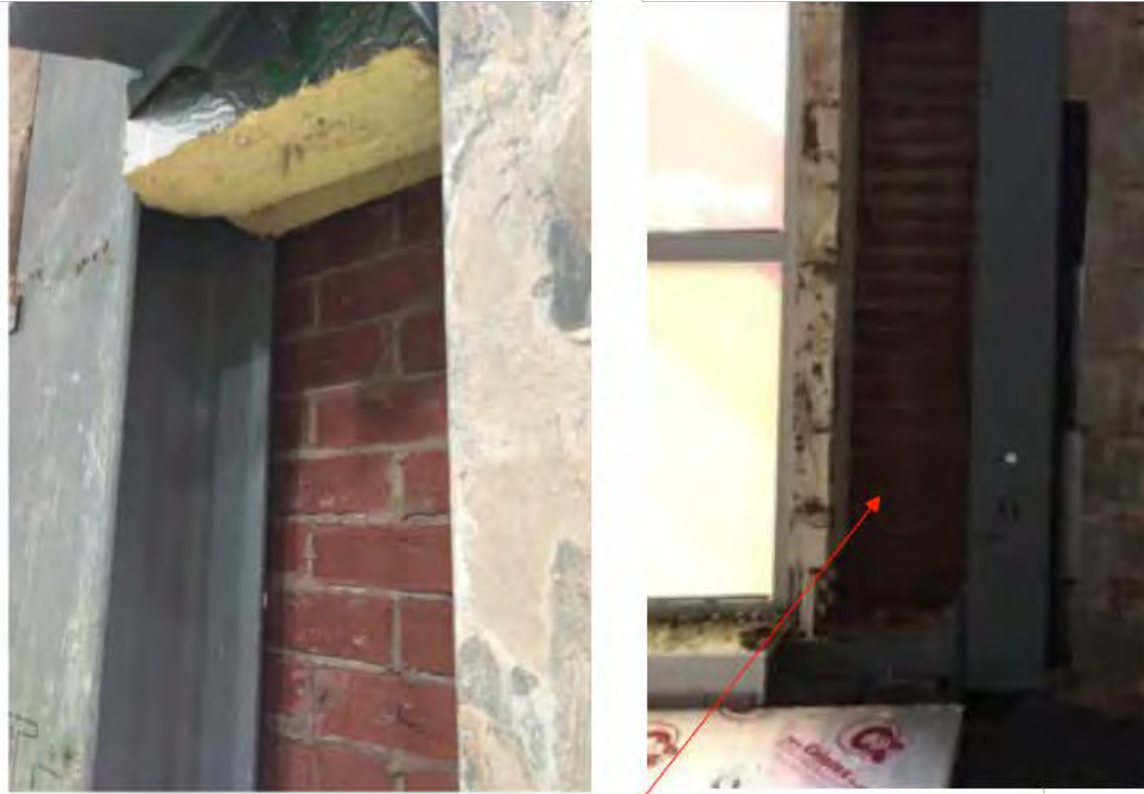
Piers 12. No inner leaf blockwork between Kalwall glazing and column. External brickwork has no tie back. Insulation boded.

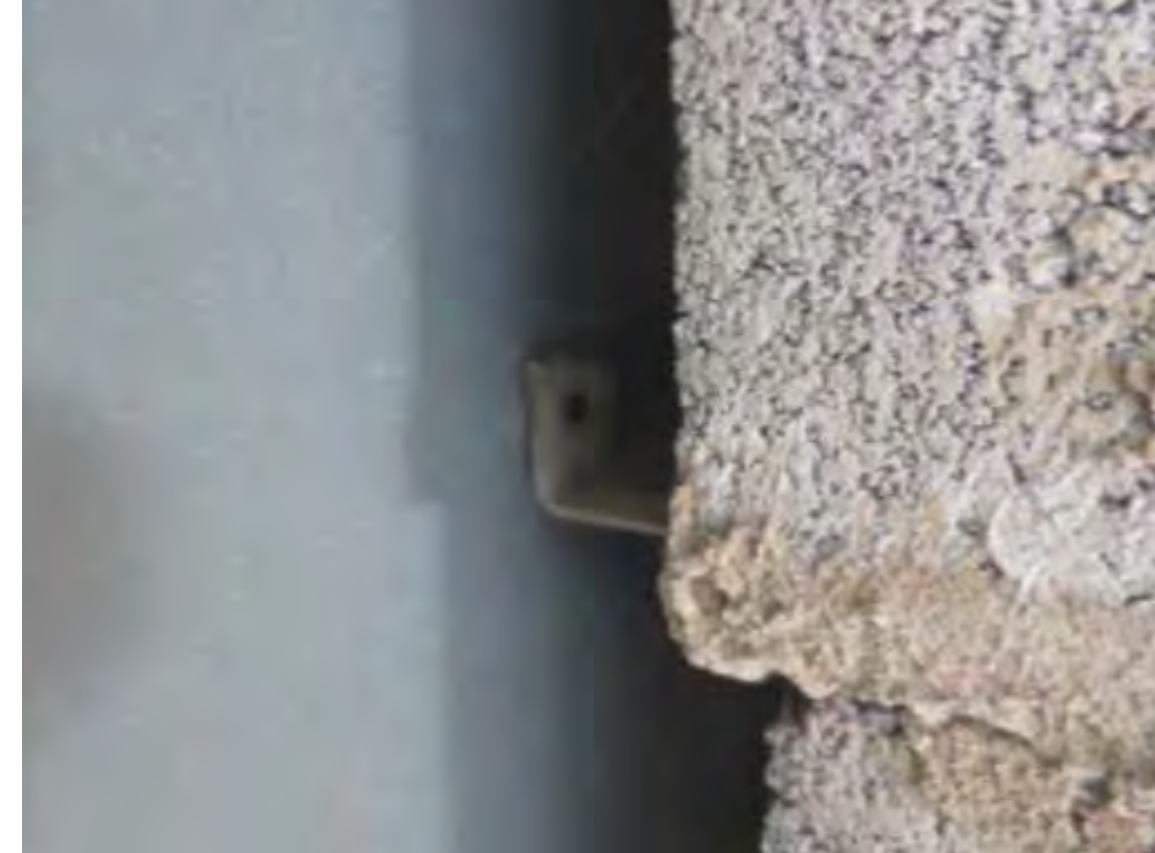
Exposed masonry. No shot fixing from tie to steel.

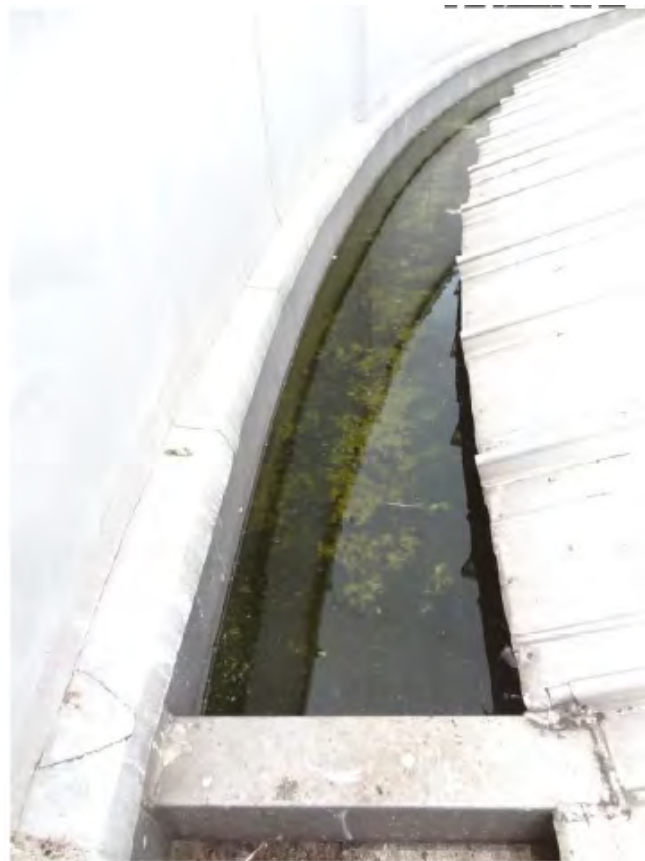
Blocked gutter at Rotunda

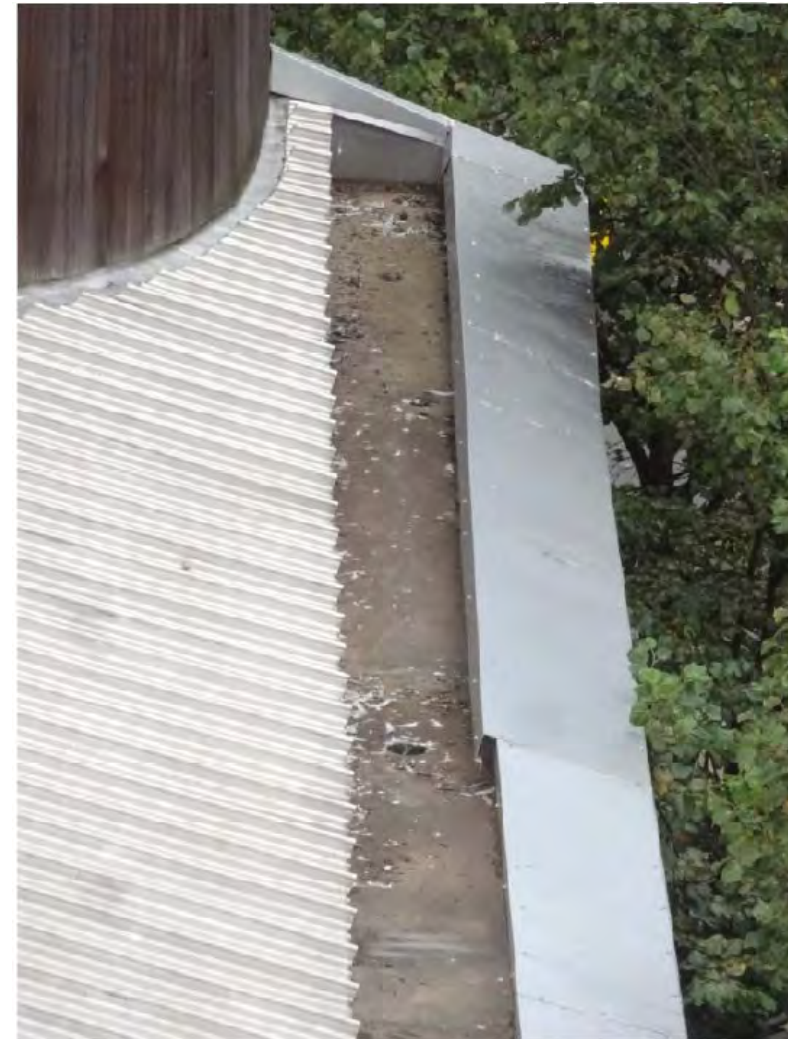
Poorly fitted and sealed flashing

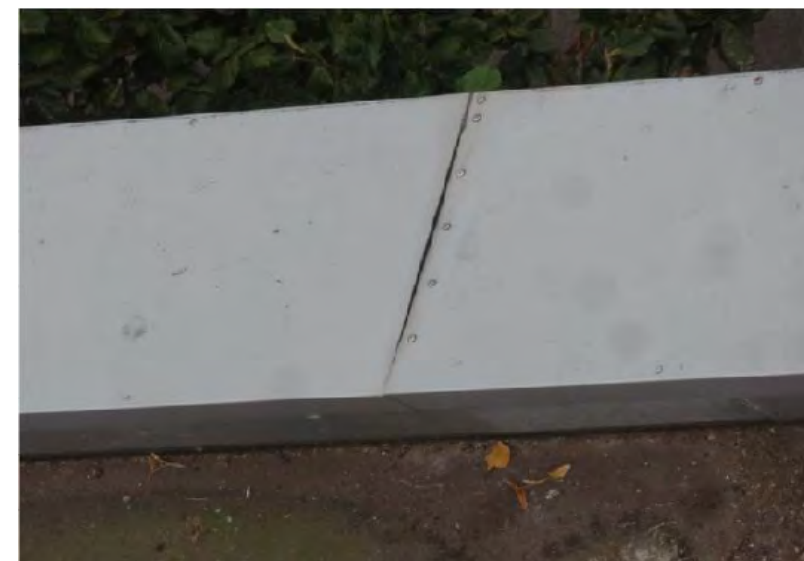
Poorly sealed and fitted coping flashing

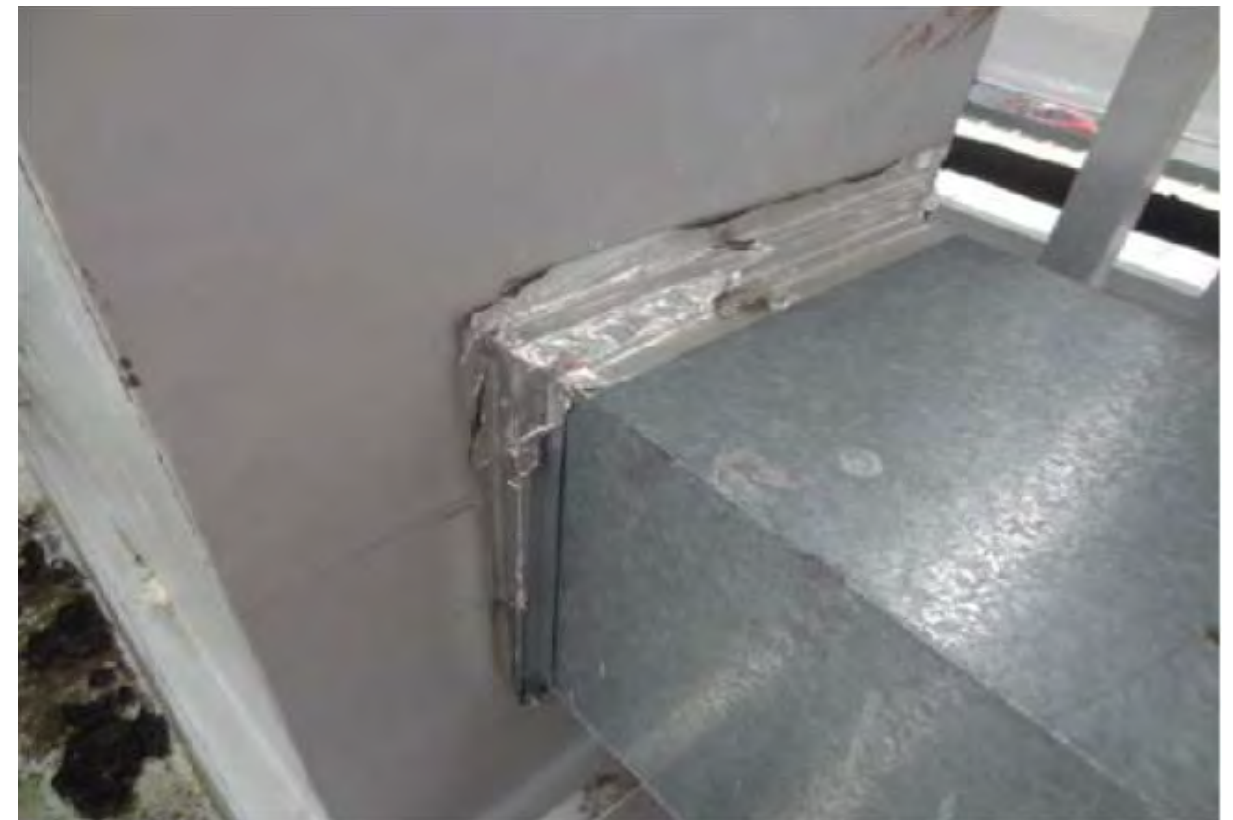
Poorly sealed ventilation duct

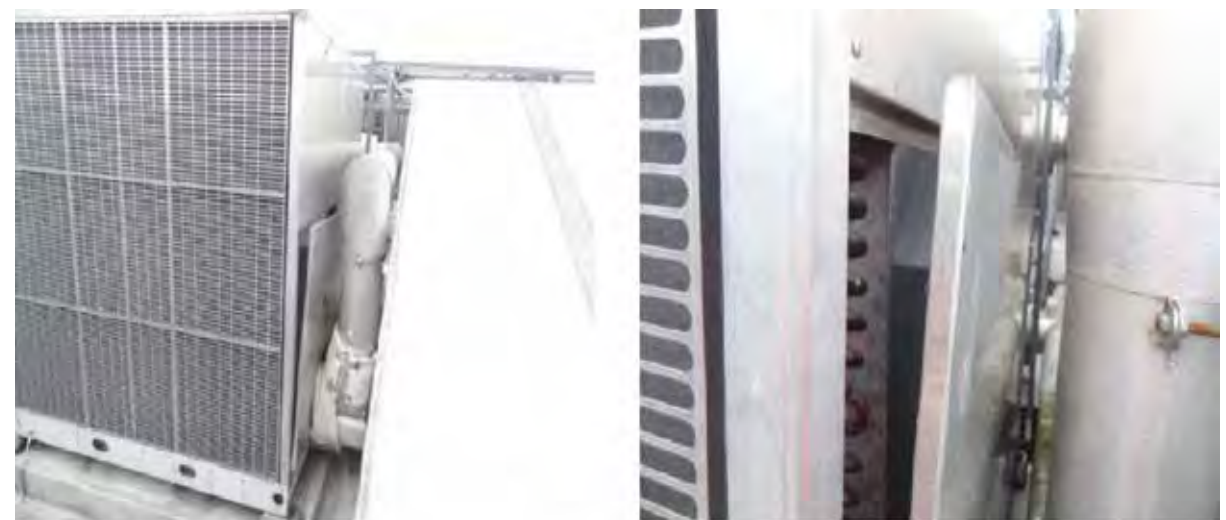
Unsecured and difficult to access panel on chiller
