Report of the Independent Inquiry into the Construction of the **DG One Complex in Dumfries**

APRIL 2018

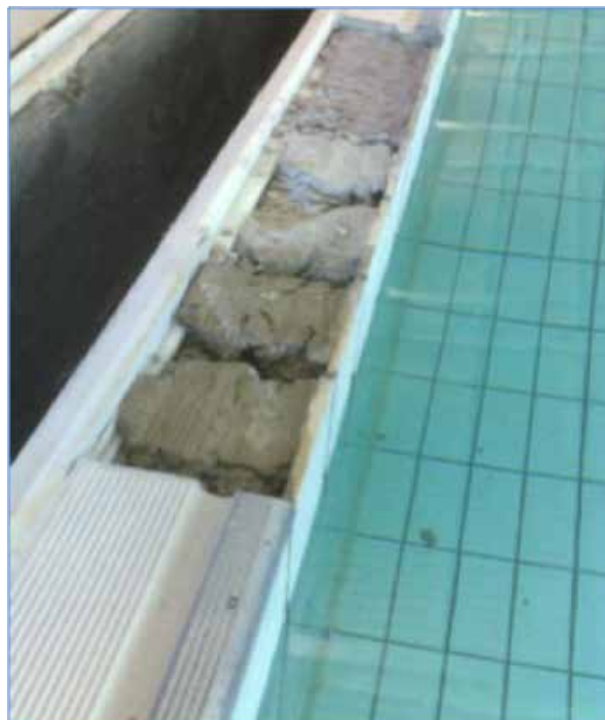
24.21 Once opened up under the current remedial contract, it became evident that the separately poured top concrete section of the pool wall, that also served to create the scum /drainage channel around the edge of the pool, had been left short of the required height by the original pool contractor. The additional necessary height to the wall had been made up with crudely formed lumps of mortar packing. The spaces between these created significant voids in the wall that would facilitate the ingress and retention of water within the wall structure. The photograph shows the crude packing and voids on a portion of the top section of the pool wall with the covering piece removed.

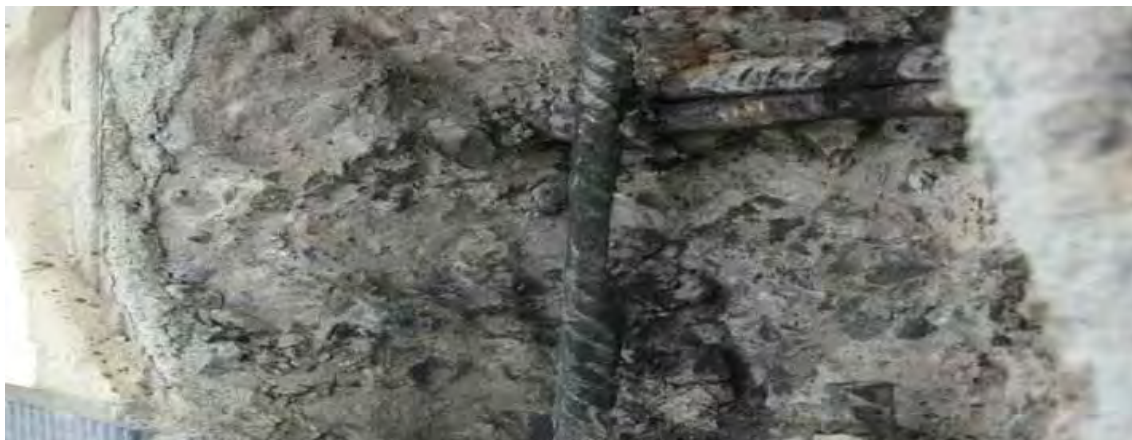
24.35 Above and below are two from many available examples of photographs of corrosion of steel reinforcement and staining of surrounding concrete in pool walls. The inset photograph above is an example of a corroded bar removed from the upper scum channel section of the tank wall showing depleted section as a result of corrosion

24.36 The pool tanks structures were suffering from water ingress into the structure and corrosion of steel reinforcement. A fully effective waterproofing internal lining would have been required. However, no clear evidence was available of tanking or waterproofing and materials tests commissioned subsequently confirmed that no effective waterproofing lining had been installed to walls and floors of the pool tanks.

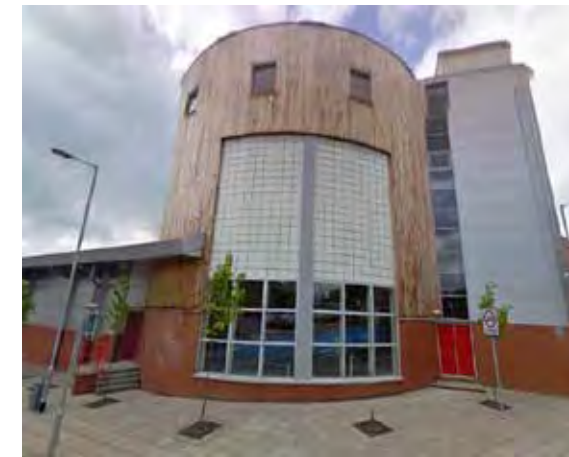
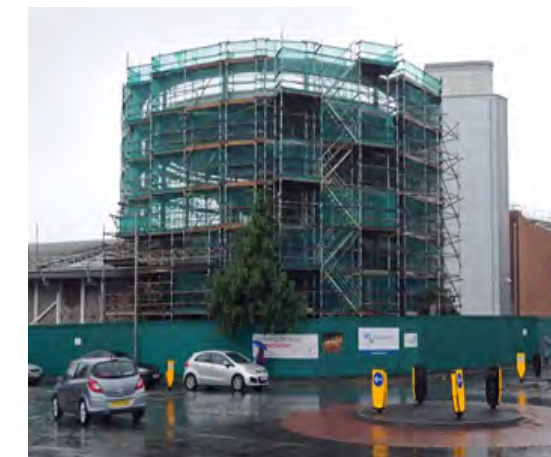
7.4 As previously stated, it had been determined by the design team that the only safe structural solution, given the level of inadequate construction now discovered to the blockwork walls, was to effectively demolish the external walls of the rotunda and rebuild them properly from their foundations. Without extra funding approval from the Council, it was beyond the authority of the Council's project management team to instruct in terms of either additional design fees or construction. The decision to proceed with this work would eventually not be given until more than six months after discovery of the defect, during which time the project would only be able to tick over.

7.5 The photographs below show the rotunda before the demolition of the walls on the left and after their necessary demolition on the right, unfortunately the reverse of the more usual before and after shots.

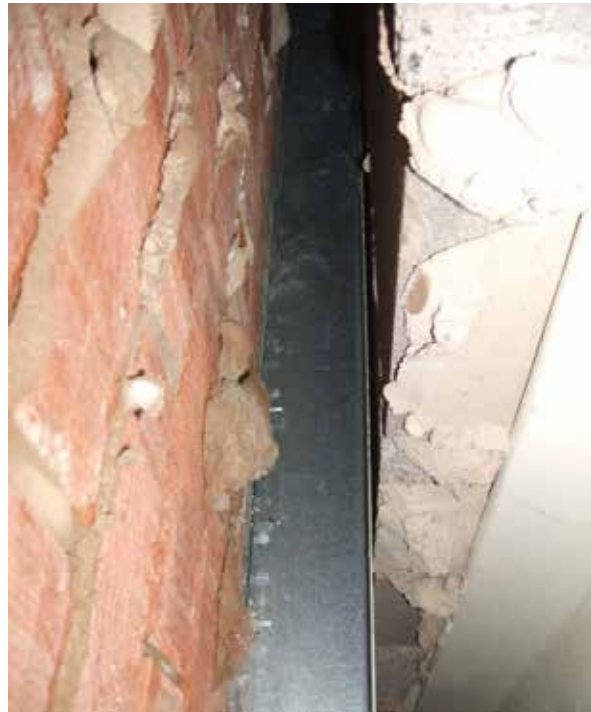
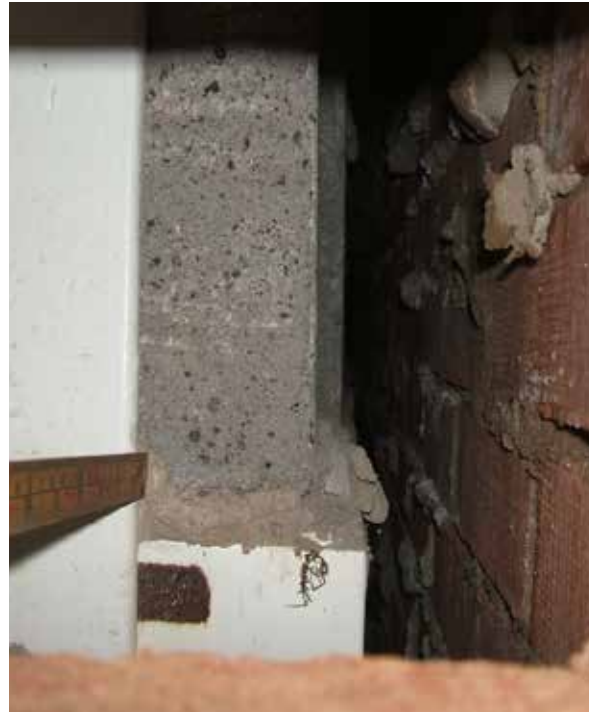
NOV 2011 PHOTOGRAPHS – NO VISIBLE EVIDENCE OF WALL TIES

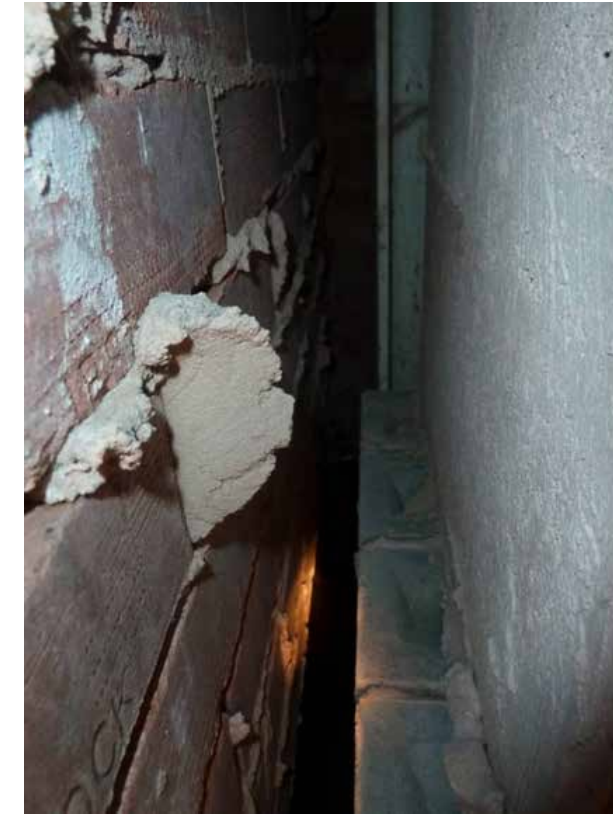
NOV 2011 PHOTOGRAPHS – NO VISIBLE EVIDENCE OF WALL TIES

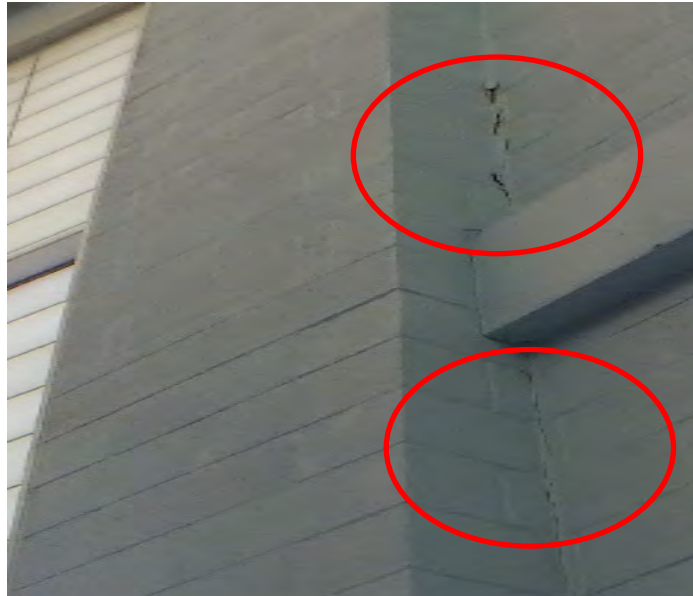
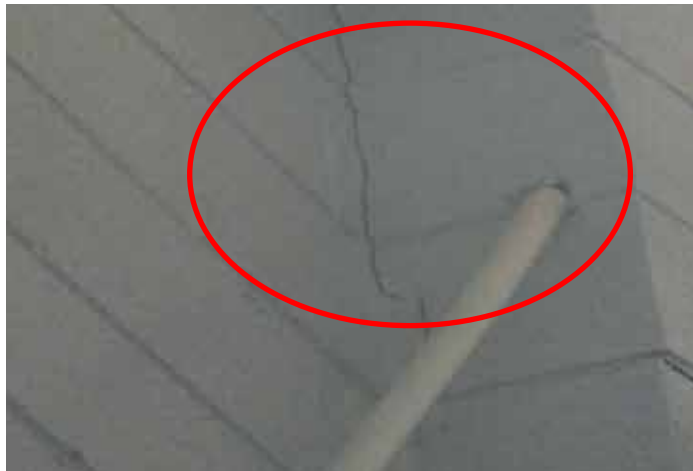
Photographs taken in Nov 2013 of cracking to blockwork encasement of columns in the Rotunda

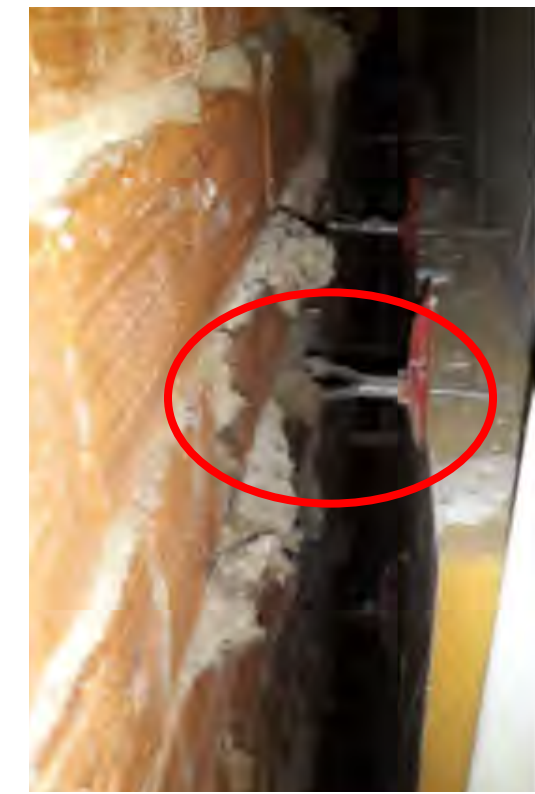
Quarter Landing 7. Ties too short. Insulation missing

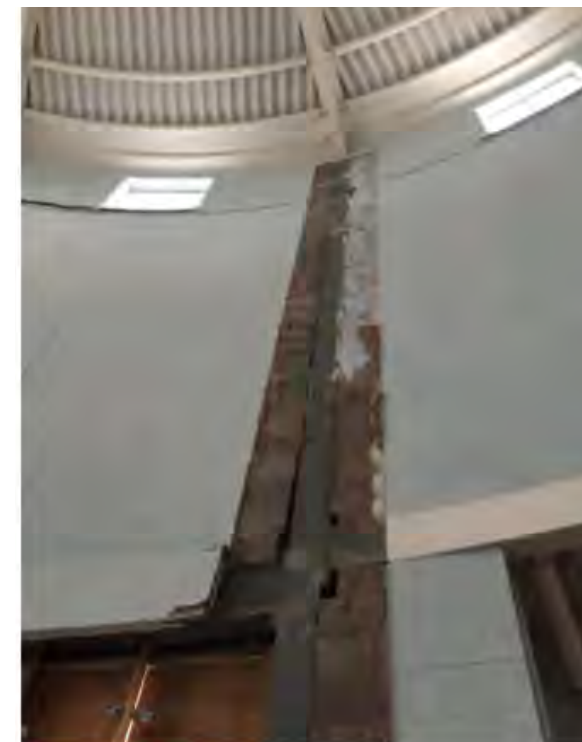
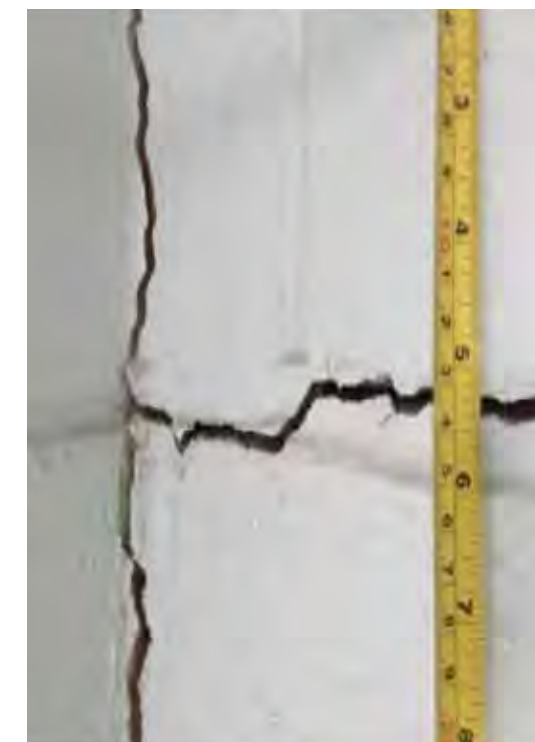
Piers 2. Block encasement removed. No ties in bottom 10 joint to left sides. No ties at all in right hand return. No ties to RHS of column in top section

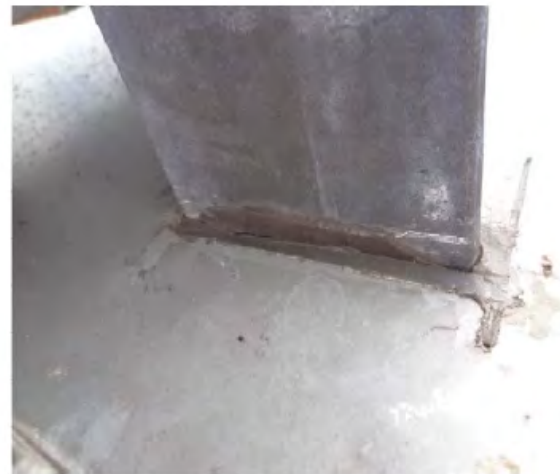
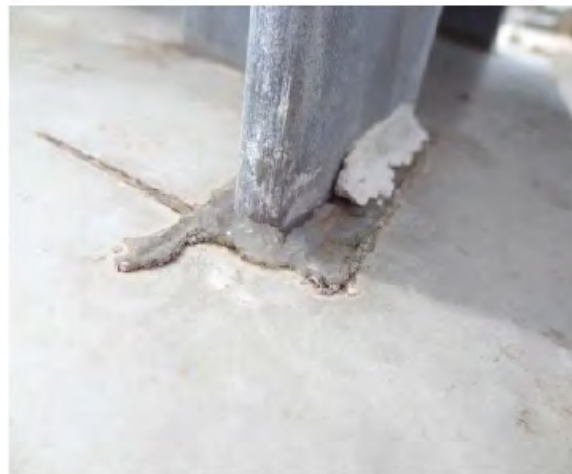
Poorly sealed penetrations through roof

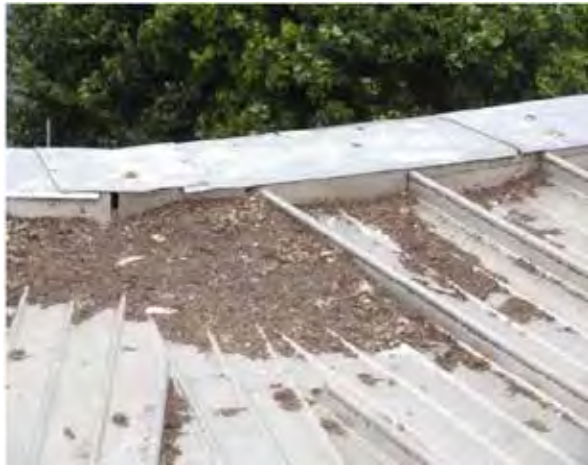
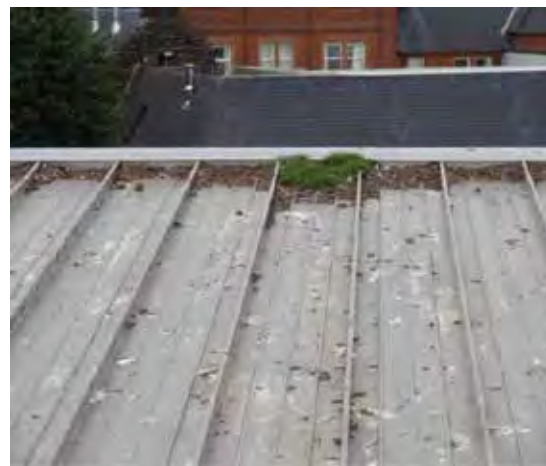
Build up of debris on roof and poorly fitted flashing

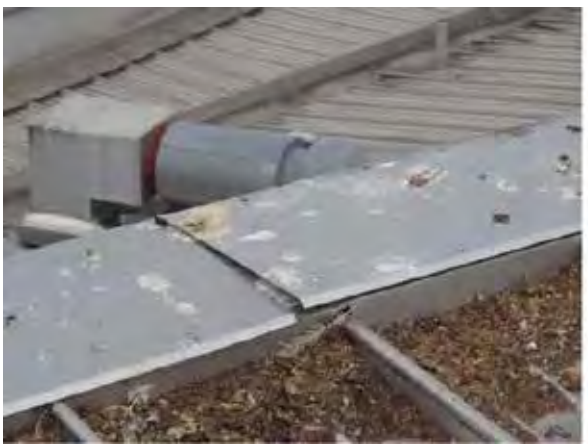
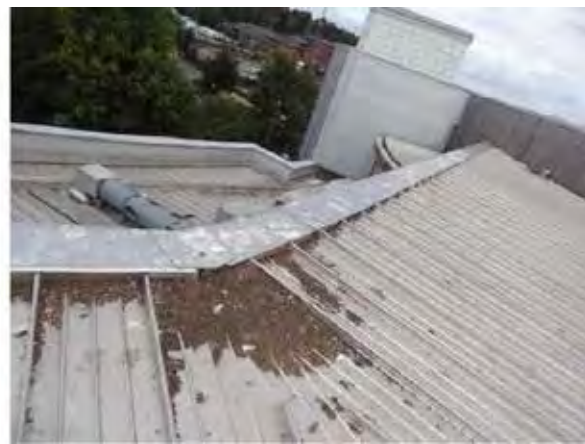
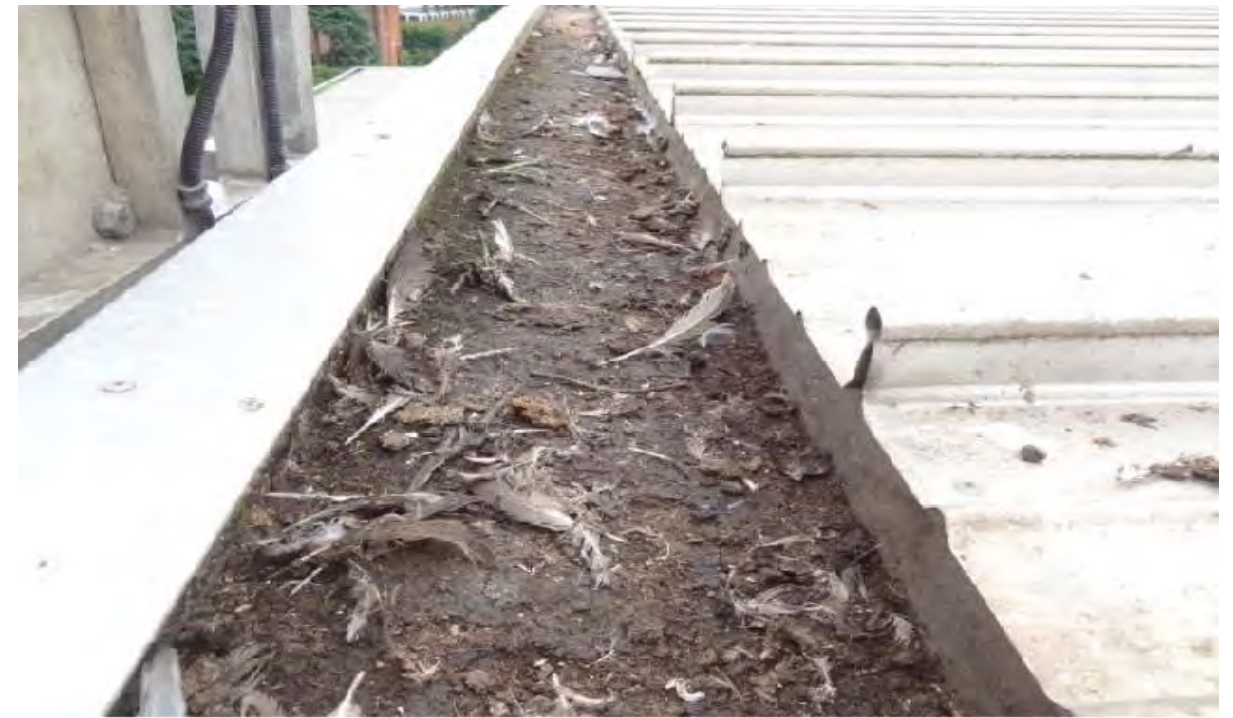
Poorly sealed ventilation duct

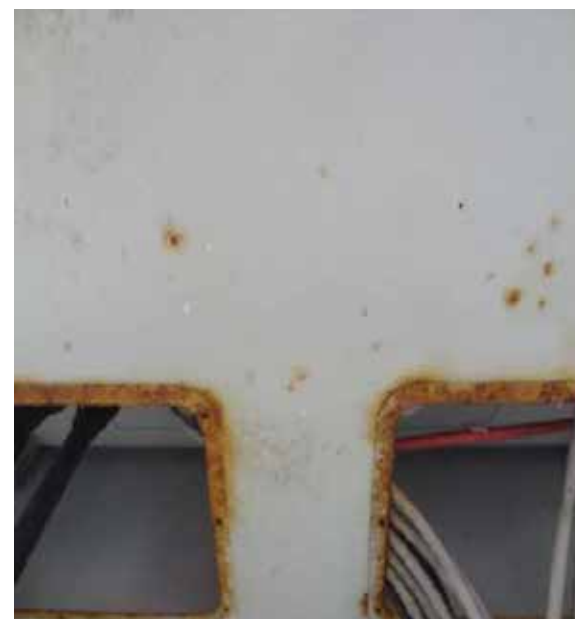
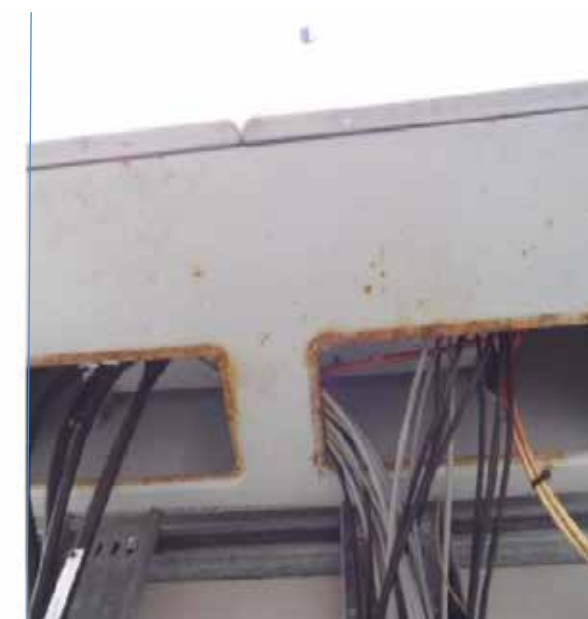
Corrosion to roof mounted plant

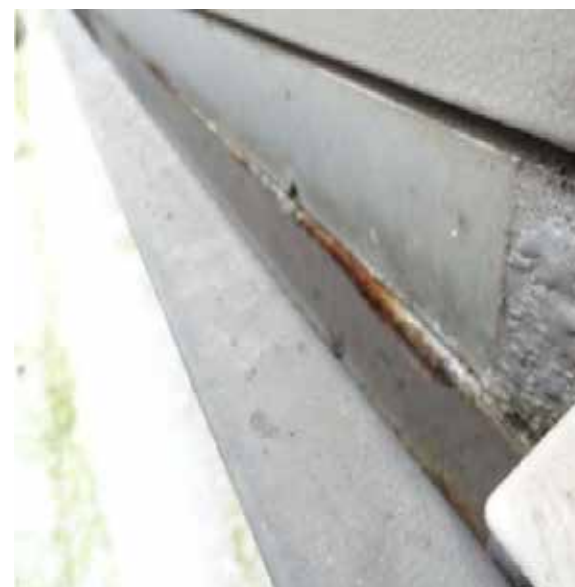
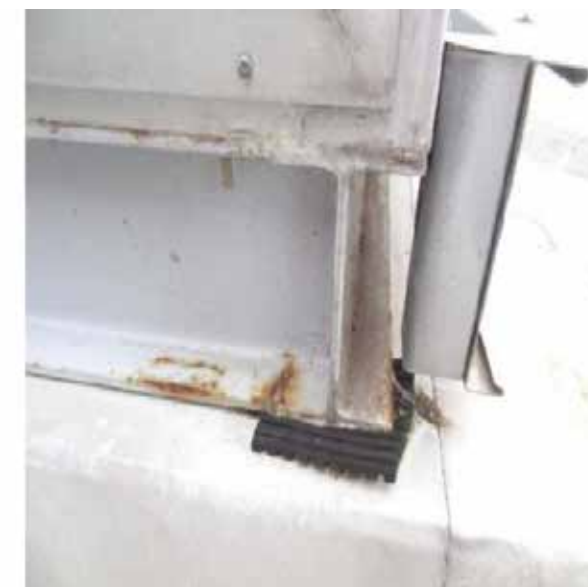
Damaged ductwork

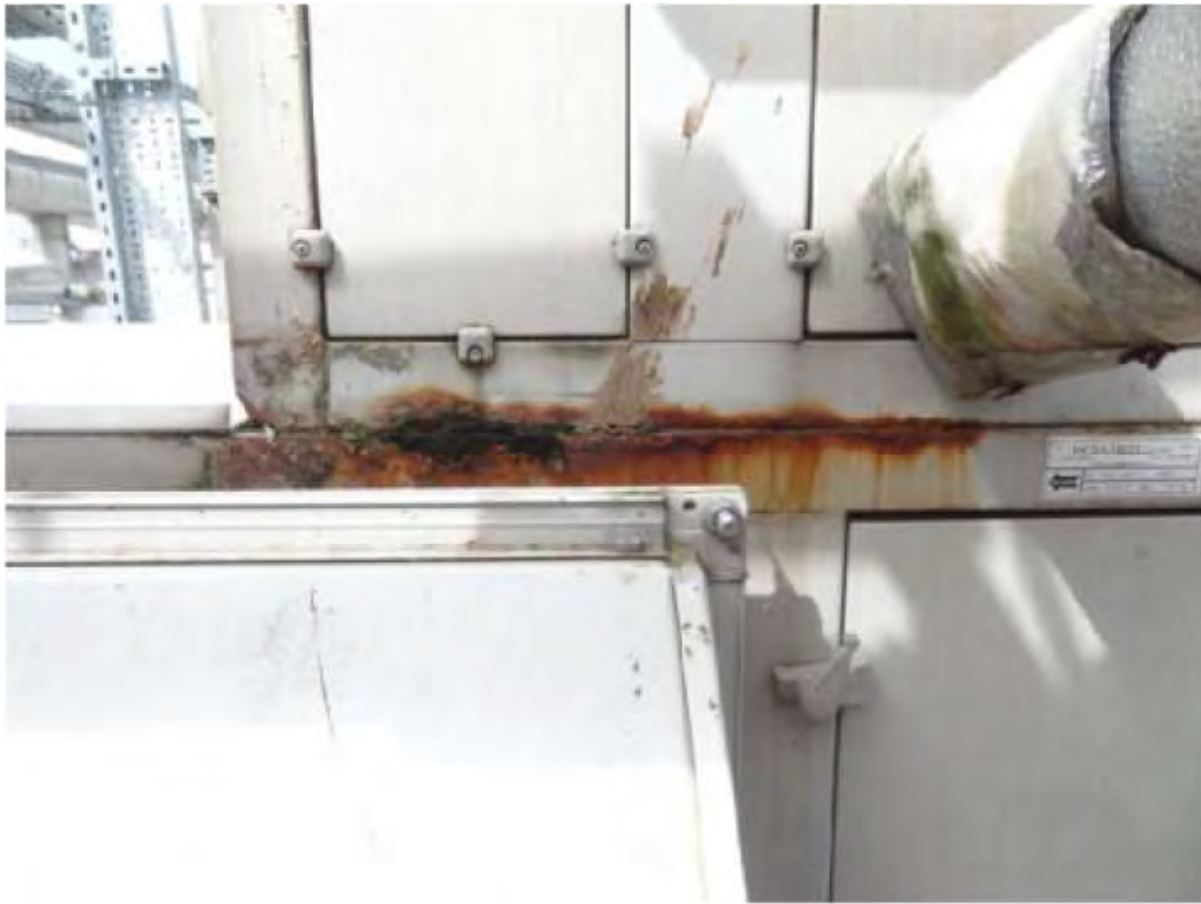
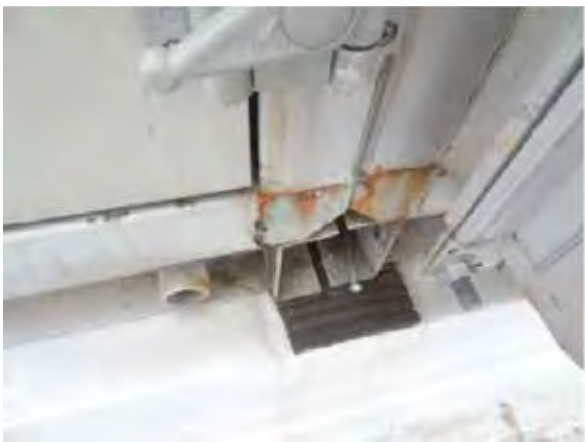
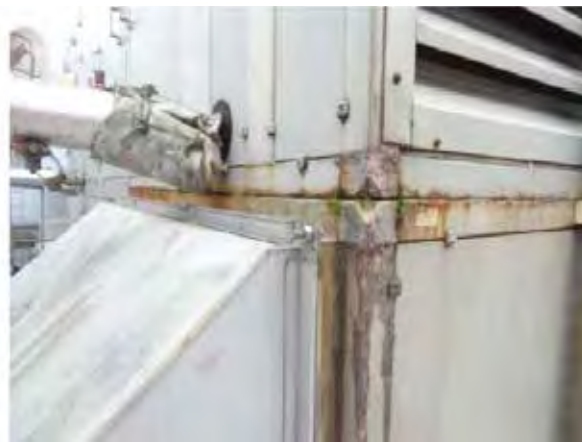
Corrosion to panels on roof

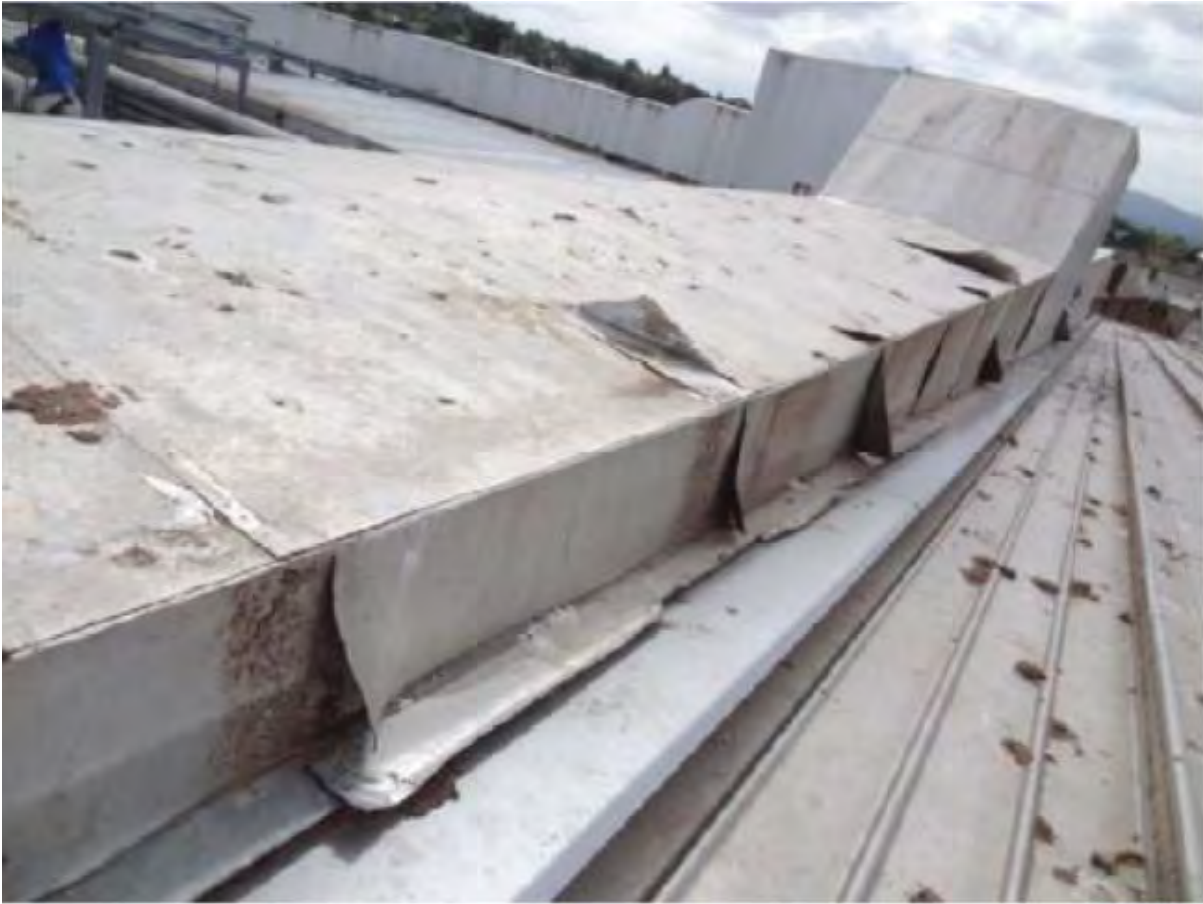
Potentially dangerous delaminating coverings

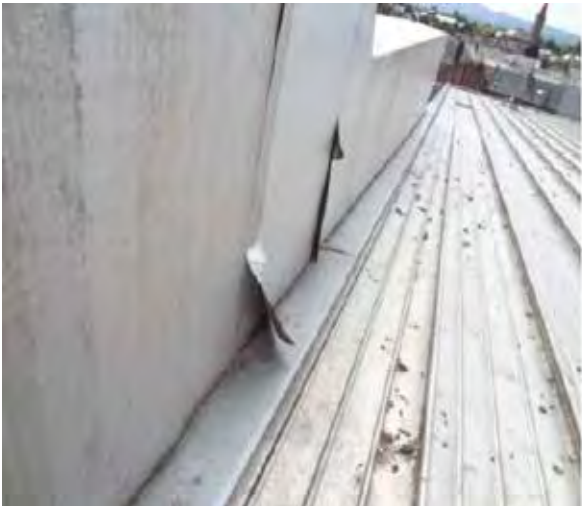
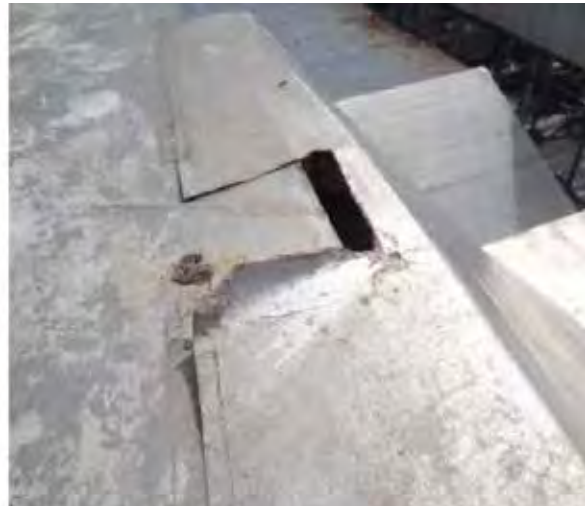
Unsecured and difficult to access panel on chiller

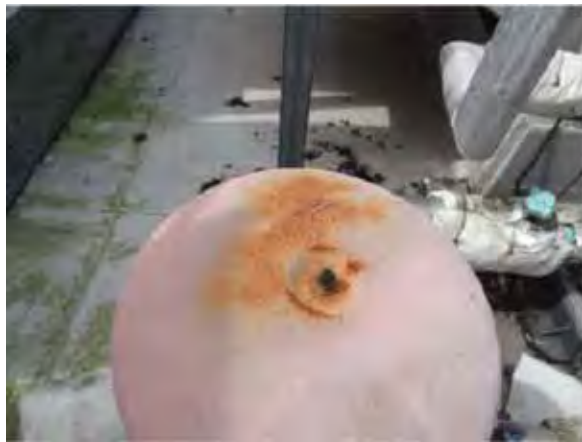
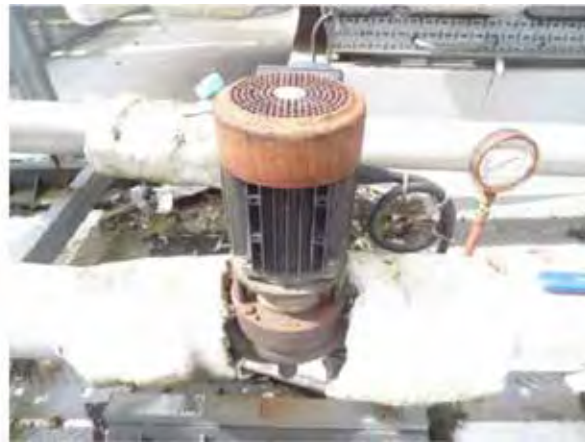
Corroding expansion chamber and valve

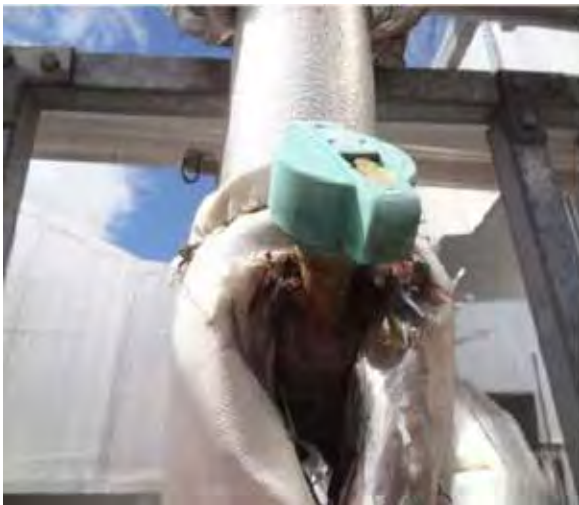
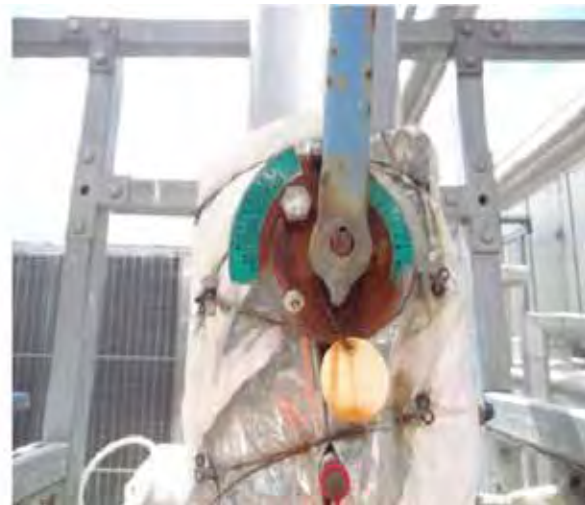
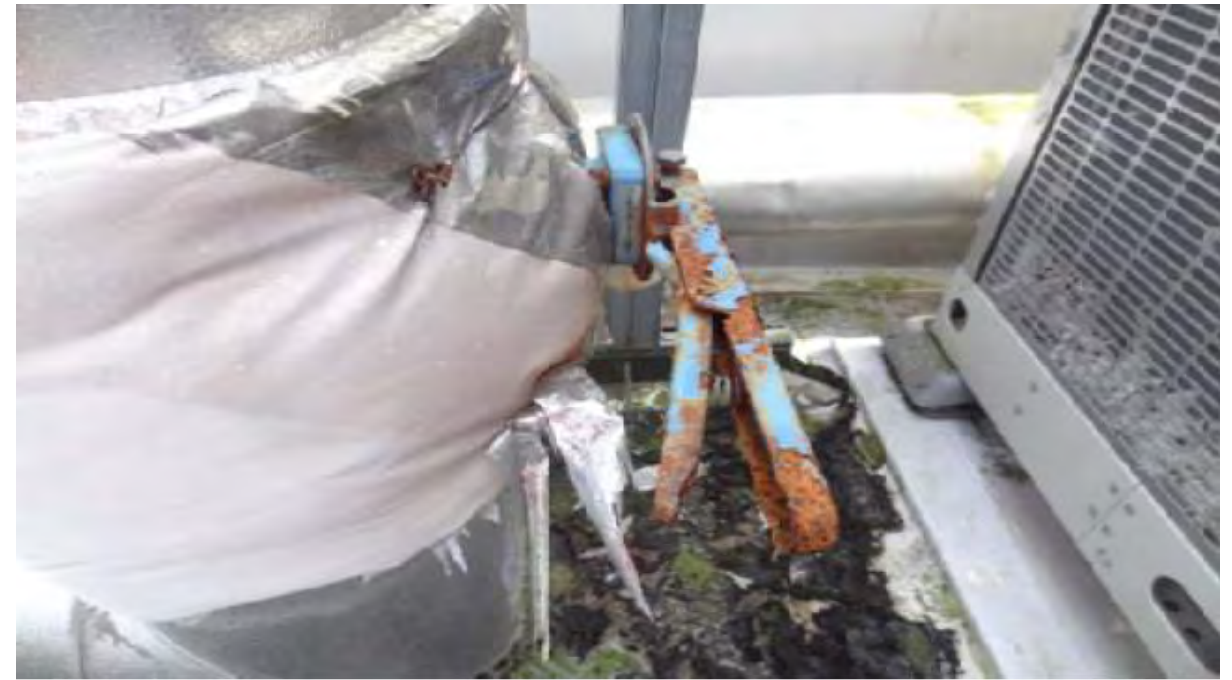
Corroded valve

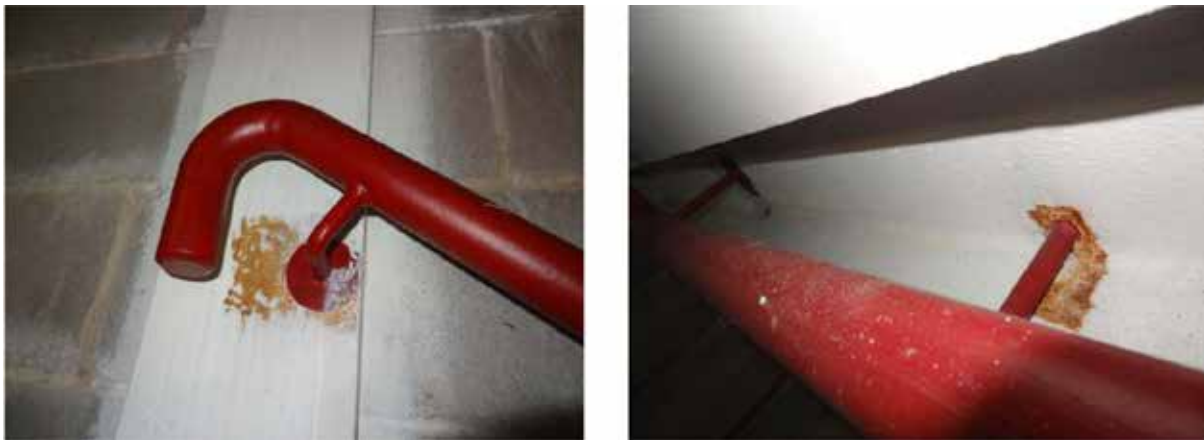
Failure of paint system

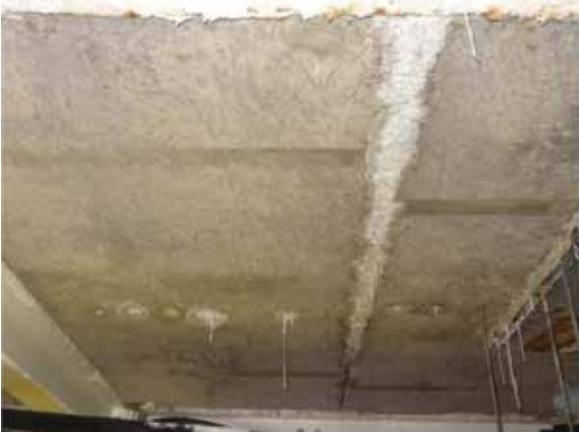
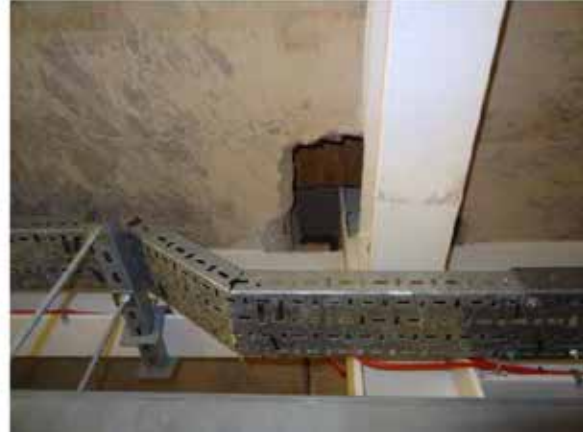
Leaks and lack of fire stopping
