Report of the Independent Inquiry into the Construction of the **DG One Complex in Dumfries**

APRIL 2018

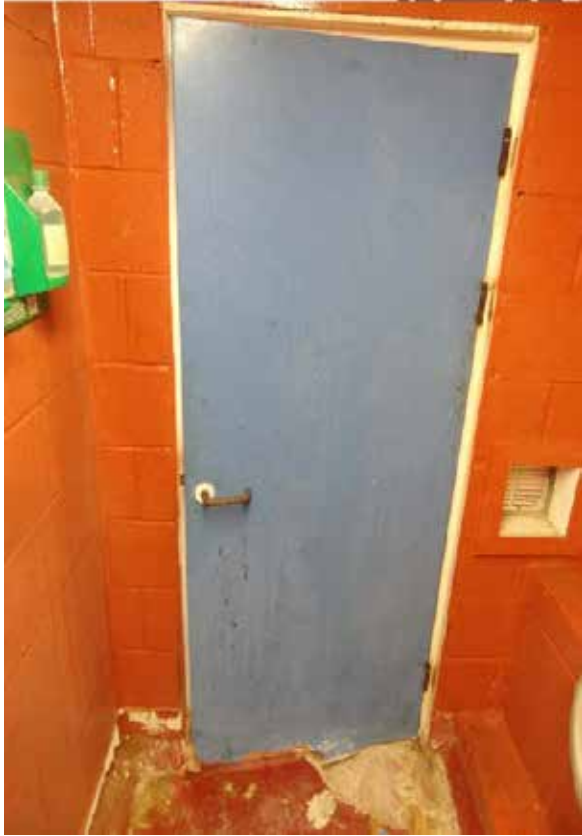
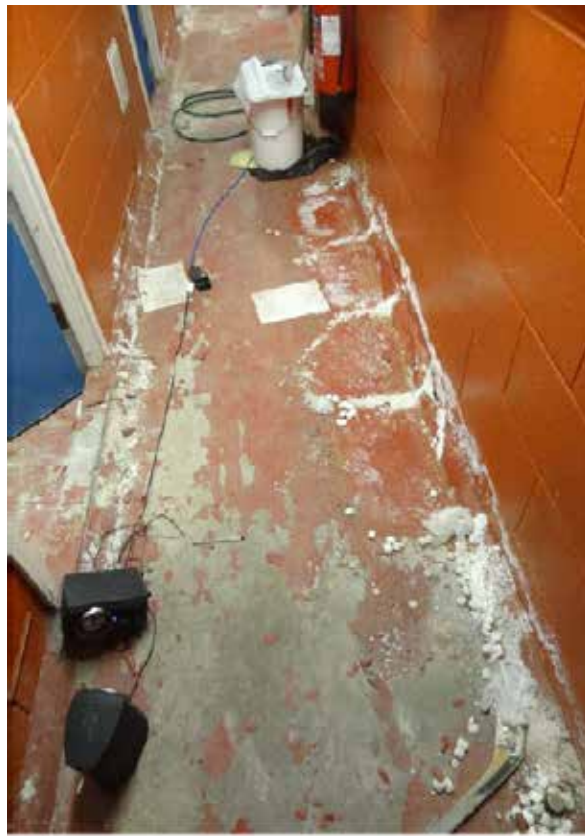
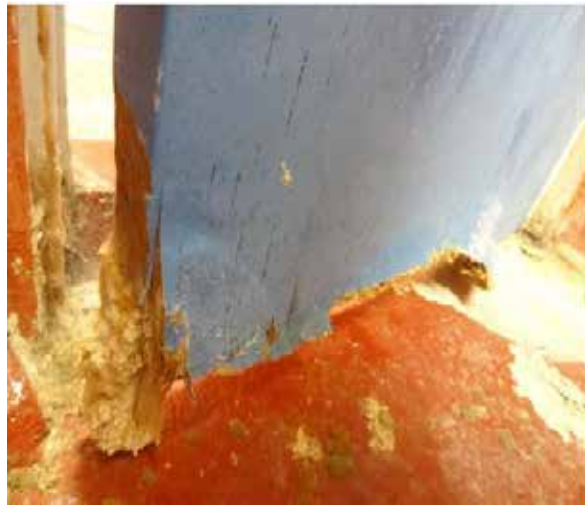
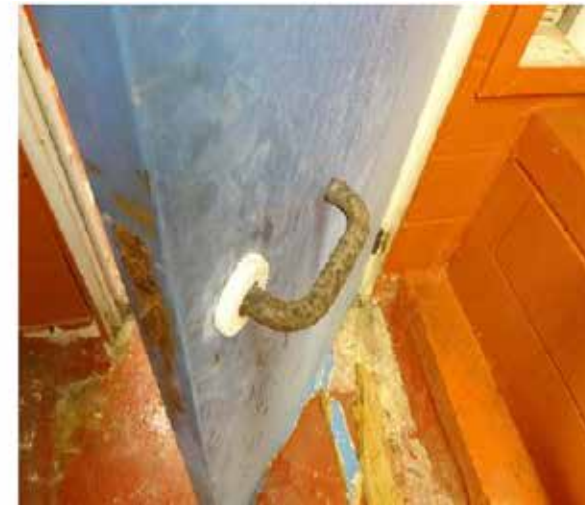
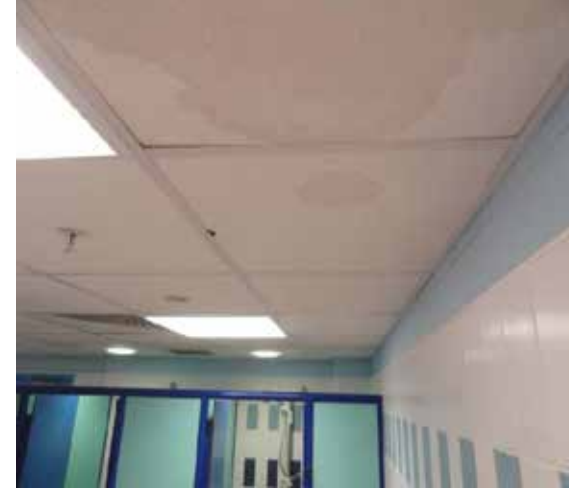
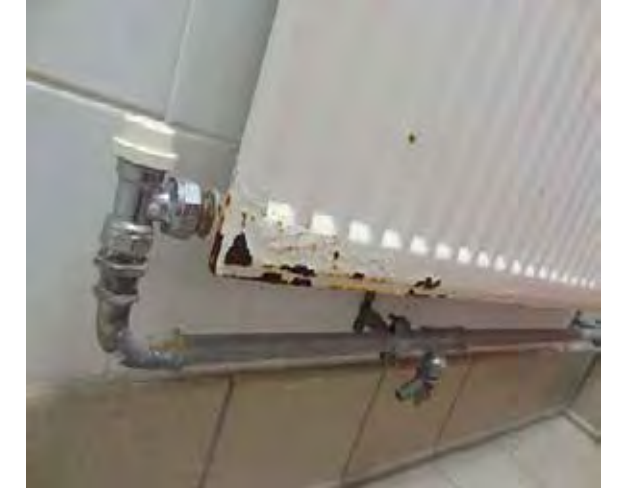
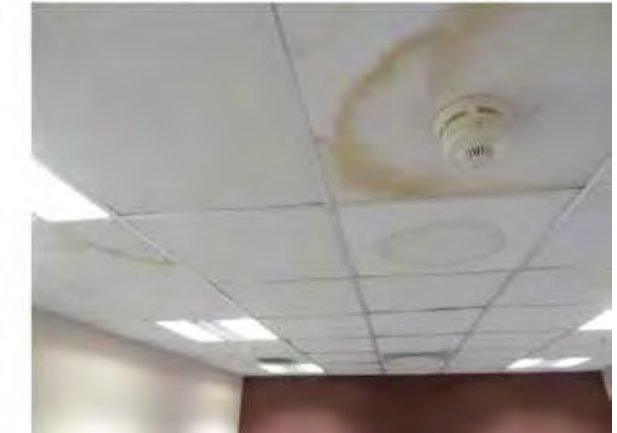
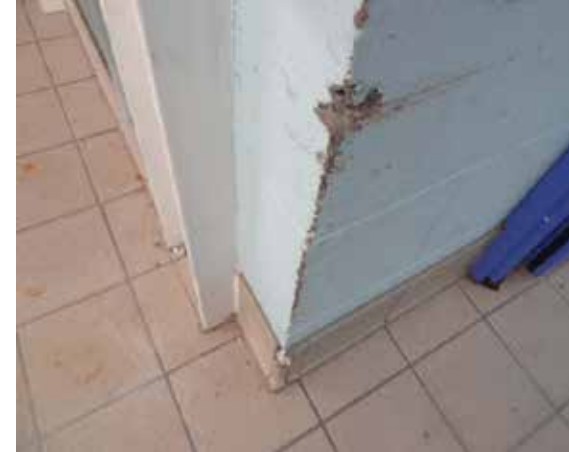
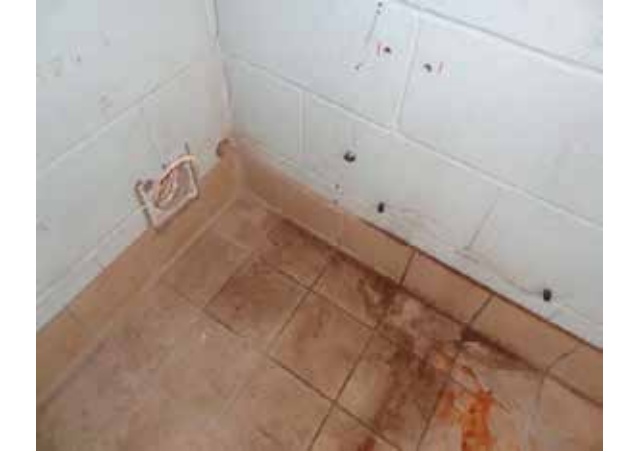
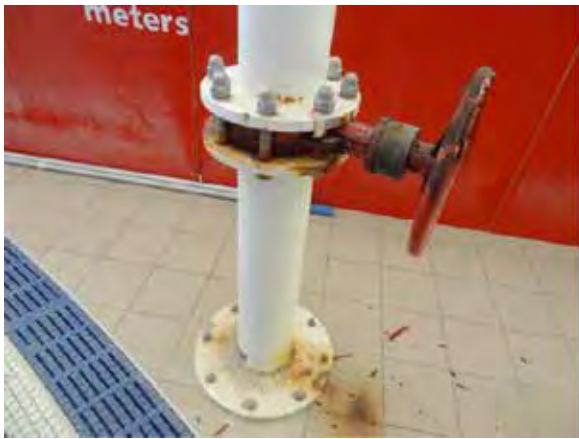
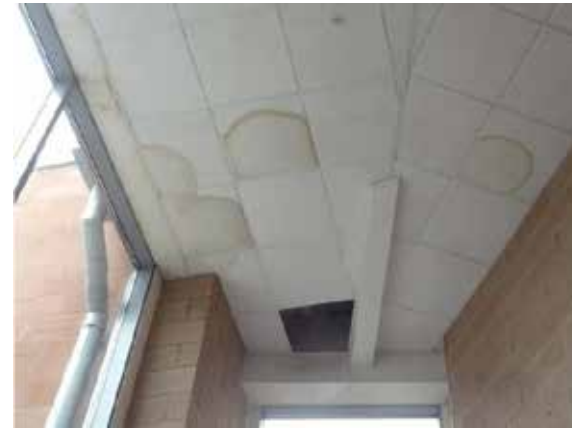
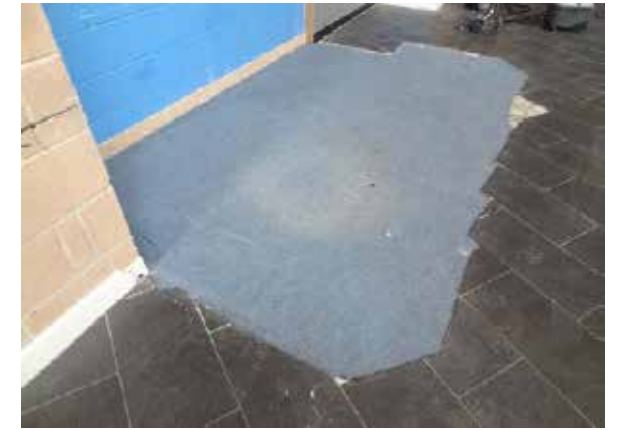
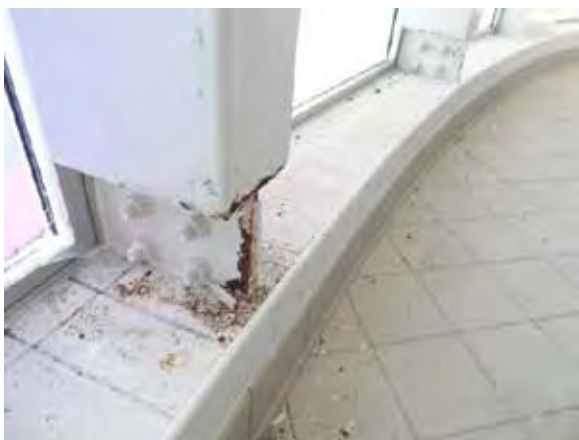
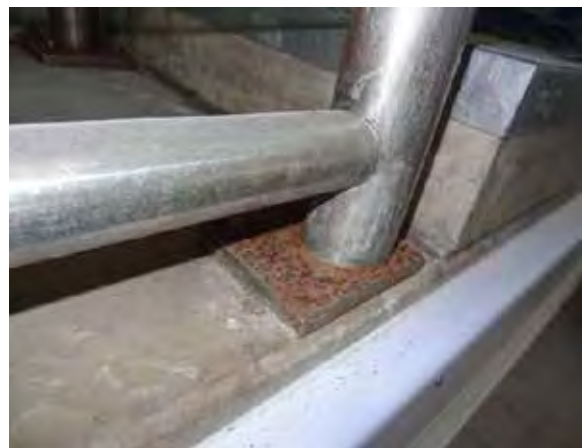
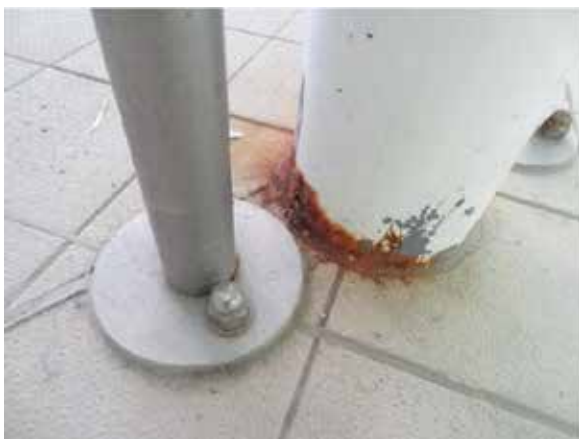
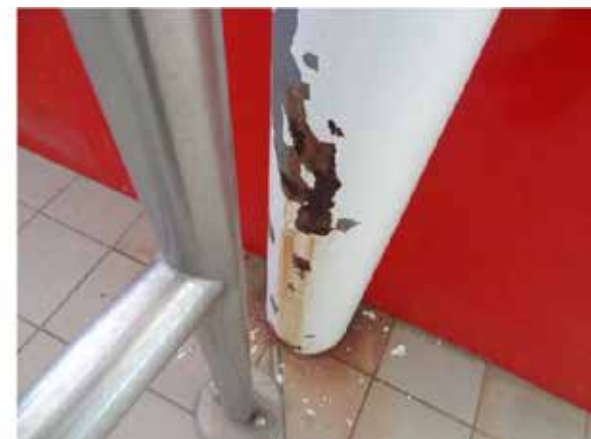
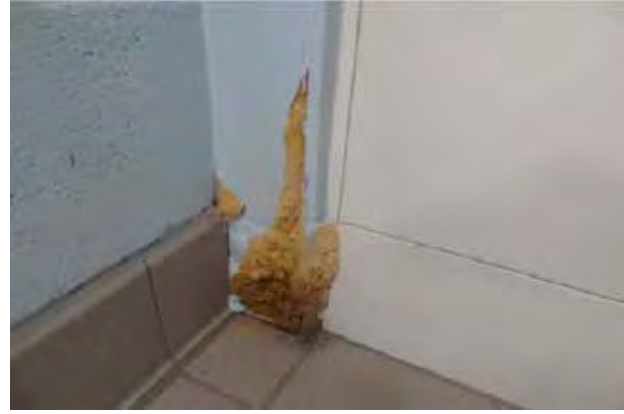
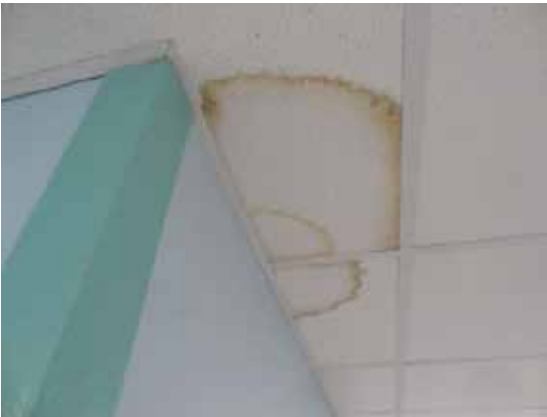
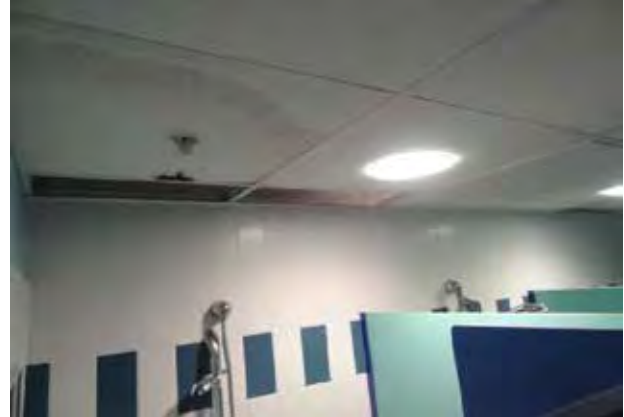
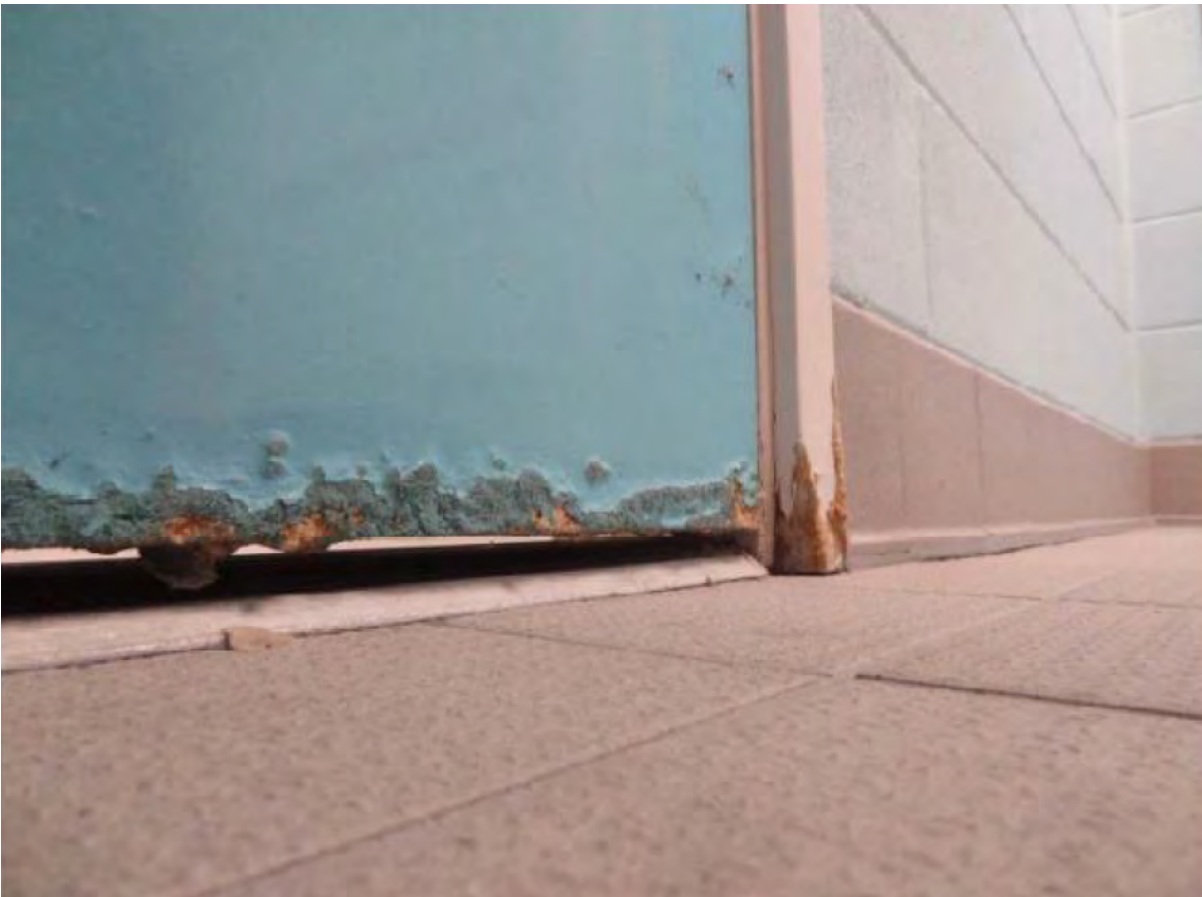
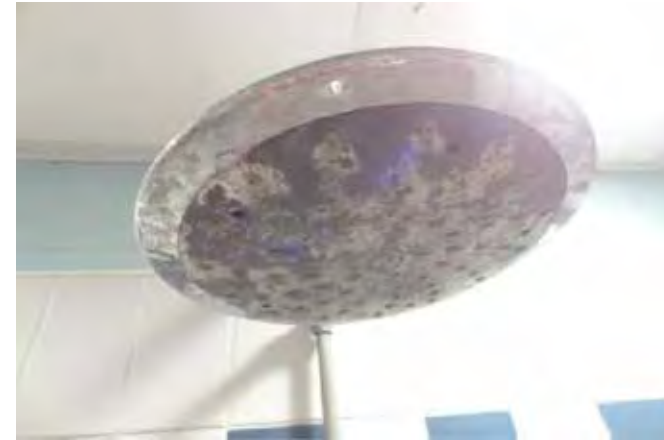
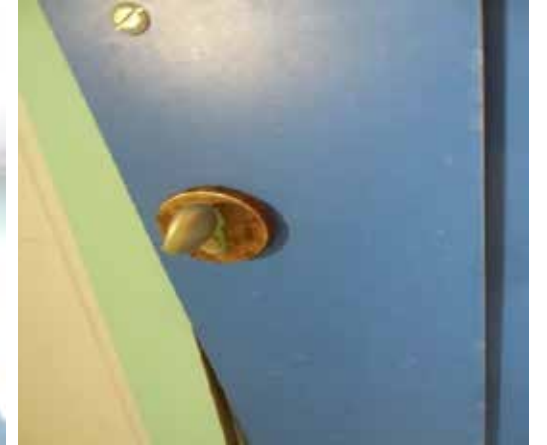
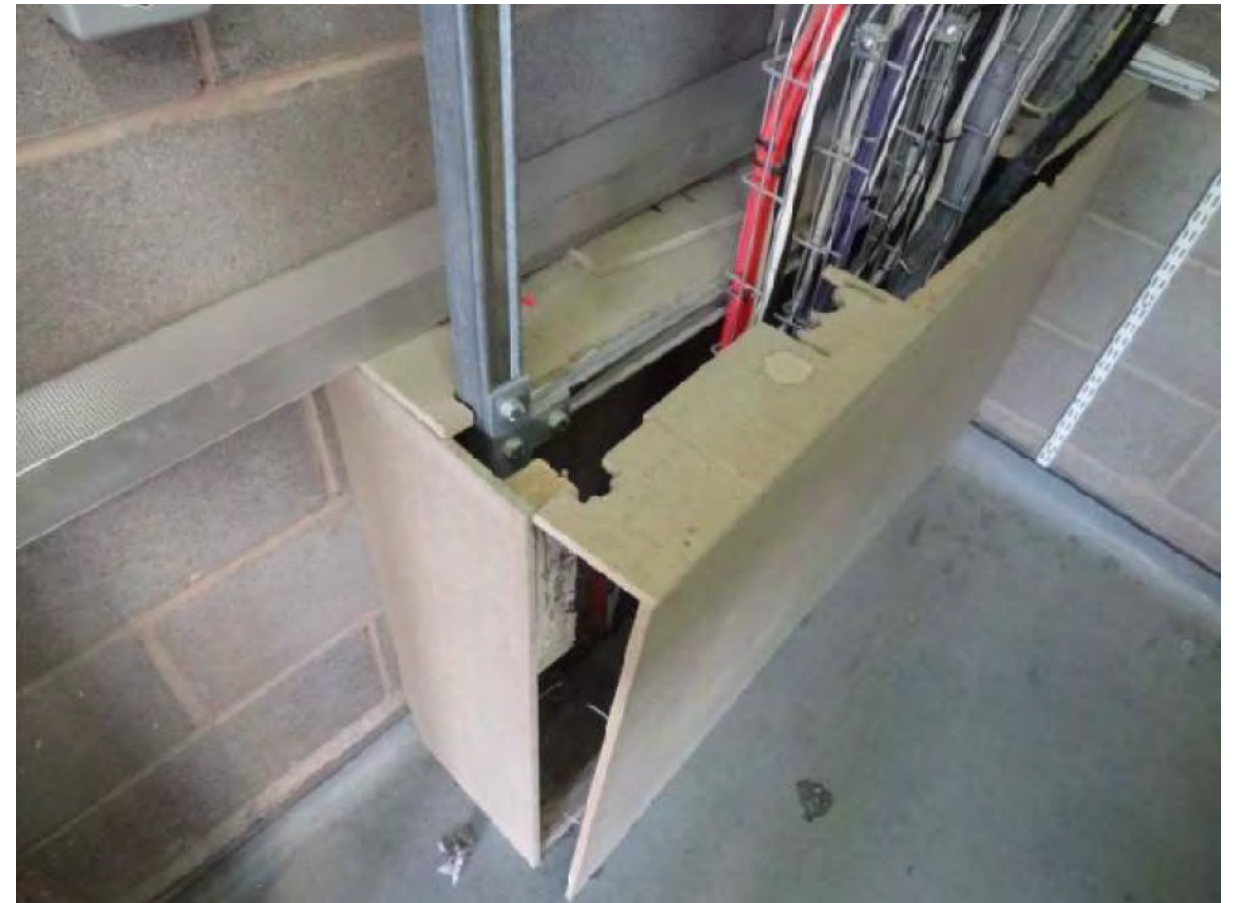
Images illustrating the condition of the DG One building prior to the start of the remedial works contract
